**Fish Passage Assessment
Report
Mare Brook Culverts**

Fish Passage Assessment
Component of Mare Brook
Watershed Assessment and
Community Engagement Project

Prepared by:
Stantec Consulting Services Inc.
30 Park Drive
Topsham, ME 04086

October 25, 2016

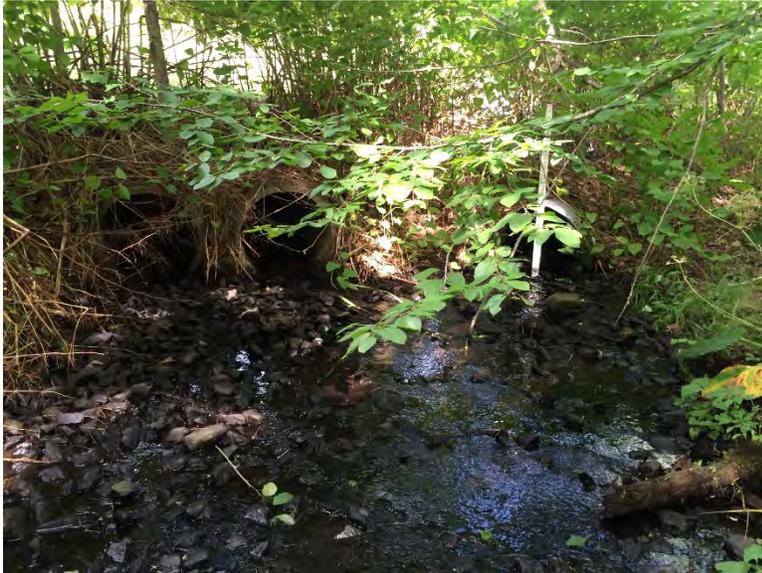
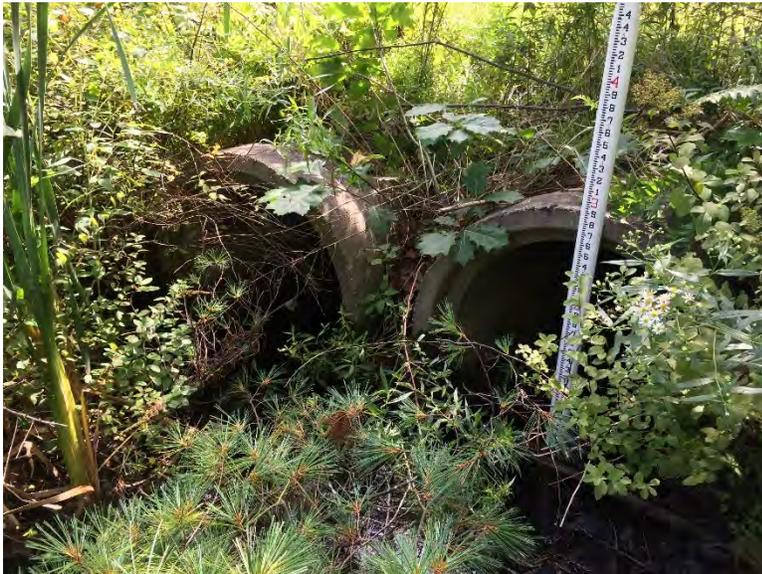
Conditions inside the culvert barrels were not observed during the site visit due to the length and relatively small diameter of the culverts.

The observed depth of water at the culvert barrel inlets was approximately 0.25 ft, which appears to result from a similar height of debris accumulation. The accumulated debris was largely comprised of woody material.

Photo 1: Outlet of Baribeau Drive Culverts. Stantec. August 2016.

Photo 2: Inlet to Right Culvert Group, Baribeau Drive Culverts. Stantec. August 2016.

The recommended action to improve upstream fish passage at the Baribeau Drive stream crossing is to replace the existing culverts with a larger culvert. An identified constraint to installation of a larger culvert(s) at this location is the relatively low height of the overlying roadway, which is estimated to be less than 3 ft. Providing conditions suitable for upstream fish passage by modifying the existing culverts or the downstream reach of stream channel (e.g., increasing the tailwater depth) does not appear to be feasible due to the small diameters and long lengths of these culverts.

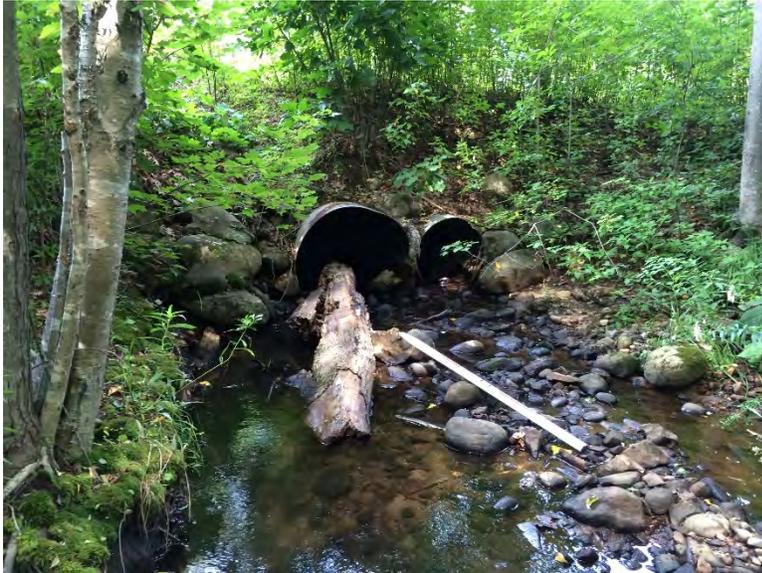
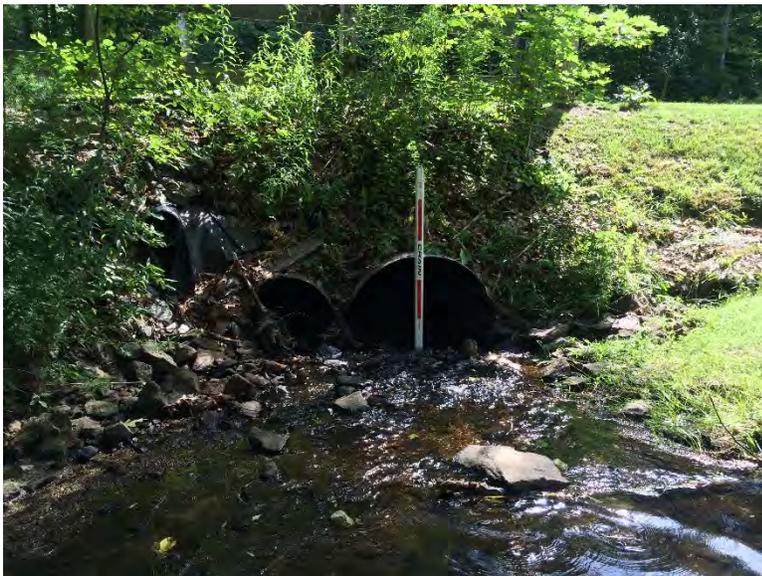
Rust and associated deterioration of metal was observed in both culvert barrels as well as rock debris. In addition, a log with a diameter of approximately 1.5 ft was lodged in the downstream end of the 4-ft-diameter culvert.

The submerged condition of the culvert outlet, heterogeneous flow conditions in the culverts that results from rock and woody debris in the culvert barrels, and the incised culvert inlets contribute to conditions that are expected to provide for upstream fish passage at this culvert during lower flow conditions. However, it is expected that inlet control at this culvert occurs during higher flows and is a barrier to upstream fish passage. The assigned rating for upstream fish passage at this stream crossing is therefore "good".

Photo 3: Outlet of Barrow Street Culverts. Stantec. August 2016.

Photo 4: Inlet of Barrow Street Culverts. Stantec. August 2016.

Conditions suitable for upstream fish passage at this culvert are good, but could deteriorate with failure of the culvert and/or accumulation of additional debris at the culvert inlets or in the culvert barrels. The recommended action to improve upstream fish passage at Barrow Drive stream crossing is to install a single, larger culvert.

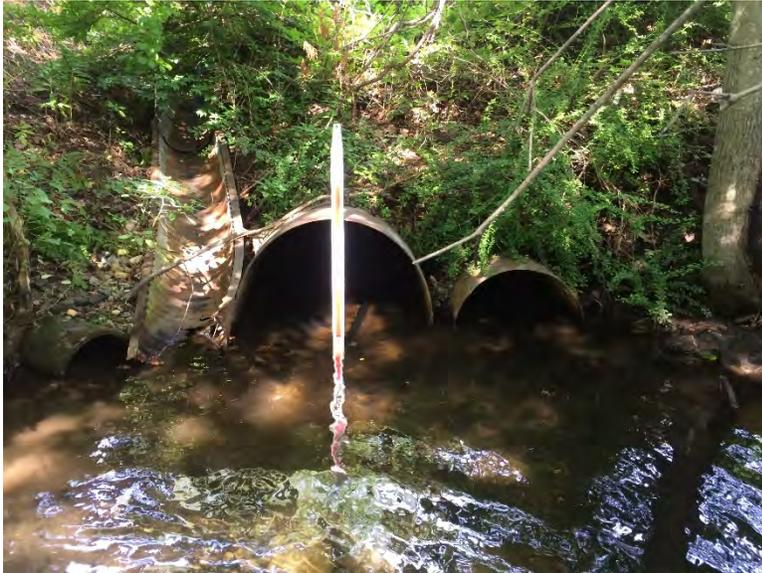
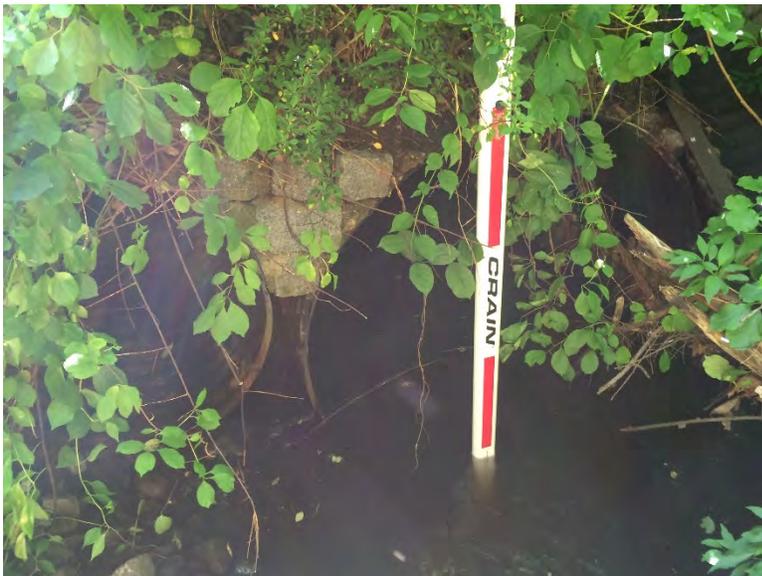
Rust and associated deterioration of metal was observed in both culvert barrels and deterioration of the concrete and rubble headwall was apparent.

The submerged condition of the right culvert and backwater through the culvert during lower flows are expected to provide for upstream fish passage at this culvert. However, it is expected that inlet control conditions occur during higher flows and are a barrier to upstream fish passage. The assigned rating for upstream fish passage at this stream crossing is therefore "good".

Photo 5: Outlet of MacMillan Drive Culverts. Stantec. August 2016.

Photo 6: Inlet of MacMillan Drive Culverts. Stantec. August 2016.

Conditions suitable for upstream fish passage at this culvert are good, but could deteriorate with failure of the culvert and/or accumulation of additional debris at the culvert inlets or in the culvert barrels. The recommended action to improve upstream fish passage at the MacMillan Drive stream crossing is to install a single, larger culvert.

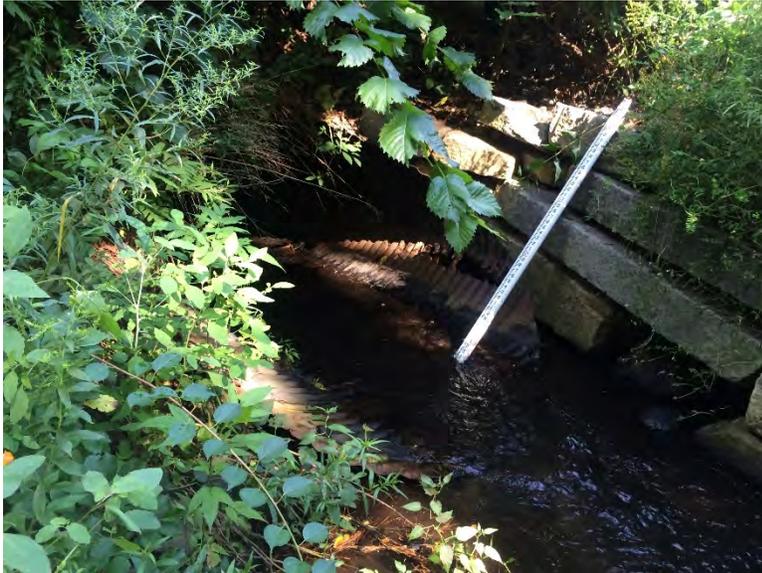
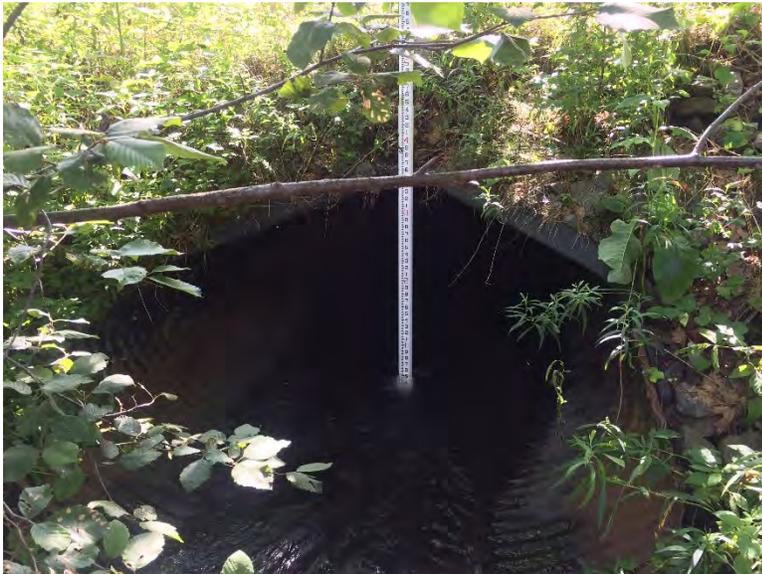
Rust and associated deterioration of metal was observed in the culvert barrel and deterioration of the concrete and rubble headwall was apparent. A few small boulders were observed in the culvert barrel. The observed depth of flow through the culvert during the site visit was uniform, and corrugations in the CMP reduce flow speeds during lower flows. The culvert barrel has an apparent slope, and the observed uniform flow condition indicate "barrel control" during lower flows such as those that were observed during the site visit. Some asphalt or tar was observed along the invert of the culvert barrel and appears to reduce otherwise beneficial effects of the corrugations to reduce flow speeds and thereby improve the potential for upstream fish passage.

The inlet invert appears to be perched and therefore resulted in some aggradation of sediment in the brook upstream from the culvert, and the observed depth of water at the inlet was approximately 0.2 ft.

The marginally perched condition of the culvert outlet and "barrel control" in the culvert during lower flows are expected to provide for very limited upstream fish passage at this culvert. While limited upstream passage through this culvert may be possible under ideal conditions, the assigned rating for upstream fish passage at this stream crossing is "not passable".

Photo 7: Outlet of Maine Street Culvert. Stantec. August 2016.

Photo 8: Inlet of Maine Street Culvert. Stantec. August 2016.

Conditions suitable for upstream fish passage at this culvert are poor to unpassable. The recommended action to improve upstream fish passage at the Maine Street stream crossing is to install a single, larger culvert.

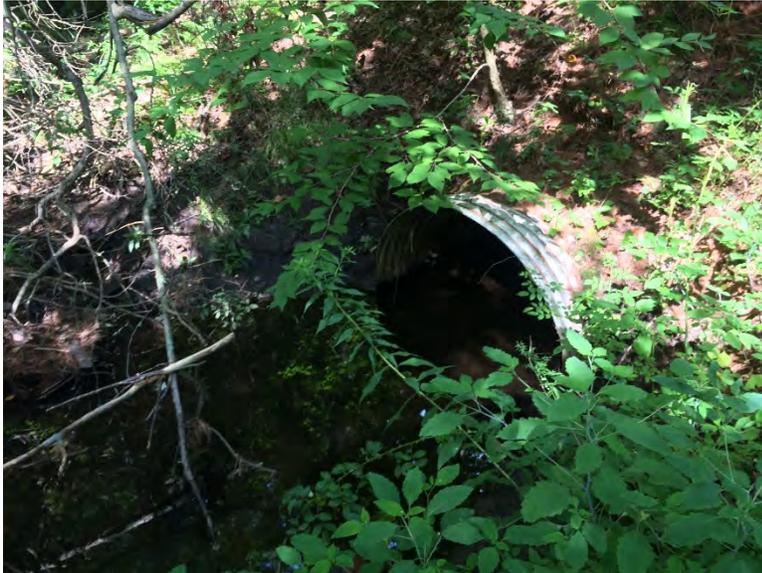
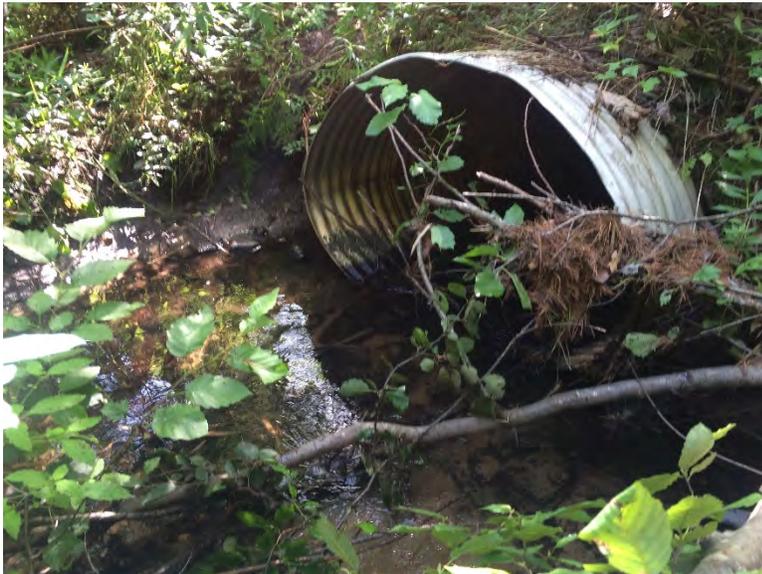
The culvert barrel appears to be constructed of aluminum, and corrosion was not observed. Observations during the site visit indicate that the culvert barrel was backwatered to within 10 ft of the culvert inlet, and corrugations in the culvert provide hydraulic conditions similar to a riffle.

The submerged and backwatered culvert outlet, backwatered conditions through most of the culvert barrel, and minimum observed depth of flow of approximately 0.2 ft at the culvert inlet are expected to provide for upstream fish passage at this culvert during lower flow conditions. The assigned rating for upstream fish passage at this stream crossing is therefore "good".

Photo 9: Outlet of Meadowbrook Road Culvert. Stantec. August 2016.

Photo 10: Inlet of Meadowbrook Road Culvert. Stantec. August 2016.

Conditions suitable for upstream fish passage at this culvert are good during lower flow conditions. However, it is expected that inlet control conditions occur during higher flows and are a barrier to upstream fish passage. The recommended action to improve upstream fish passage at the Meadowbrook Road stream crossing is to install a single, larger culvert.

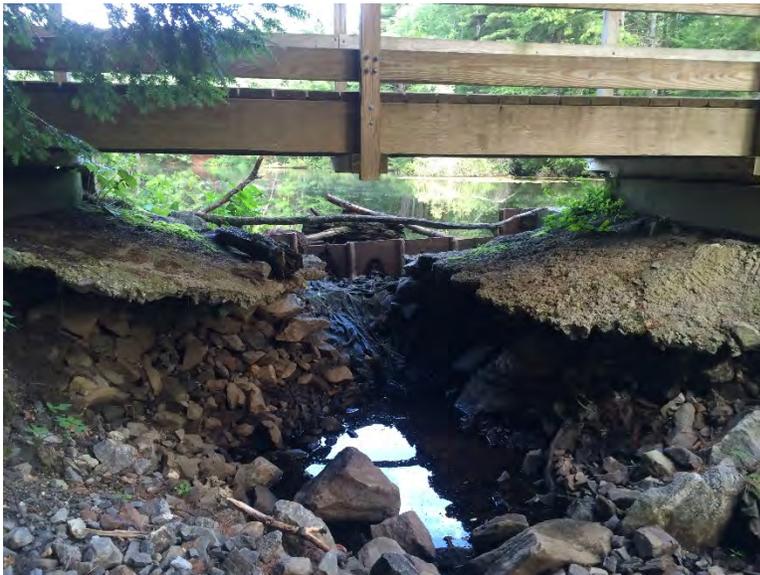
Coffin Pond Dam is located on Mare Brook downstream from Meadowbrook Road and upstream from State Route 123. The dam consists of an approximately 400-ft-long embankment with an uncontrolled spillway with an overlying footbridge. The spillway and footbridge are approximately 40 ft long and located adjacent to the right abutment of the dam. The spillway is constructed of stone rubble and cast-in-place concrete and is deteriorated. Steel sheet pile is present along the upstream side of the spillway, and was apparently installed as a repair to maintain water surface elevations in the impoundment. The estimated hydraulic and structural heights of the dam are 5 ft and 8 ft, respectively.

Photo 11: Coffin Pond Dam Spillway. Stantec. August 2016.

Potential actions to provide upstream fish passage at Coffin Pond Dam include installation of a fishpass or removal of the dam. Additional study is therefore recommended at this site.

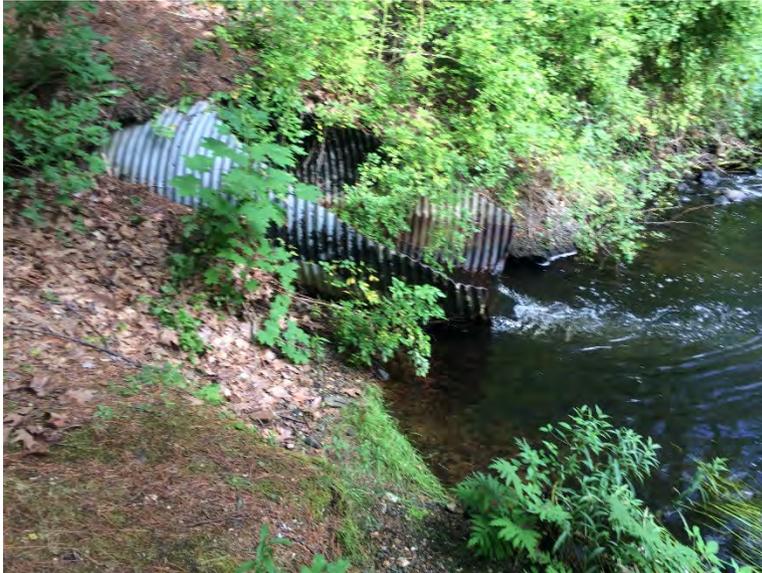
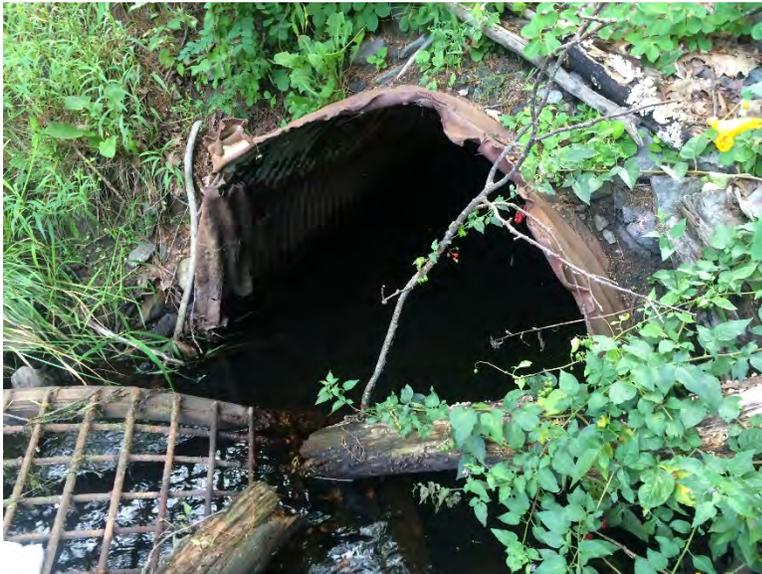
The culvert barrel outlet invert was at the water surface of the tailwater plunge pool but was hydraulically perched by approximately 0.3 ft. The depth of the plunge pool was estimated to be more than 3 ft, and substrate in the plunge pool included sand, gravel, and cobble material. Deterioration of the culvert barrel was observed adjacent to the outlet, including loss of metal and exposure of fill.

The culvert barrel has metal struts installed along the length of the culvert, and debris was observed lodged on the struts. An obstruction that results in a hydraulic drop of approximately 1 to 2 ft was observed in the culvert. The physical condition of the culvert appears to be very poor. Flow in the downstream end of the culvert appeared to exhibit pipe control.

The culvert inlet invert appears to be perched approximately 1 ft above the upstream thalweg, and the depth of water at the lip of the culvert was approximately 0.2 ft. A deteriorated debris grate was lying across the bottom of the culvert inlet and there was accumulated woody debris on the debris grate. Substrate upstream from the culvert consists of sand.

It is not expected that this culvert is upstream-passable due to the perched condition of the culvert outlet, the length of the culvert and shallow depths of water in the culvert, and accumulation of debris in the culvert and at on the debris grate at the culvert inlet. The assigned rating for upstream fish passage at this stream crossing is therefore "not passable".

Photo 12: Outlet of State Route 123 Culvert. Stantec. August 2016.

Photo 13: Inlet of State Route 123 Culvert. Stantec. August 2016.

Providing conditions suitable for upstream fish passage by modifying the existing culvert or the downstream reach of stream channel (e.g., increasing the tailwater elevation) does not appear to be practical or feasible due to the length, hydraulic gradient between the upstream and downstream ends (estimated to be approximately 2 ft), and poor condition of this culvert.

The recommended approach to improving upstream fish passage at the State Route 123 stream crossing is to replace the existing culvert with a larger culvert that is designed to provide upstream fish passage. Identified constraints to installation of a larger culvert(s) at this location include high use of State Route 123 and relatively deep fill (estimated to be approximately 12 ft) over the culvert.

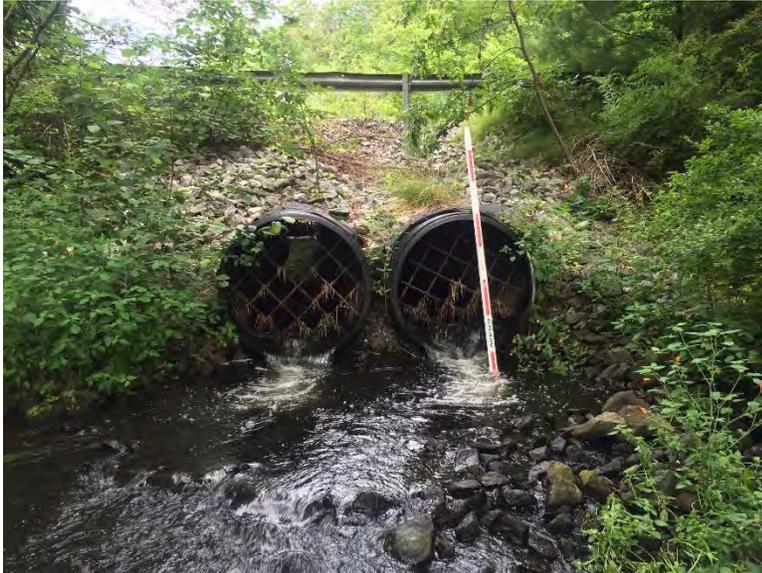
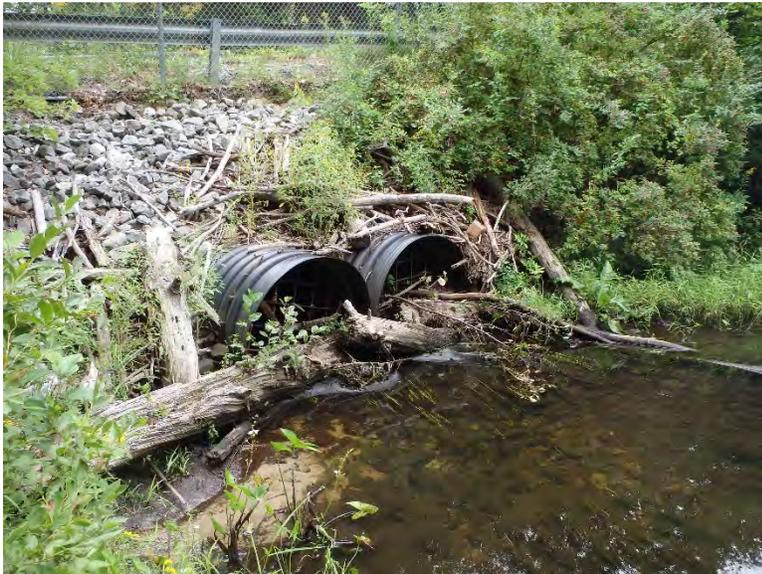
Flow through the culverts barrels was backwatered in the downstream section of both barrels due to accumulated debris on the security grates at the culvert outlet. Higher-speed flow was observed in the upstream section of both culvert barrels.

Observations through the culverts from the downstream end of the culverts indicate that accumulated debris on the culvert inlet security grates results in hydraulic drops of approximately 1 ft at the inlets to both culverts. Lack of access to the upstream side of this stream crossing during the site visit precluded observation of other conditions at the culvert inlets at this stream crossing. The photograph of the culvert inlet (Photo 15) was taken by Stantec during other Project studies.

Photo 14: Outlet of Security Road Culverts. Stantec. August 2016.

Photo 15: Inlet of Security Road Culverts. Stantec. August 2016.

Accumulation of debris on the inlet and outlet security grates is expected to prevent upstream fish passage at this stream crossing even if the tailwater elevation is increased to backwater the culverts. The recommended approach to improving upstream fish passage at the Security Road stream crossing is to replace the existing culverts with a single, larger culvert. If it is determined that access for motorized vehicles is not required along the Security Road, a potential alternative approach is to remove the roadway embankment and culverts. This approach could be combined with installation of a pedestrian bridge to facilitate use as a pedestrian trail.

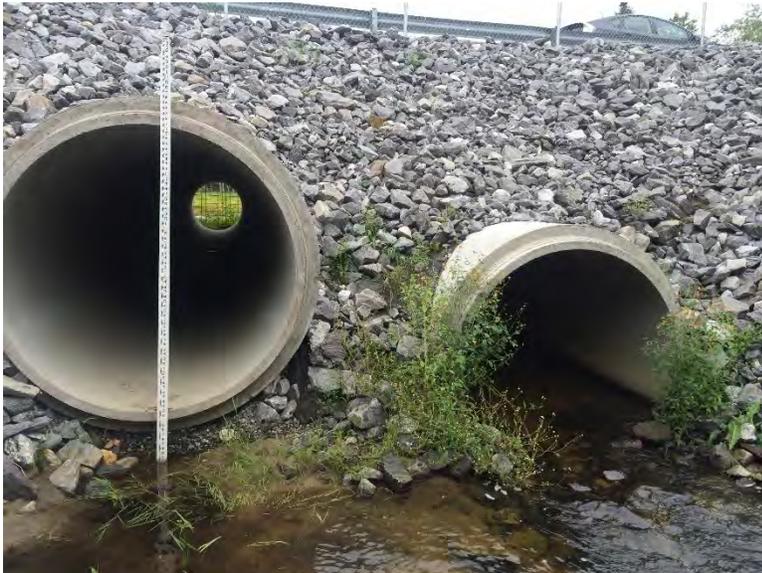
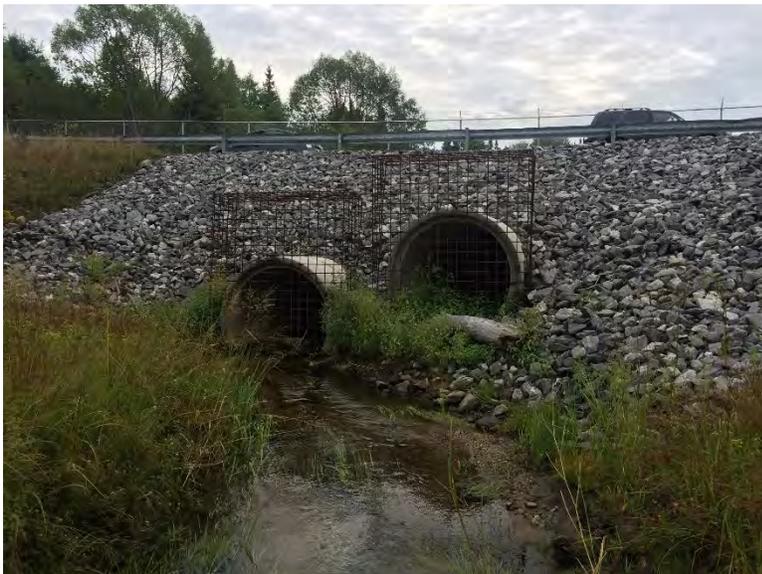
The Samuel Adams Drive stream crossing of Mare Brook consists of two adjacent PCP culverts with diameters of 6 ft and lengths of approximately 75 ft. The left culvert is set approximately 2.5 ft lower than the right culvert, and water was flowing through the left culvert during the site visit. This culvert appears to have been designed to provide for upstream fish passage during typical flow conditions.

The left (wetted) culvert barrel was backwatered during the site visit and sandy substrate was observed along the bottom of the full length of this culvert.

There are security grates over the inlets to both culverts that are combined with a security fence along the downstream side of the overlying roadway to limit access to the Brunswick Executive Airport runway area. Woody debris was accumulated on the debris gate over the inlet to the left (wetted) culvert, and the estimated depth of water at the inlet to the left culvert was approximately 0.9 ft. The observed debris on the security grate did not appear to be a barrier to upstream fish passage.

The submerged condition of the left culvert and backwater through the culvert during the observed, lower-flow condition are expected to provide for upstream fish passage at this culvert. While the observed debris on the security grate did not appear to be a barrier to upstream fish passage during the site visit, additional accumulation of debris could hinder or prevent upstream fish passage. The assigned rating for upstream fish passage at this stream crossing is "good".

Photo 16: Outlet of Samuel Adams Drive Culverts. Stantec. August 2016.

Photo 17: Inlet of Samuel Adams Drive Culverts. Stantec. August 2016.

This culvert appears to have been designed to provide for upstream fish passage during typical flow conditions and the culvert appears to be upstream-passable during the site visit, but accumulation of debris on the left-barrel security grate could prevent upstream passage. The suggest approach to providing upstream fish passage at this culvert is regular maintenance to remove debris from the security grate over the inlet to the left culvert barrel.

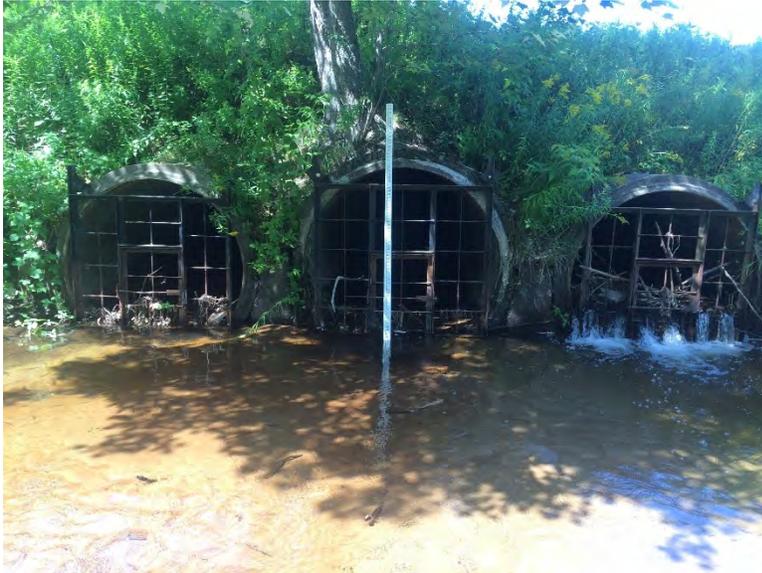
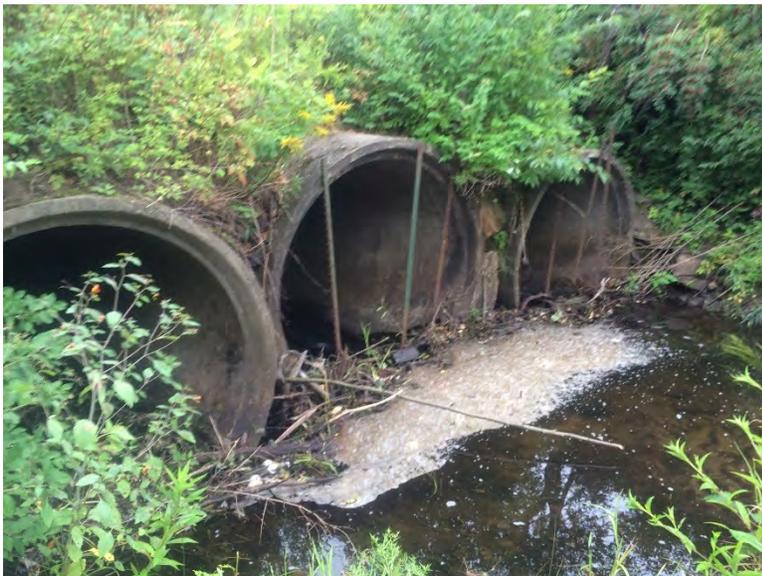
The culvert that conveys Mare Brook under the Brunswick Executive Airport runway consists of three PCP culverts with diameters of 6 ft and lengths of approximately 3,500 ft. Water was observed flowing into and out of the three culvert barrels during the site visit.

The culvert barrel outlet inverts were approximately 1 ft below the water surface of the tailwater plunge pool, but accumulated debris on security grates attached to the culvert outlets resulted in hydraulic drops of 0.5 to 1 ft at the culvert outlets during the site visit. Observed substrate in the plunge pool downstream from the culverts consisted of sand.

Accumulated debris at the culvert outlets and inlets may result in hydraulic conditions that hinder or prevent upstream fish passage, and the long length of the culvert may result in a behavioral barrier to upstream fish passage. In addition, there may be physical barriers in the culvert barrels that were not identified as part of this study. The assigned rating for upstream fish passage at this stream crossing is therefore "not passable".

Photo 18: Outlet of Runway Culverts. Stantec. August 2016.

Photo 19: Inlet of Runway Culverts. Stantec. August 2016.

A potential approach to restoring upstream fish passage in Mare Brook in the vicinity of the Brunswick Executive Airport runway is to realign the stream channel around the south side of the runway. This approach would be a significant undertaking, but is recommended for evaluation if it is determined that replacement of the existing culverts is necessary to maintain conveyance in Mare Brook. Additional study is therefore recommended at this site.

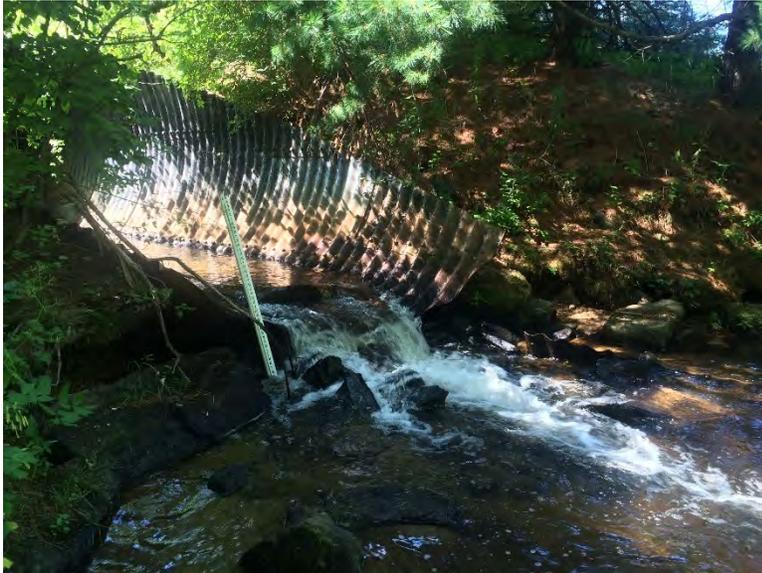
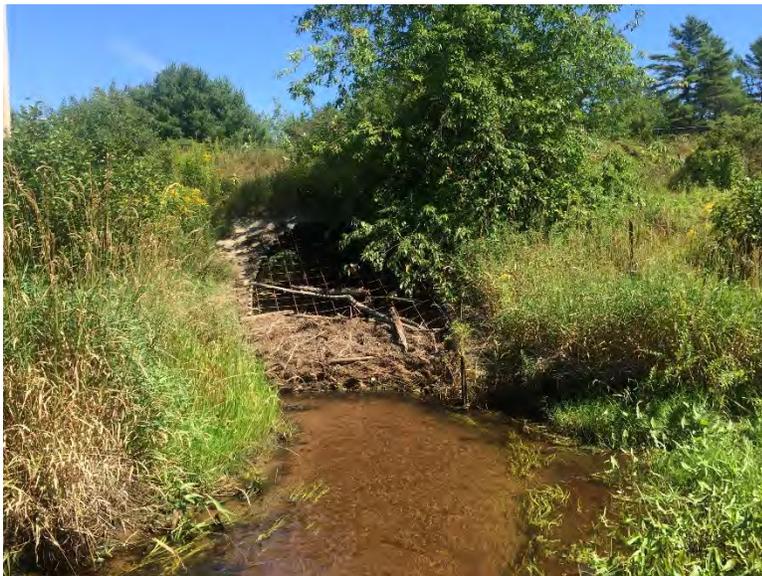
The culvert barrel outlet invert was perched approximately 1 ft above the water surface in the downstream plunge pool and was hydraulically perched by approximately 1.5 ft. Flow discharges onto a riprap apron downstream from the culvert outlet. The depth of the plunge pool was estimated to be more than 3 ft, and substrate in the plunge pool included sand, gravel, cobble, and boulder material. Deterioration and deformation of the culvert barrel was observed at the outlet.

It is not expected that this culvert is upstream-passable due to the perched condition of the culvert outlet and debris on the debris gate upstream from the culvert outlet. The assigned rating for upstream fish passage at this stream crossing is therefore "not passable".

Photo 20: Outlet of Major Pope Avenue Culvert. Stantec. August 2016.

Photo 21: Inlet of Major Pope Avenue Culvert. Stantec. August 2016.

Providing conditions suitable for upstream fish passage by modifying the existing culvert or the downstream reach of stream channel (e.g., increasing tailwater elevation) does not appear to be practical or feasible due to the hydraulic gradient between the upstream and downstream ends (estimated to be approximately 2.5 ft) and accumulation of debris on the two security grates that are installed in this culvert.

The recommended approach to improving upstream fish passage at the Major Pope Avenue stream crossing is to replace the existing culvert with a larger culvert that is designed to provide for upstream fish passage.

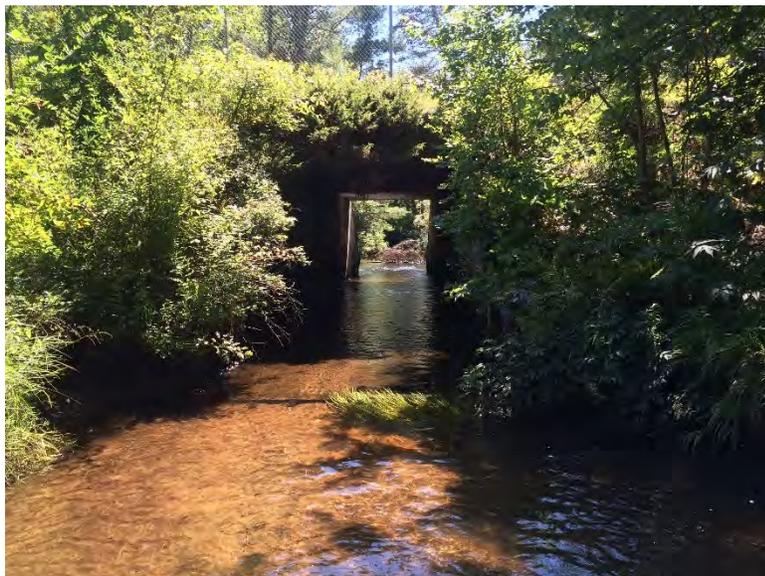
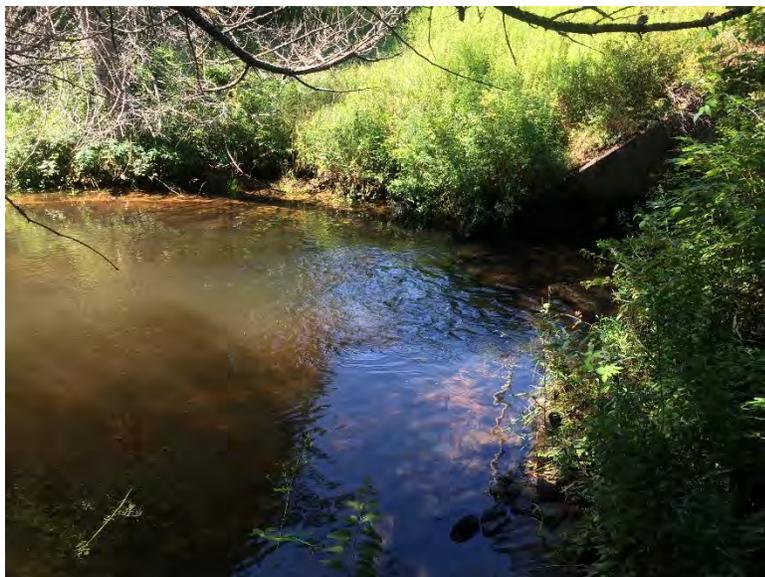
The Liberty Crossing Drive stream crossing of Mare Brook consists of a rectangular CIP culvert with a height and width of 9 ft. The estimated length of both culverts is approximately 60 ft. This stream crossing is located in the tidally affected reach of Mare Brook, and water was observed flowing seaward (“downstream”) through the culvert during the site visit.

**Photo 22: Inlet of Liberty Crossing Drive Culvert (seaward flow is into the image).
Stantec. August 2016.**

**Photo 23: Outlet of Liberty Crossing Drive Culvert (seaward flow is from right to left).
Stantec. August 2016.**

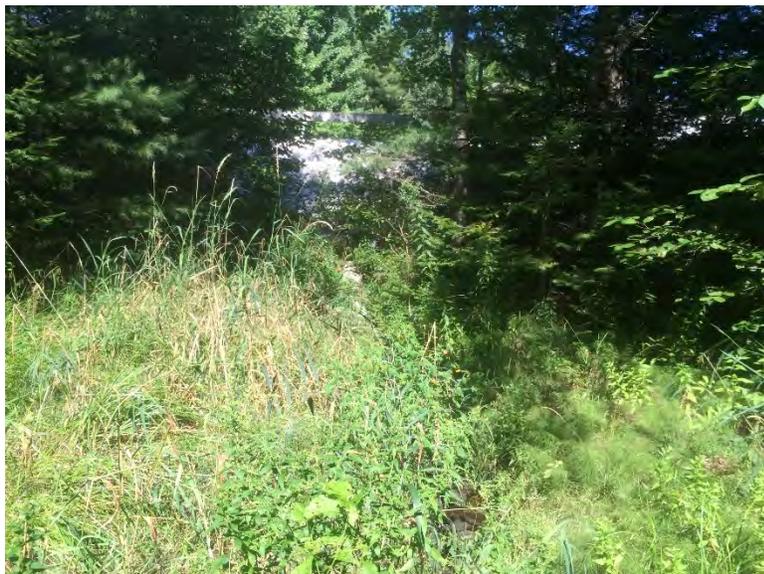
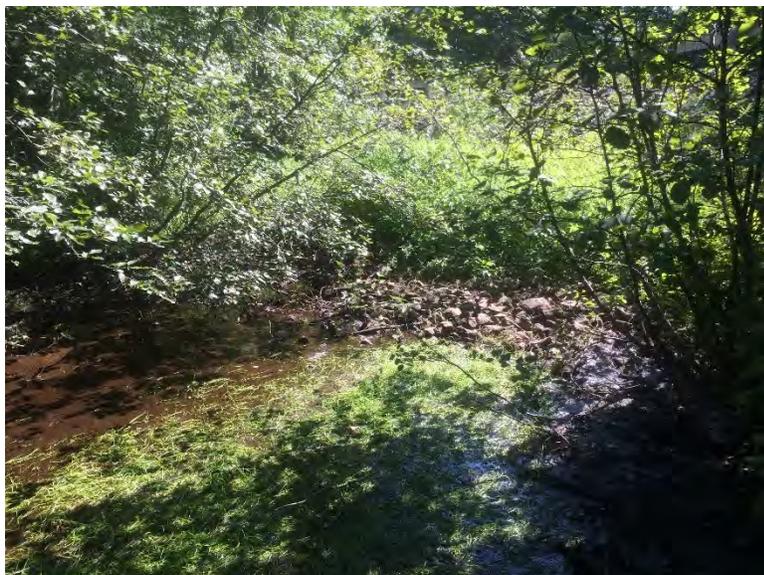
Photo 24: Channel (foreground) and Roadway Embankment (background) on Downstream Side of Beaver Pond Drive. Stantec. August 2016.

Photo 25: Merriconeag Stream Upstream from Beaver Pond Drive (flow is into rock on right side of image). Stantec. August 2016.

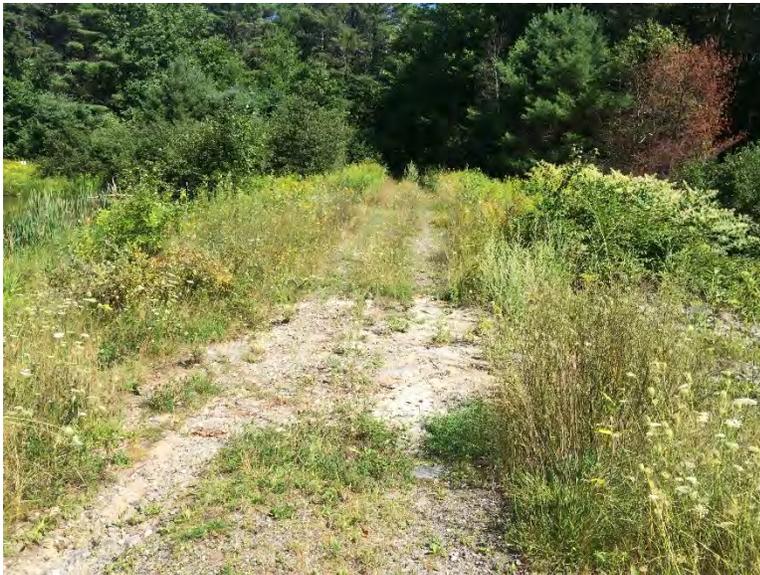
Photo 26: Picnic Pond Dam (flow is from left to right). Stantec. August 2016.

Potential actions provide upstream fish passage at Picnic Pond Dam include installation of a fishpass or removal of the dam. Additional study is therefore recommended at this site.

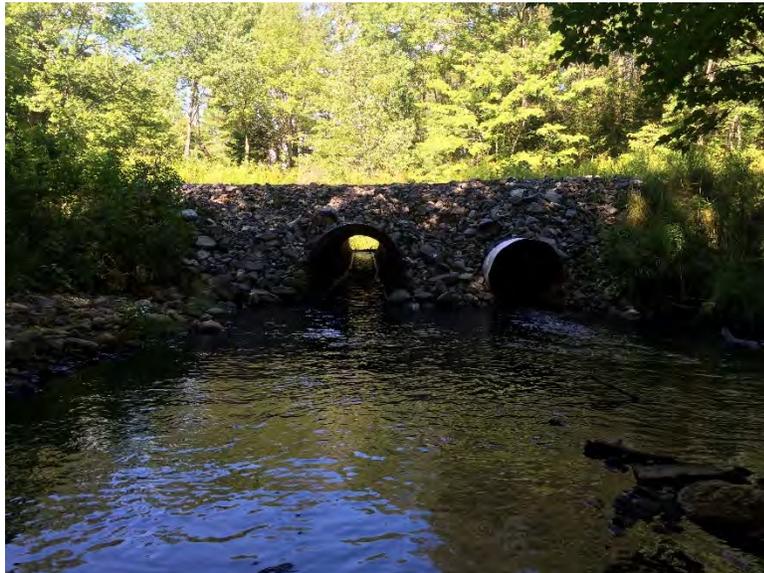
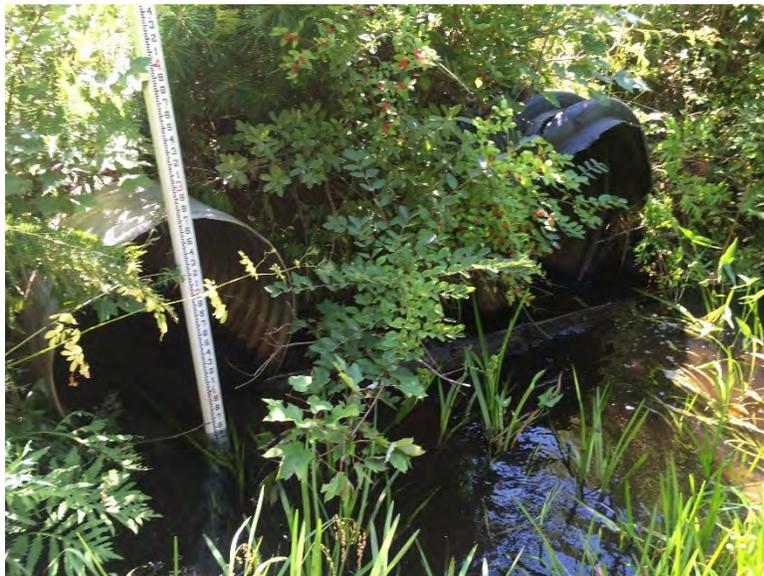
Photo 27: Outlets of Purinton Road Culvert. Stantec. August 2016.

Photo 28: Inlets of Purinton Road Culvert. Stantec. August 2016.
