Mare Brook Geomorphic Assessment

Geomorphic Assessment
Component of Mare Brook
Watershed Assessment and
Community Engagement Project

Prepared by:
Stantec Consulting Services Inc.
30 Park Drive
Topsham, Maine 04086

October 25, 2016

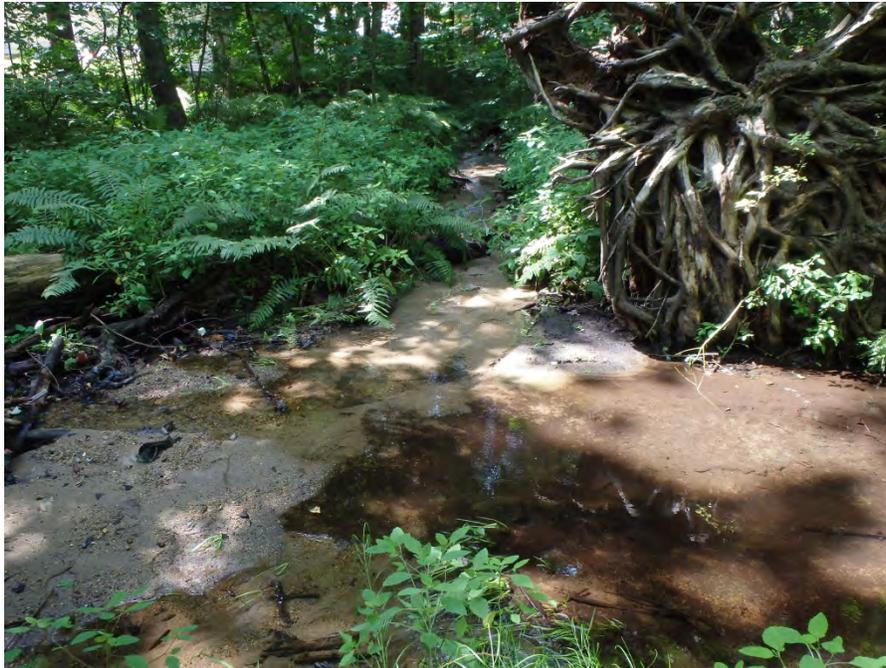
In urbanized environments, stormwater drain outfalls can contribute significant sediment loading to downstream reaches through direct inputs from road drainage (e.g., curb drains) and from structural deficiencies in buried pipe networks (e.g., separated pipe joints). Stormwater drainage networks can result in significant inputs of sand-sized fractions of sediment, resulting in impairment to geomorphic condition through channel aggradation.

Photo 1. Example of excessive sediment supply. Stantec, August 15, 2016.

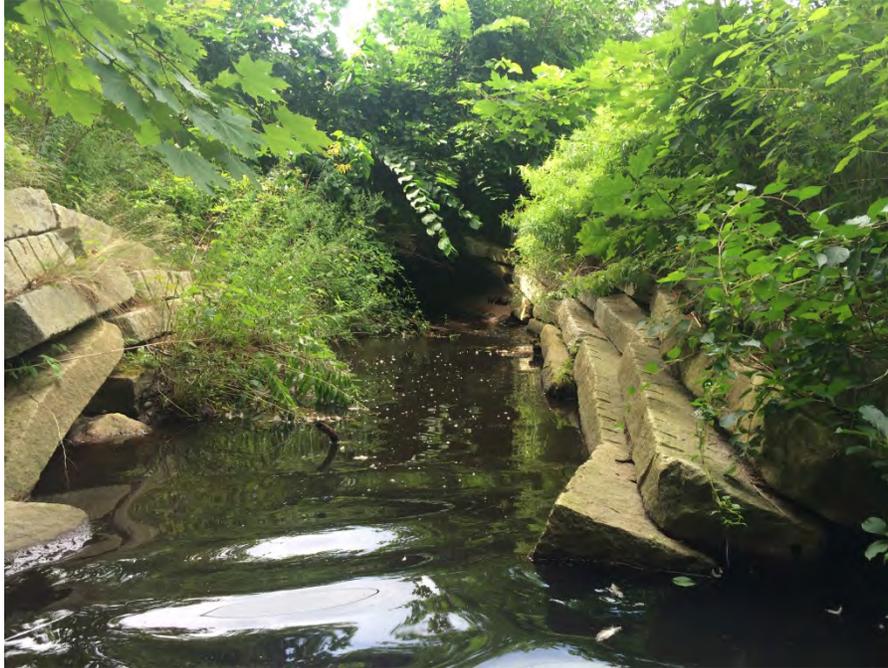
Stream channel alteration occurs in many forms, including straightening, diverting, encroachment, filling, and damming. Stream channel alteration has the potential to destabilize stream channels through increased bed aggradation or degradation (vertical instability) and increased bank erosion or material deposition (lateral instability).

Photo 2. Example of stream channel alteration (and encroachment). Stantec, August 15, 2016.

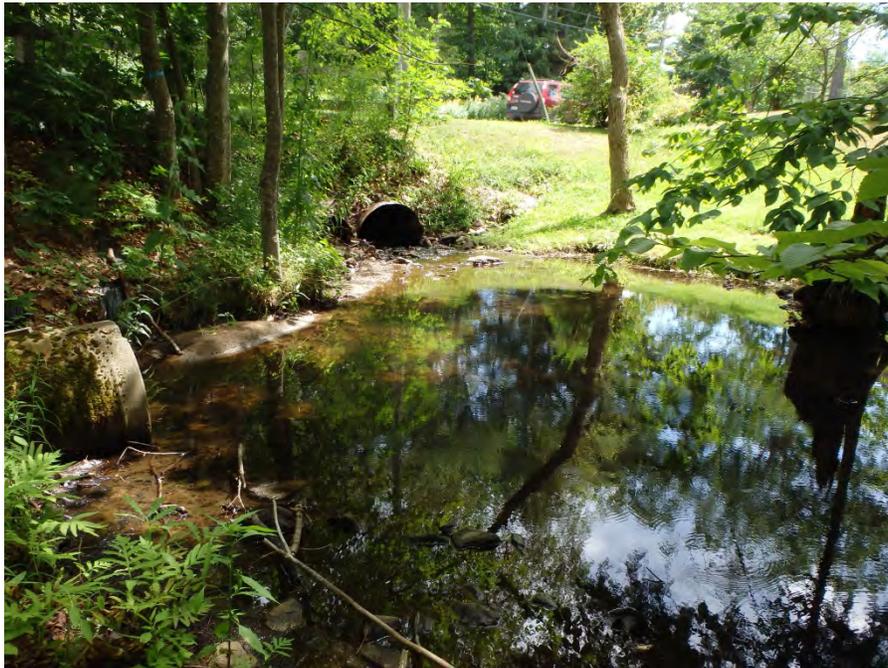
Stream crossings can result in interruption of natural sediment transport processes. Stream crossings installed with inlet elevations set above the natural stream bed result in a decrease in energy slope and therefore decrease the sediment transport capacity resulting in channel aggradation. Debris buildup at the inlet to a stream crossing structure also can result in channel aggradation upstream from the structure. Undersized and crossings installed at a slope steeper than the natural stream bed can result in vertical and lateral channel instability downstream from a crossing.

Photo 3. Example of a perched inlet condition (with debris on culvert inlet). Stantec, August 15, 2016.

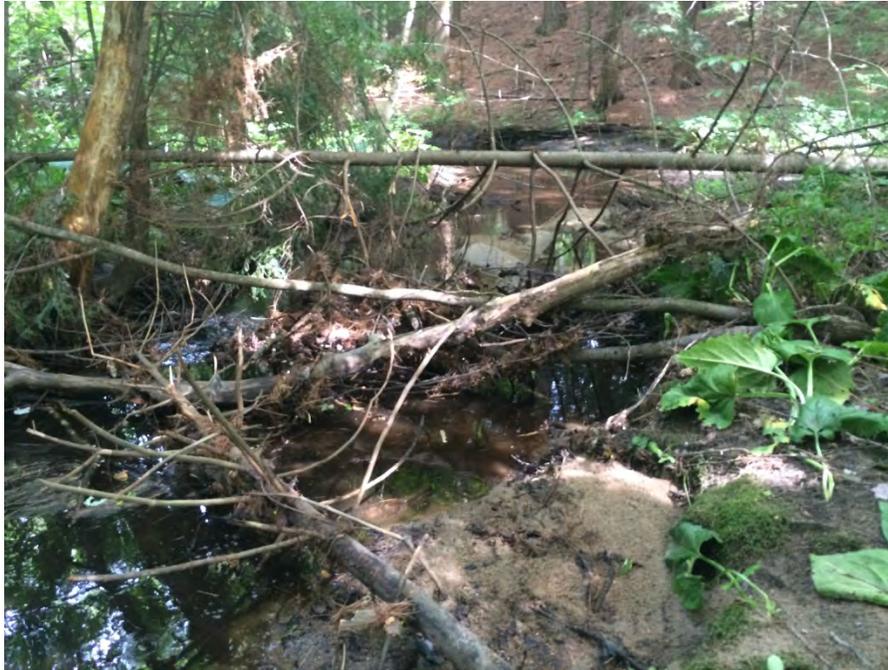
Debris can collect at specific locations along a channel and force flows into the channel bed and banks, leading to vertical and lateral channel instability around debris jams. Such features are typically a natural phenomenon (i.e., wood debris) that come and go with periodic floods or beaver activity, but they can also be affected by anthropogenic alteration, such as at culvert inlets.

Photo 4. Example of a debris jam. Stantec, August 15, 2016.

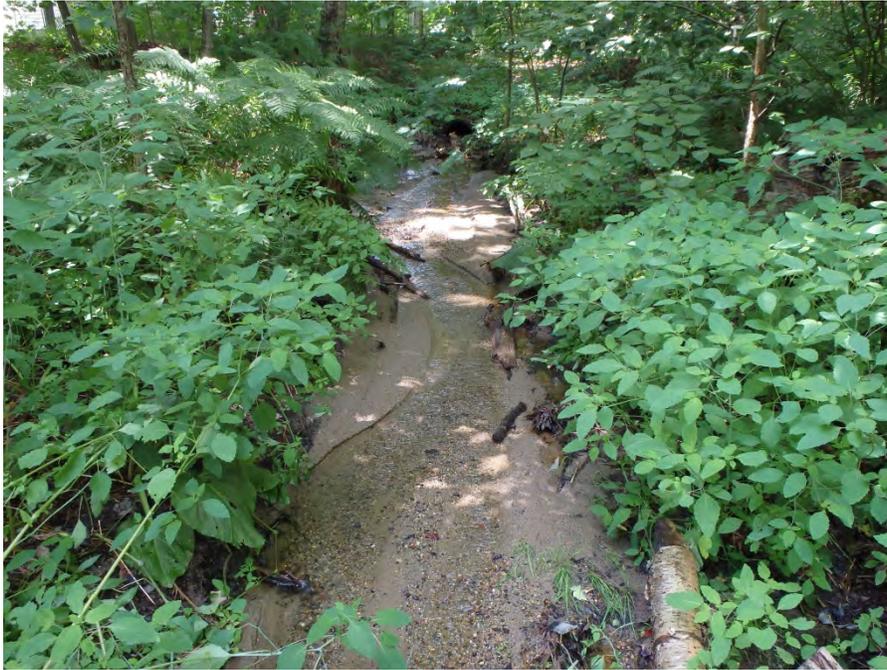
Mare Brook flows from the culvert at Baribeau Drive with limited sediment supply due to a perched inlet culvert condition that limits sediment supply from the upstream reach. However, the brook within this reach is supplied with sediment from various stormwater and/or subsurface drainage systems, as evidenced by sand aggradation downstream from such features, and from channel bed and bank erosion adjacent to accumulations of wood debris. The low-gradient nature of this reach combined with ample wood debris supply and excess sediment supply within this reach have resulted in channel aggradation and channel widening through bank erosion along the upper half of this reach.

Photo 1. Excess sediment loading from stormwater outfall between Baribeau Drive and Barrows Street. Stantec, August 15, 2016.

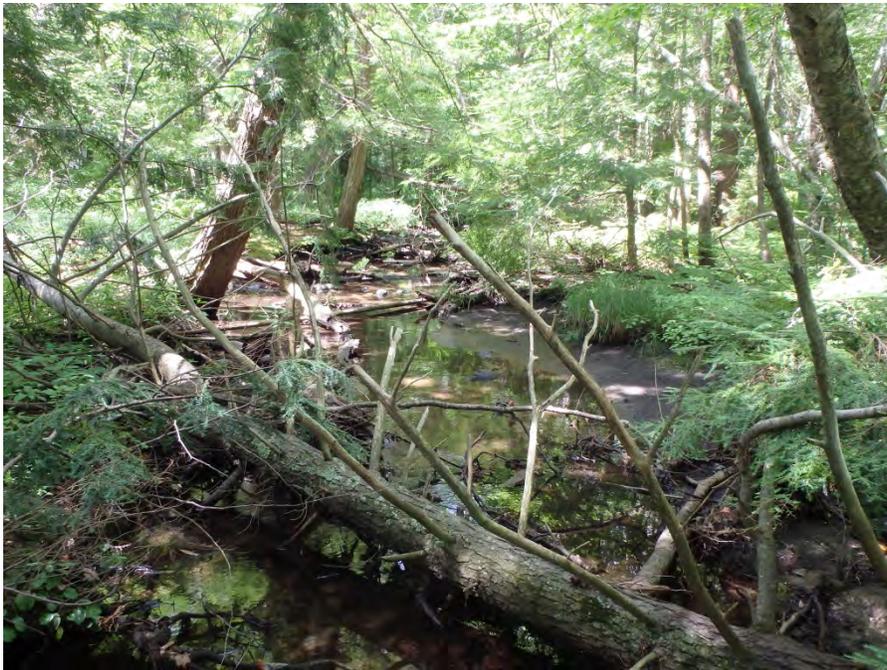
debris weir structure apparently installed as “stepping stone” channel crossings for local residents further affects sediment transport. Lateral channel migration resulted in channel impingement against the valley wall near one residence at some point in the past; however, this condition appears to have been remedied by installation of wood debris revetment. The downstream end of the reach is affected by a perched culvert inlet at Barrows Street, which contributes to channel aggradation and lateral instability.

Photo 2. Excess sediment loading and wood debris between Baribeau Drive and Barrows Street. Stantec, August 15, 2016

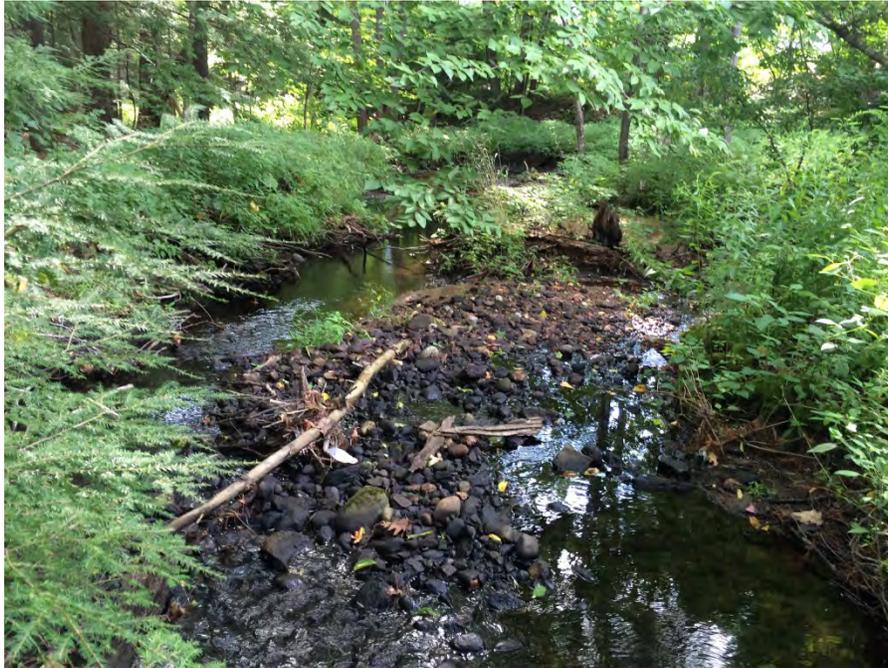
Mare Brook between Barrows Street and MacMillan Drive receives a limited sediment supply from the upstream reach due to a perched culvert inlet condition. However, lateral channel adjustment is occurring downstream from Barrows Street, as evidenced by areas of bank erosion. High-energy flows resulting from a potentially undersized stream crossing at Barrows Street are a potential driver for bank erosion processes within this reach.

Photo 3. Minor vertical and lateral instability between Barrows Street and MacMillan Drive. Stantec, August 15, 2016.

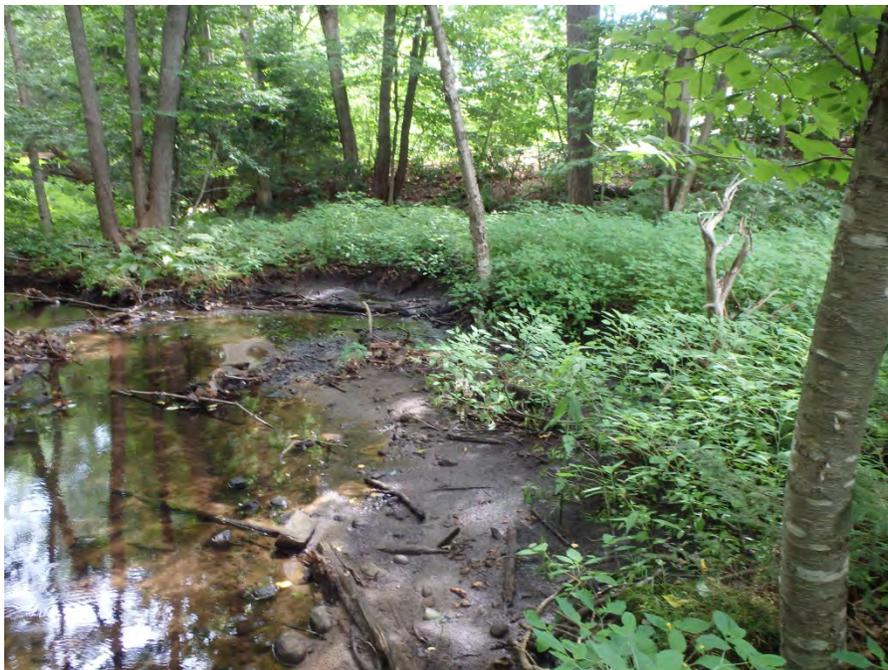
Sediment transport processes appear to be functional within this reach due to sufficient stream energy due to the moderate channel slope through this reach. A “moderately unstable” condition is assigned to this reach due to the presence of areas of lateral instability that could result in a condition downgrade to “unstable” if bank erosion rates increase or sediment transport processes are interrupted (e.g., by wood debris addition).

Photo 4. Minor lateral channel instability between Barrows Street and MacMillan Drive. Stantec, August 15, 2016.

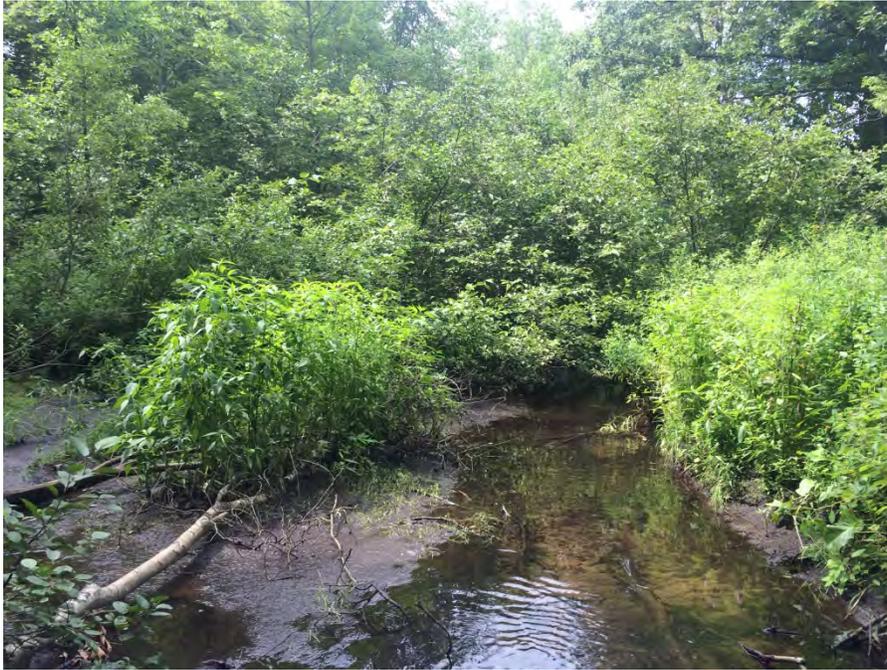
The slope of Mare Brook flattens between MacMillan Drive and Maine Street, resulting in decreased energy to transport sediment through the reach. Channel aggradation has occurred immediately downstream from MacMillan Drive as a result of sediment sourced from the upstream reach being deposited within this reach. Wood debris jams within this reach have resulted in a multi-channel condition, decreasing sediment transport capacity. A perched culvert inlet condition at Maine Street further exacerbates this issue and results in lateral instability due to channel aggradation issues within the small backwater created by the perched inlet to the Maine Street culvert.

Photo 5. Low-gradient due to perched culvert inlet at Maine Street. Stantec, August 15, 2016.

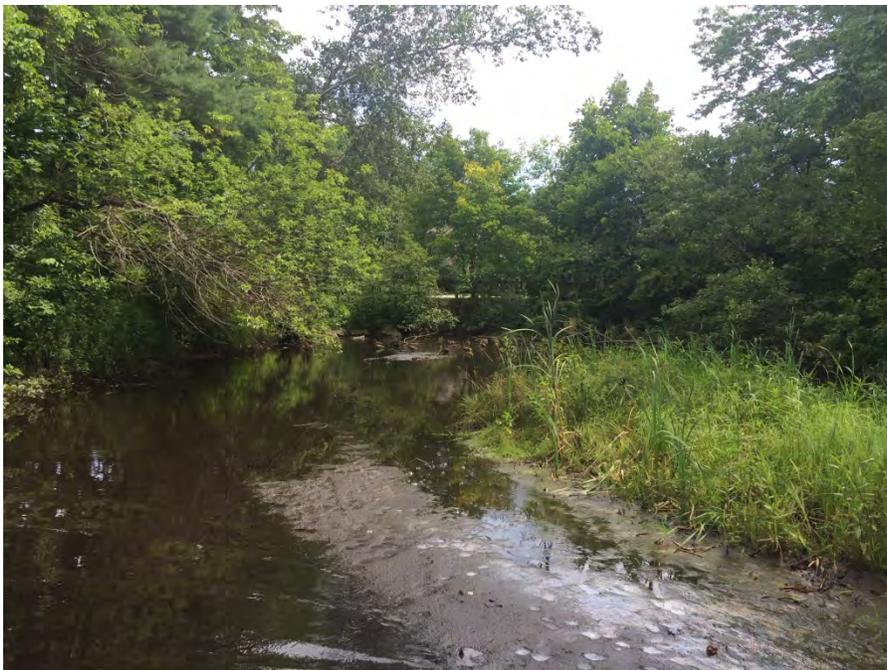
This reach is assigned a “moderately unstable” rating due to the multi-channel condition and lateral instability associated with the constraints to sediment transport identified above. A “moderately unstable” condition is assigned in lieu of an “unstable” condition as this reach appears to be trending towards a stable condition through vegetation control of the channel under the existing Maine Street culvert inlet condition. A “moderately unstable” rating was also assigned over a “stable” rating due to the potential for the Maine Street culvert inlet condition to change, and therefore result in channel adjustment within the reach.

Photo 6. Backwater created by perched culvert inlet at Maine Street. Stantec, August 15, 2016.

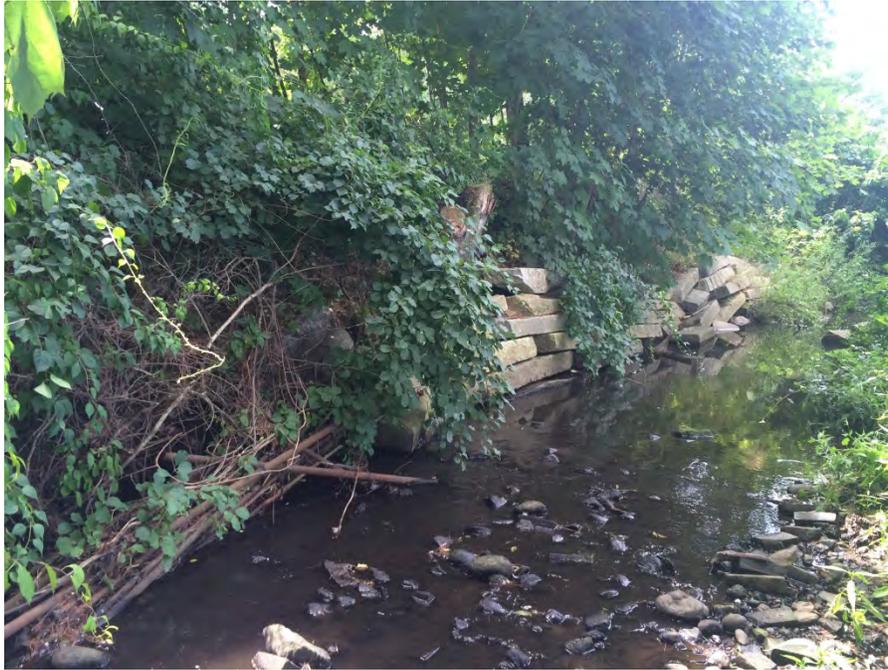
The stream channel immediately downstream from Maine Street is confined between granite block retaining walls and anthropogenic fill for a distance of a few hundred feet. Increased energy resulting from a potentially undersized culvert impinging upon downstream retaining walls and channel confinement results in increased shear forces on the channel bed and banks within the walled section of this reach. Vertical channel degradation has formed a scour pool through this reach, undermining and destabilizing adjacent granite block retaining walls. The scour pool at this location is partially held in check by wooden sheet piling and brick debris spanning the channel downstream from the scour pool.

Photo 7. Stream channel alteration downstream from Maine Street. Stantec, August 15, 2016.

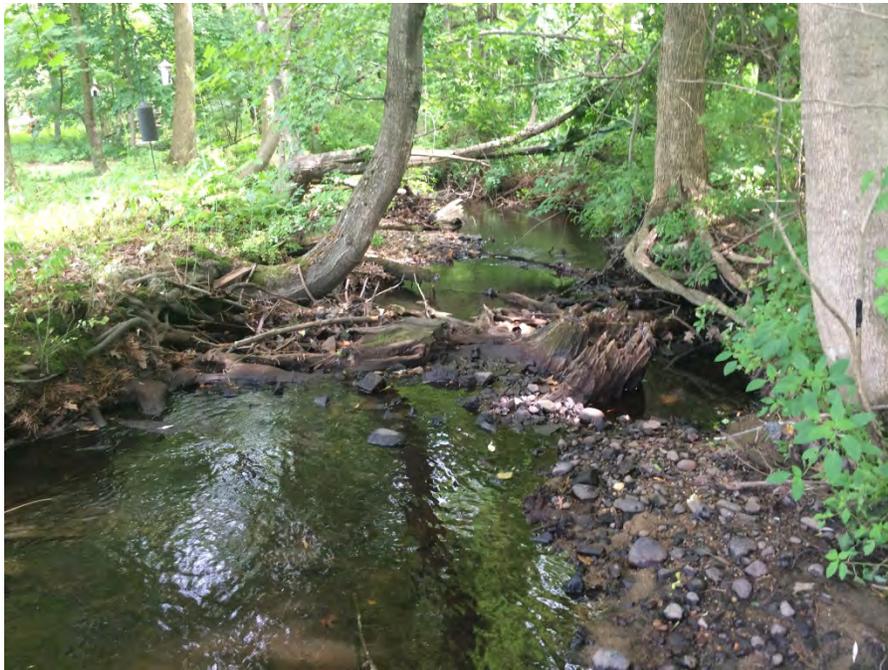
Lateral channel instability is also apparent near the downstream extent of the channel revetment. Scour countermeasures consisting of bundled metal pipes have previously been installed to assist with bank protection in this area. However, this revetment technique appears to be ineffective as bank erosion in the vicinity of the pipes is actively occurring during high flow events. Anthropogenic straightening of the channel is also apparent in this area. A large, mid-channel stump with roots continuing into either bank of the stream is noted as evidence of the channel being anthropogenically forced to the current alignment at some time prior. An anthropogenic berm across the floodplain downstream from this reach in proximity to a parcel property line is further evidence of historic channel manipulation in this area.

Photo 8. Evidence of stream channel alteration (mid-channel stump) downstream from Maine Street, indicative of a channel that was forced to the present location. Stantec, August 15, 2016.

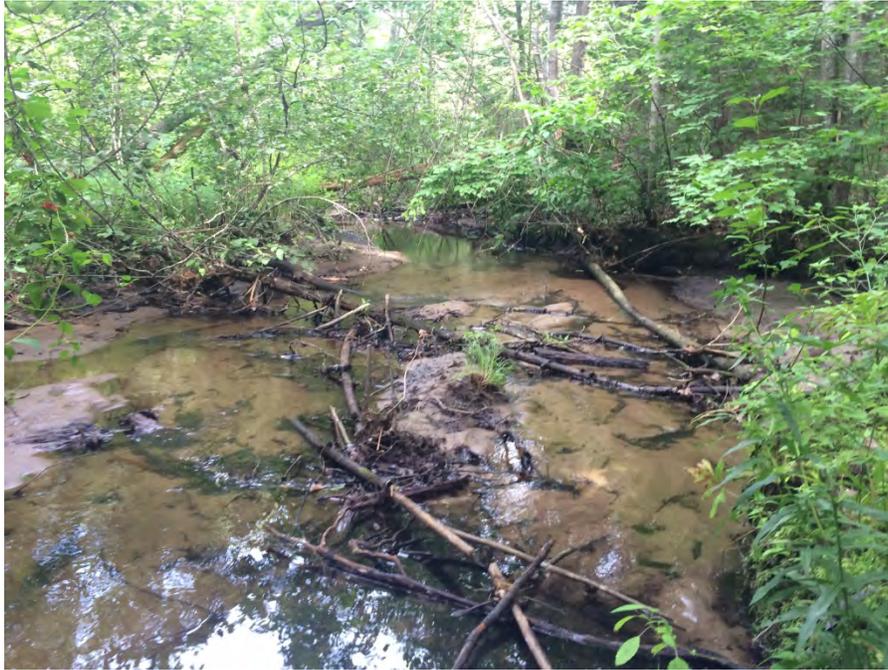
This reach is assigned a "moderately unstable" rating upstream from Coffin Pond Dam and an "unstable" rating downstream from the dam due to channel aggradation and debris loading. A "moderately unstable" rating was applied to the reach upstream from Coffin Pond due to the channel in this reach trending towards a "stable" rating through vegetative influence. However, failure or removal of Coffin Pond Dam may result in upstream channel adjustment.

Photo 9. Poor sediment transport capacity upstream from Coffin Pond Dam. Stantec, August 15, 2016.

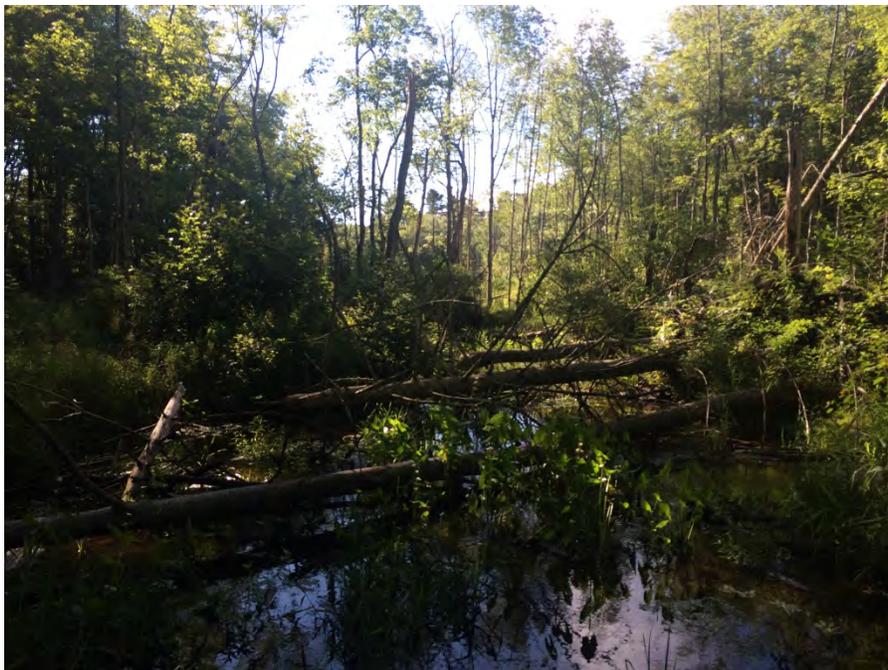
Downstream from Coffin Pond Dam, coarse sediment apparently sourced from erosion of the dam structure during high flow events has aggraded within the channel resulting in a lack of a well-defined channel through the adjacent wetland complex. Debris loading within this reach further interrupts channel forming processes. A perched culvert inlet condition at State Route 123, combined with debris jamming at the inlet and within this culvert, contributes to the reduced sediment transport capacity within this reach and results in channel aggradation.

Photo 10. Debris jams and poor sediment transport downstream from Coffin Pond Dam. Stantec, August 16, 2016.

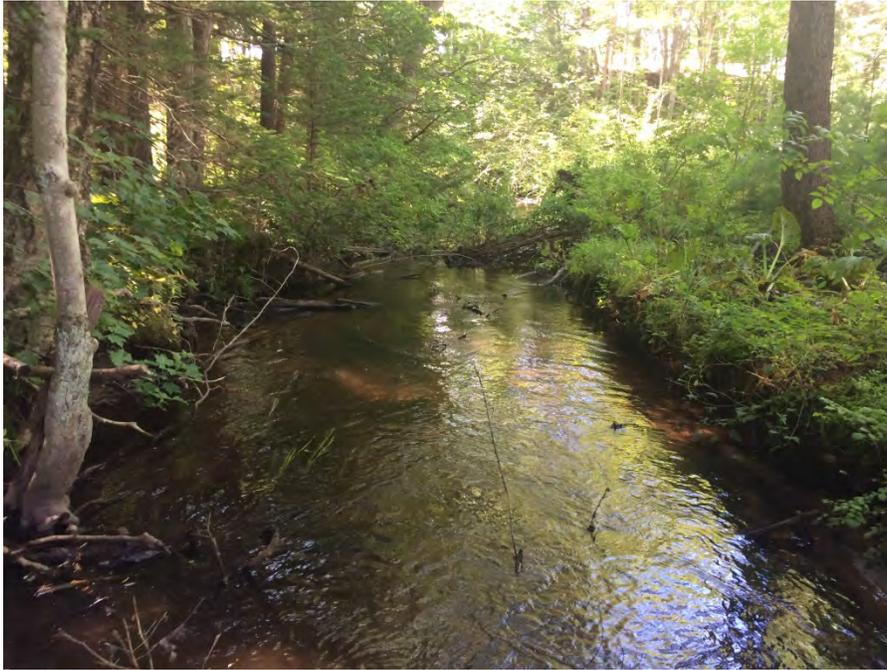
Despite minor aggradation of material (e.g., sand) within the channel along the lower portion of this reach, this reach is assigned a "stable" rating due to lack of apparent negative influences on overall geomorphic condition.

Photo 11. Stable channel between State Route 123 and Security Road. Stantec, August 16, 2016

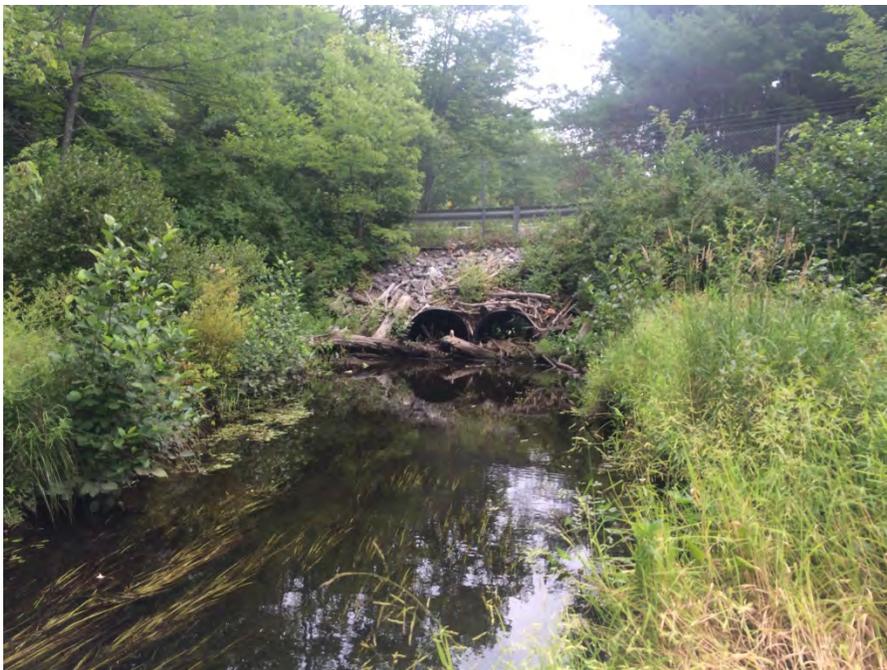
Photo 12. Perched inlet condition and debris jamming at Security Road. Stantec, August 16, 2016.

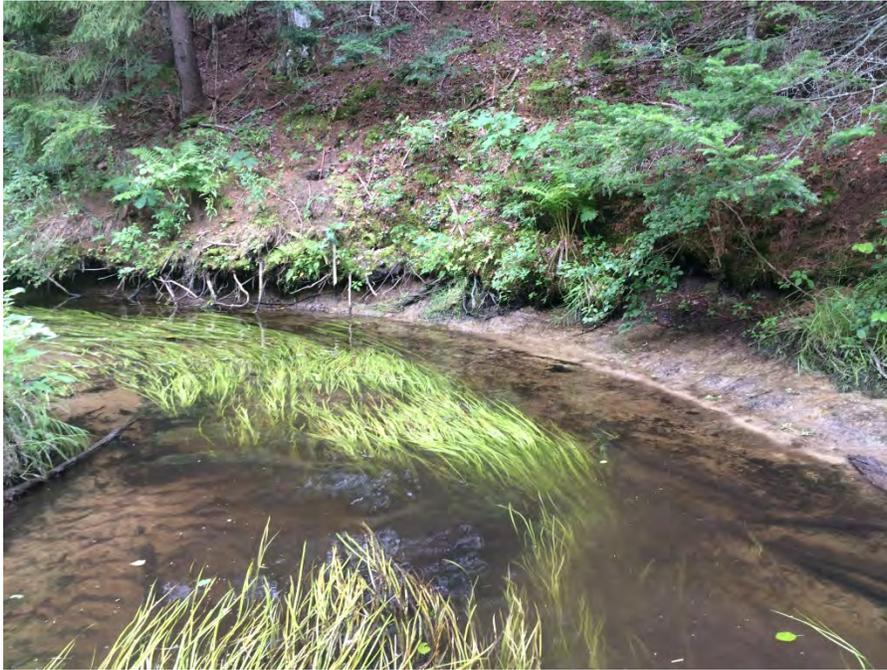
Photo 13. Minor channel lateral migration between Security Road and Samuel Adams Drive. Stantec, August 16, 2016.

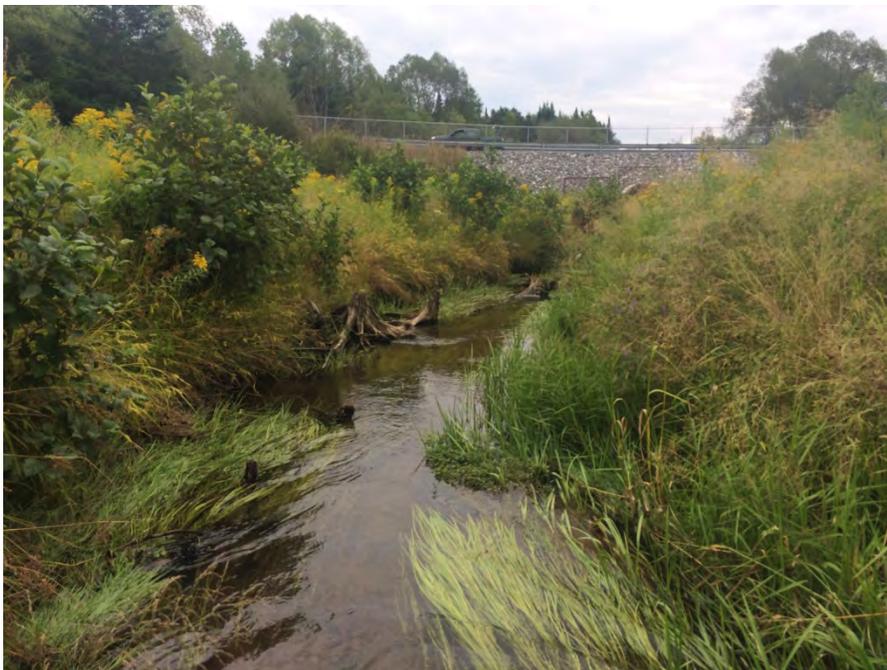
Photo 14. Vegetation-controlled channel upstream from Samuel Adams Drive. Stantec, August 16, 2016.

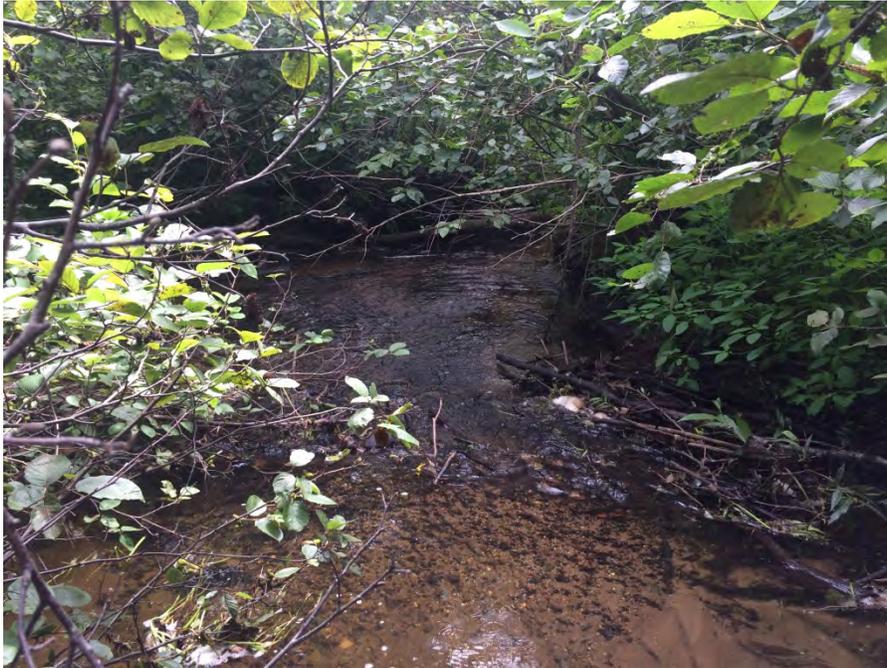
Photo 15. Vegetation-controlled channel between Samuel Adams Drive and Brunswick Executive Airport runway culverts. Stantec, August 16, 2016.

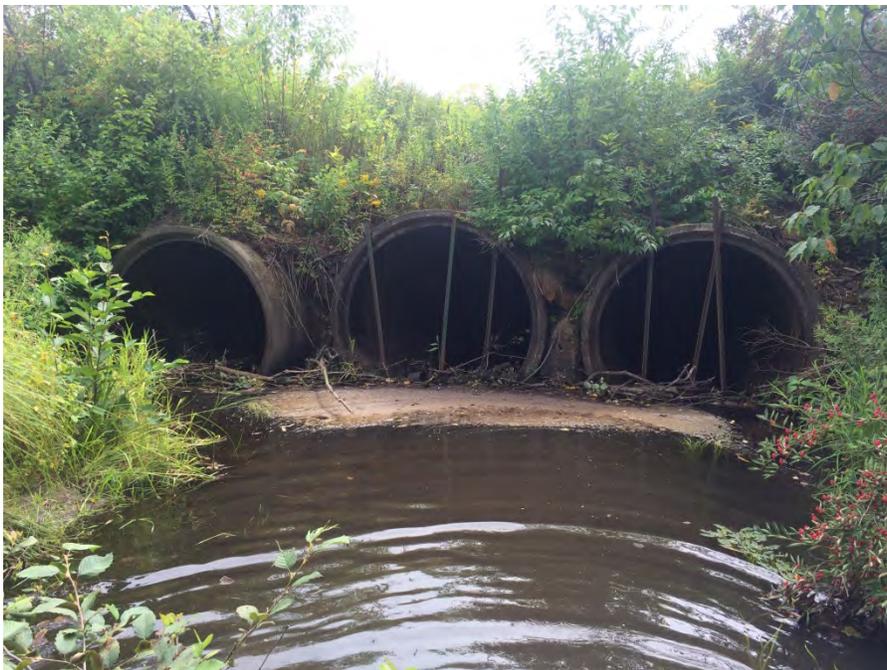
Photo 16. Debris jam (beaver dam) in front of Brunswick Executive Airport runway culvert inlets. Stantec, August 16, 2016.

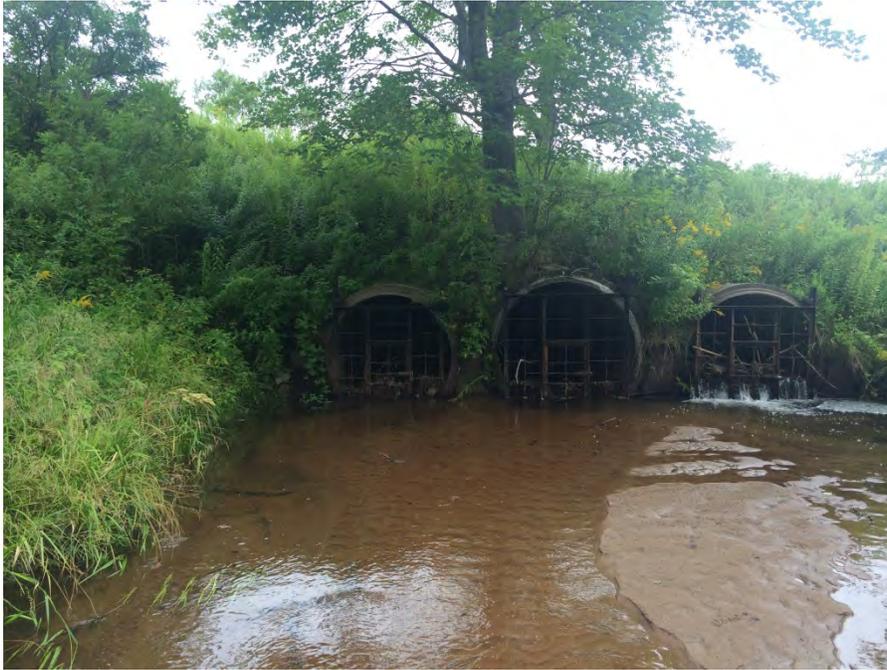
Photo 17. Excessive sediment loading downstream from Brunswick Executive Airport runway culvert outlets. Stantec, August 16, 2016.

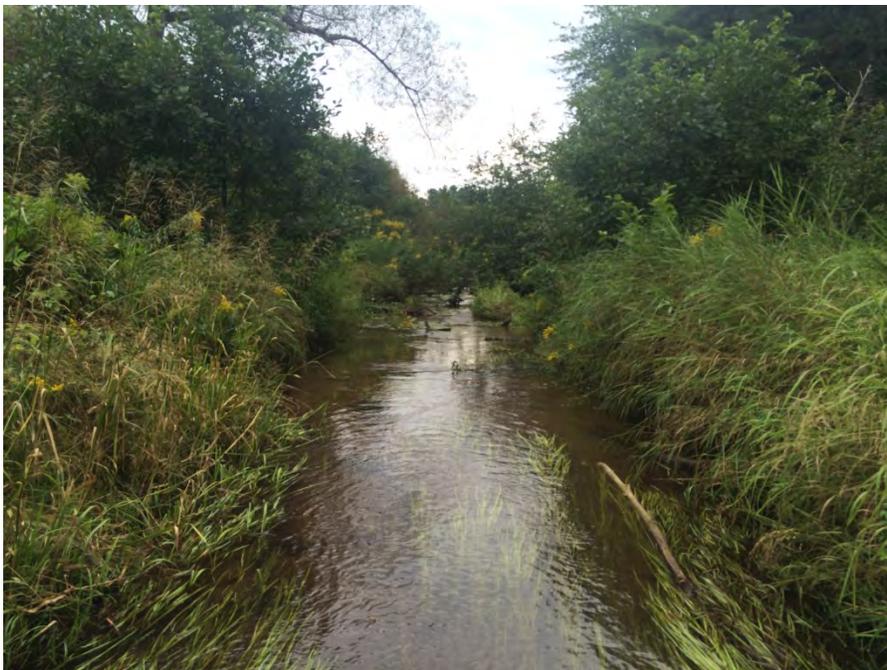
This reach is assigned an “unstable” geomorphic condition rating due to channel aggradation, channelization, and loss of access to the adjacent floodplain during lower-spectrum flood events. Further, the failure, removal, or replacement of the Major Pope Avenue culvert may result in upstream channel adjustment.

Photo 18. Overly widened, straightened reach between Brunswick Executive Airport runway culverts and Major Pope Avenue. Stantec, August 16, 2016.

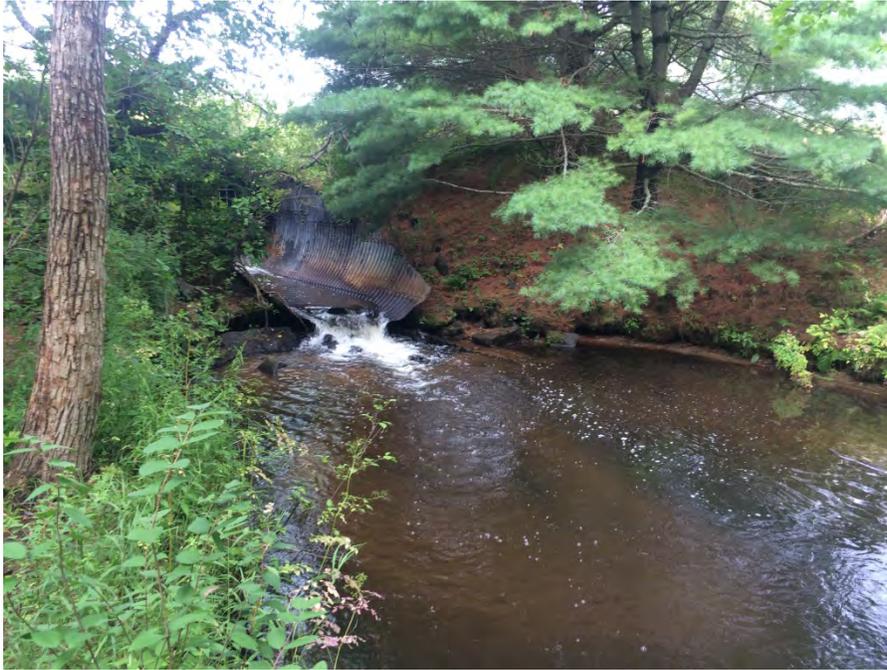
A significant plunge pool exists downstream from Major Pope Avenue, as a result of a perched (and possibly undersized) culvert outlet at Major Pope Avenue. Mare Brook exhibits flows through a well-defined, vegetation-controlled channel downstream from Major Pope Avenue to Liberty Crossing Drive. One oxbow meander was noted cut-off from the main channel due to a channel evulsion and is now acting as a depositional feature (sediment depository).

Photo 19. Plunge pool downstream from Major Pope Avenue culvert outlet. Stantec, August 17, 2016.

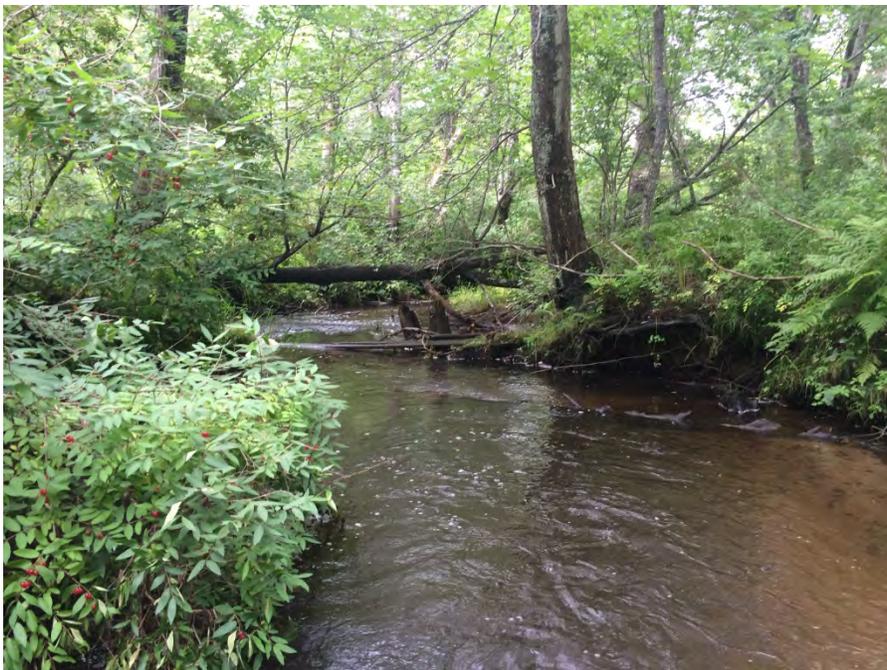
Despite the plunge pool downstream from the Major Pope Avenue culvert and minor bank erosion associated with the channel evulsion and debris jamming, this reach is assigned a “stable” geomorphic condition rating due to lack of apparent negative influences on overall geomorphic condition. Streamside vegetation is likely a significant factor in channel stability along this reach.

Photo 20. Vegetation-controlled channel downstream from Major Pope Avenue. Stantec, August 17, 2016.

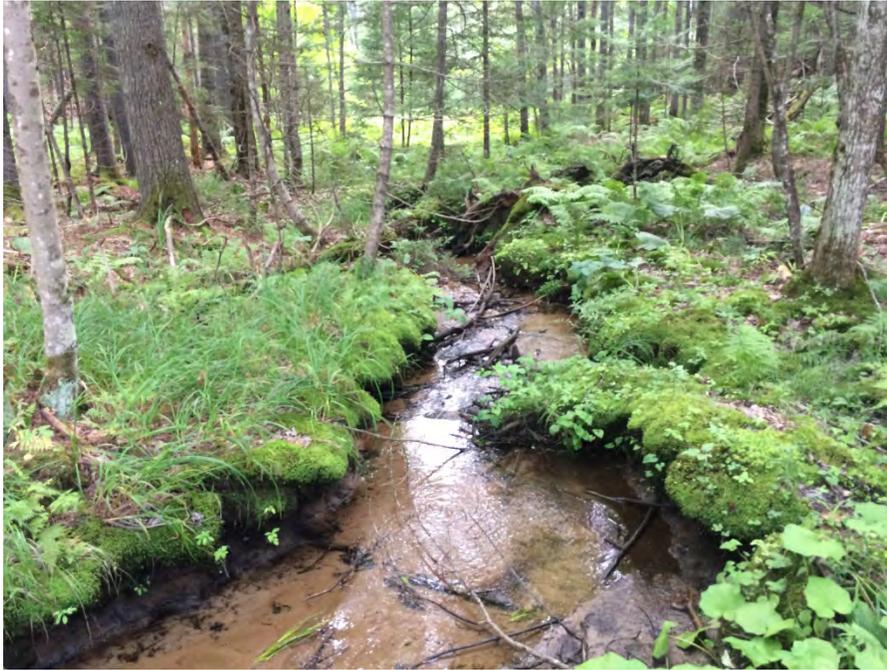
Photo 21. Merriconeag Stream downstream from Beaver Pond Drive. Stantec, August 17, 2016.

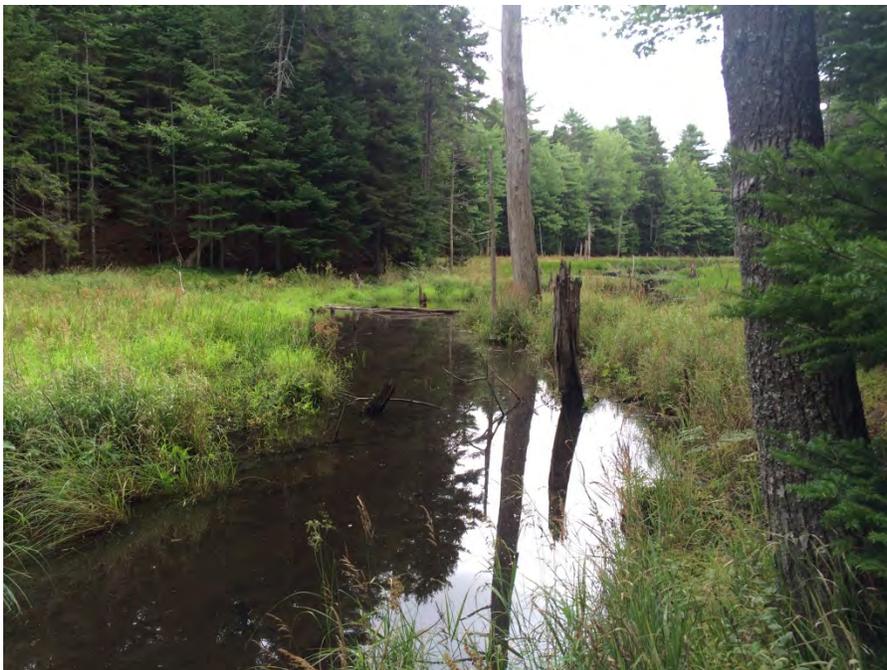
The overall geomorphic condition of Merriconeag Stream between Beaver Pond Road and Purinton Road is “stable”; however, failure or removal of Picnic Pond Dam could alter this rating.

Photo 22. Merriconeag Stream backwatered by Picnic Pond Dam. Stantec, August 17, 2016.

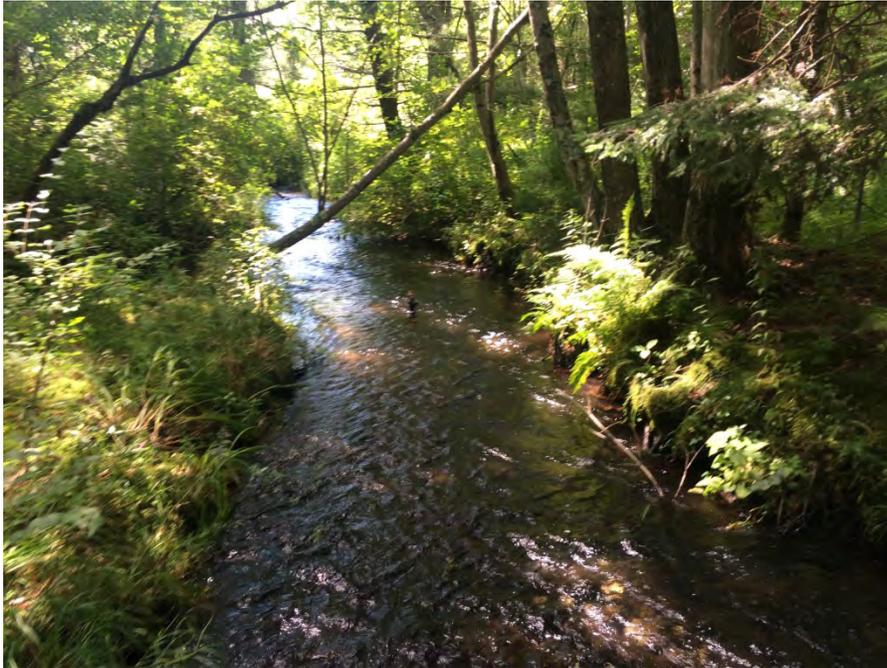
Despite the condition of the channelized-reach of Merriconeag Stream downstream from Purinton Road, the overall geomorphic condition of Merriconeag Stream between Purinton Road and the confluence with Mare Brook is “stable”.

Photo 23. Overly-widened, straightened reach of Merriconeag Stream downstream from Purinton Road. Stantec, August 17, 2016.

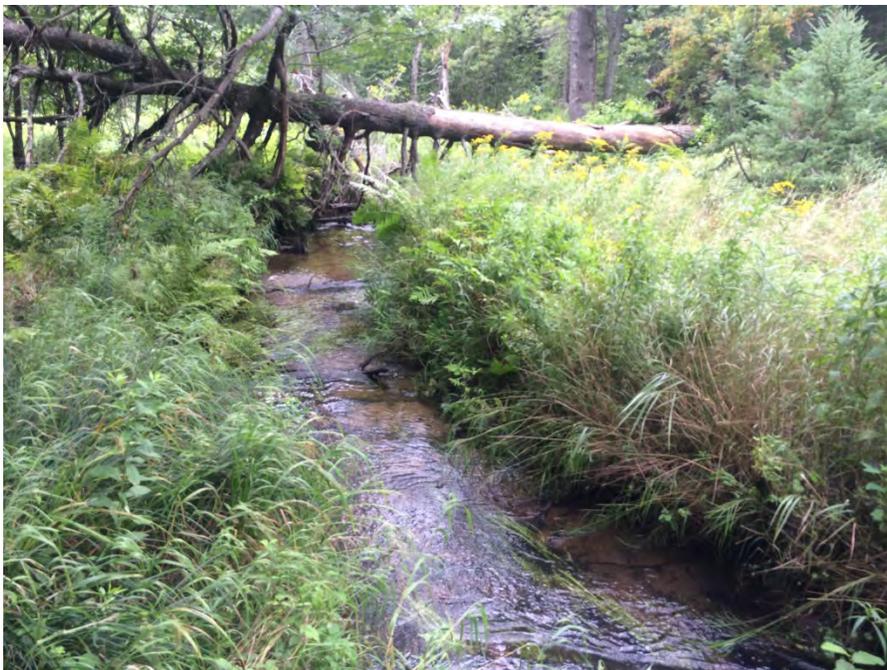
Photo 24. Merriconeag Stream near confluence with Mare Brook. Stantec, August 17, 2016.

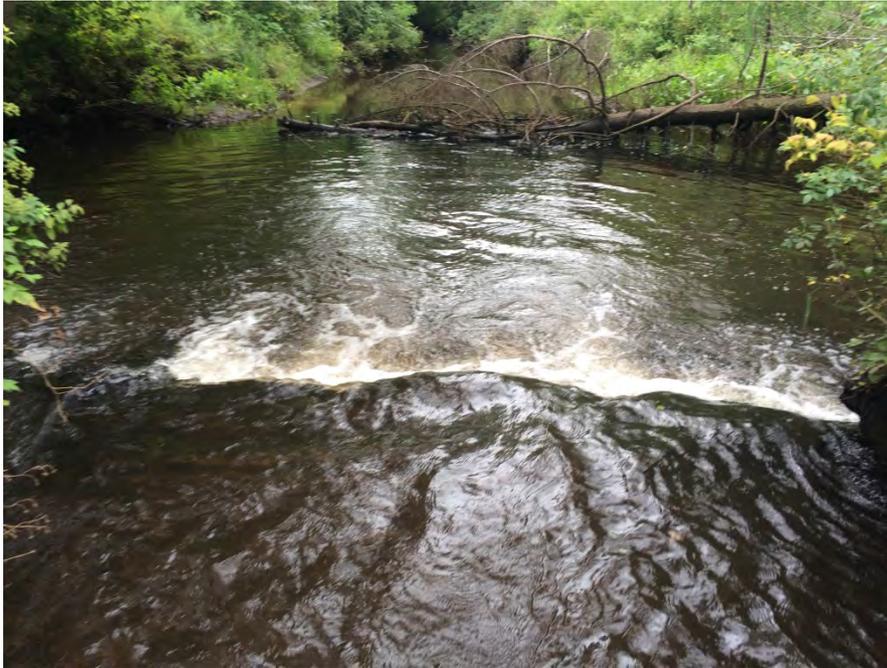
The tidal reach of Mare Brook downstream (seaward) from Liberty Crossing was assessed based on a review of aerial photographs. Planform characteristics of this reach indicate that tidal hydraulic conditions are the primary factor that influences the geomorphic conditions of this reach. This reach of Mare Brook exhibits significant meandering and the channel width

Photo 25. Tidally affected reach of Mare Brook looking downstream from Liberty Crossing culvert. Stantec, August 17, 2016.

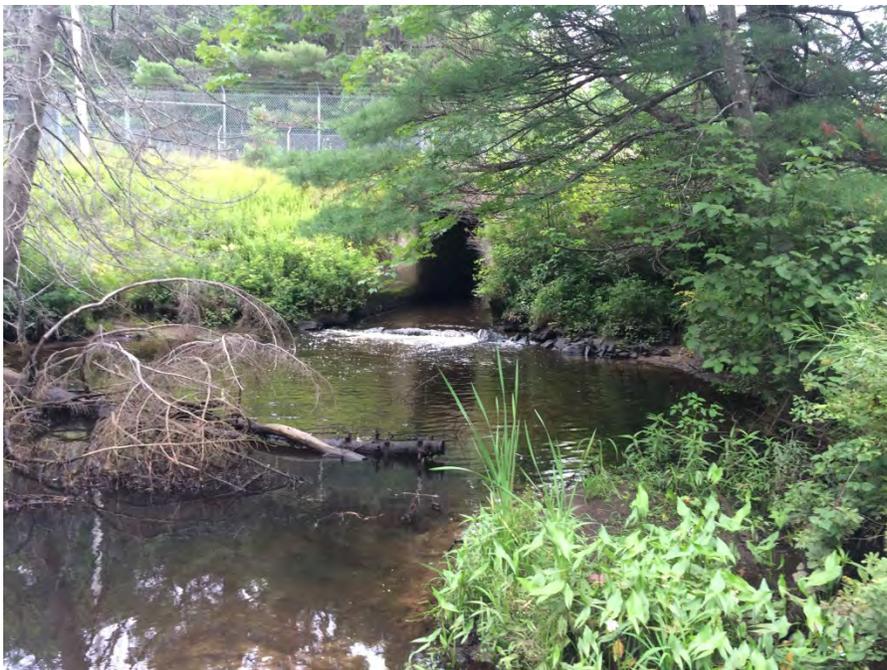
Photo 26. Plunge pool downstream from Liberty Crossing culvert (tidally affected). Stantec, August 17, 2016.
