**Merepoint Boat Launch Facility Eelgrass Mitigation Measures:  
2012 Monitoring Report**

**MER Assessment Corporation**

16 November 2012

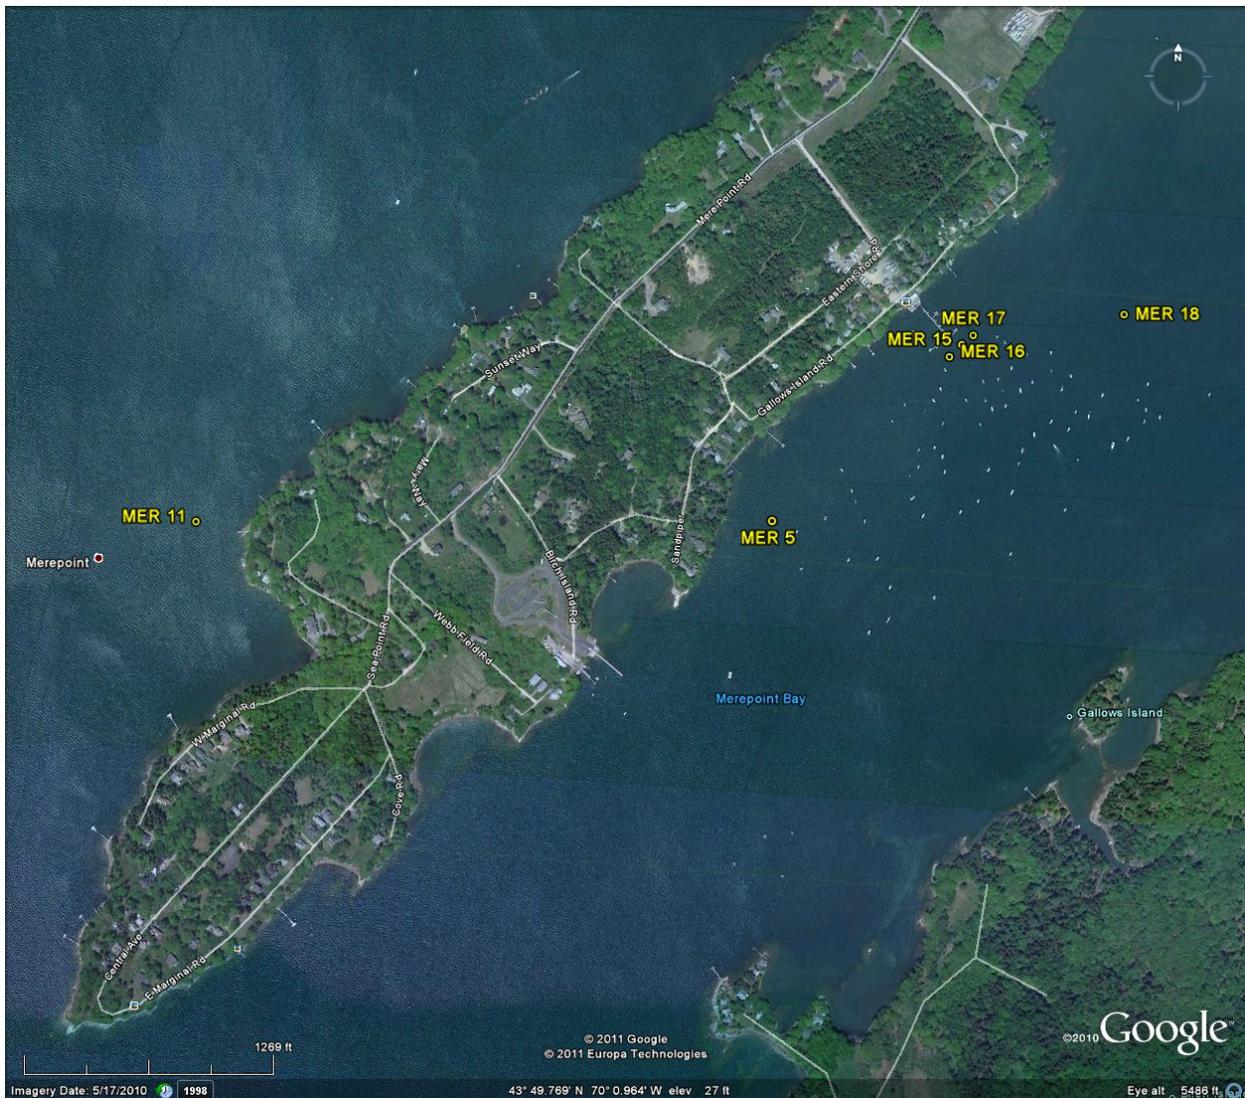
**Figure 3. Location of the six (6) moorings selected in 2008 (Google Earth image)**

Mooring scar measurements were made on August 8-9, 2012 around the six (6) moorings selected in 2008 for removal and either relocation of the mooring or replacement of the traditional mushroom/block-chain mooring with an embedment helix mooring. The location of the six moorings is shown in Figure 3.

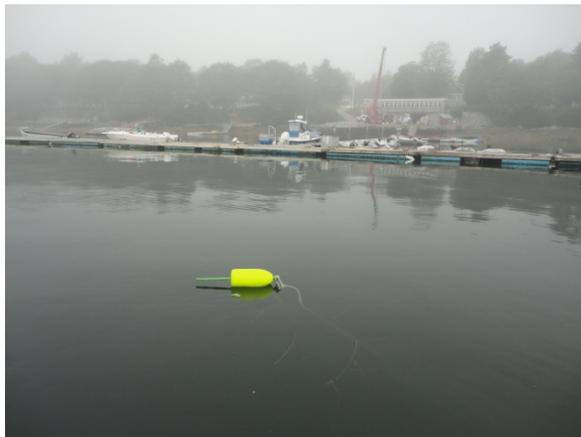
**Figure 4. Thoroughfare between MER 15 and float**      **Figure 5. Proximity of boat to MER 16**

As reported in 2011, measurement of certain scars was relatively straightforward where eelgrass boundaries encircling the scar are clearly defined; however, measurement of the scar area associated with other moorings was again rendered difficult to measure where eelgrass boundaries are poorly defined due to patchy and/or sporadic eelgrass, particularly in the cases of former mooring locations MER 15, MER 16 and MER17. These moorings are in shallow water and in close proximity to the service floats and access thoroughfare of Paul’s Marina (Figure 4); these moorings are also in close proximity of adjacent moorings and boats (see Figure 5).

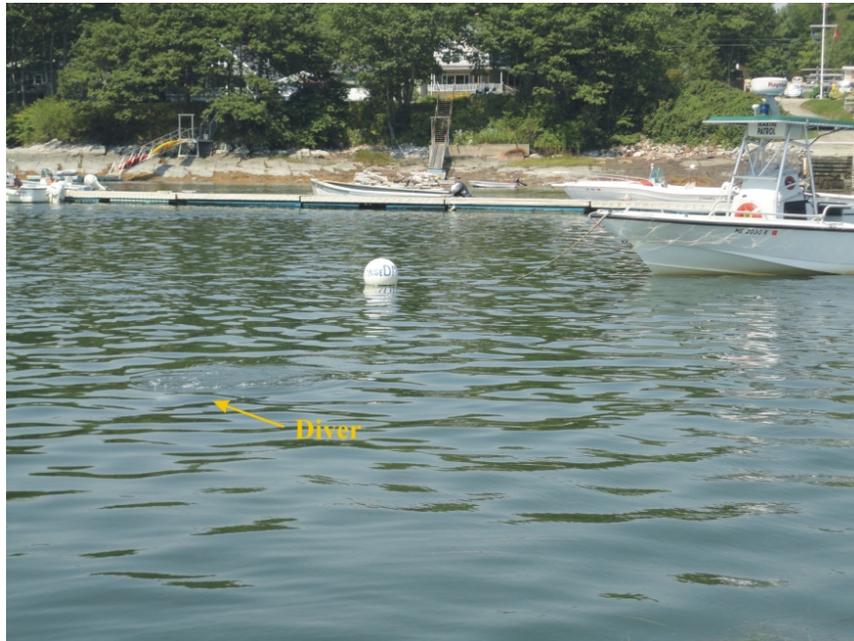
**Figure 6. Diver crossing through mooring scar adjacent to scar MER 16**

Scars were generally found to be devoid of eelgrass with the exception of occasional individual shoots and patches; the exposed bottom is generally covered by a layer of brown epilithic diatoms and some eelgrass detritus. Eelgrass at the scar boundary and elsewhere in the surrounding area was found to be encrusted to varying extents with the invasive tunicates, *Botrylloides violaceus*, including the violet and/or orange variant, and the pancake tunicate, *Didemnum vexillum*. The possible implications of the occurrence of these tunicates are discussed later.

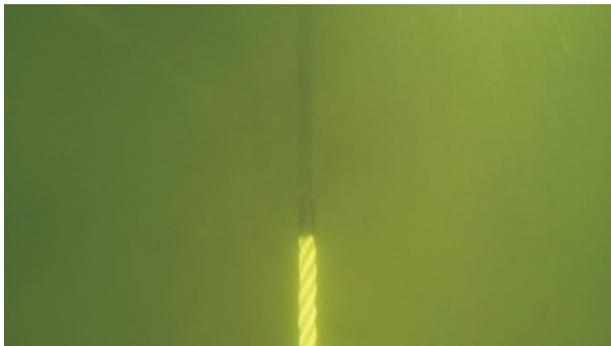
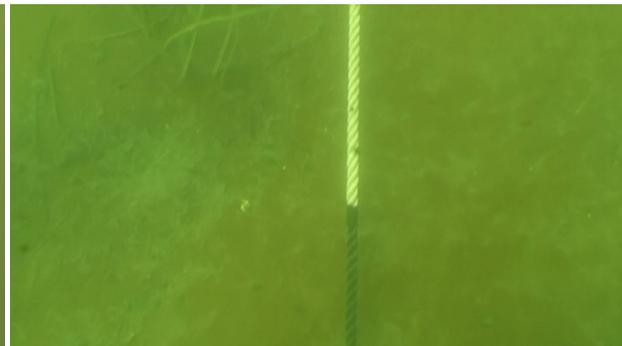
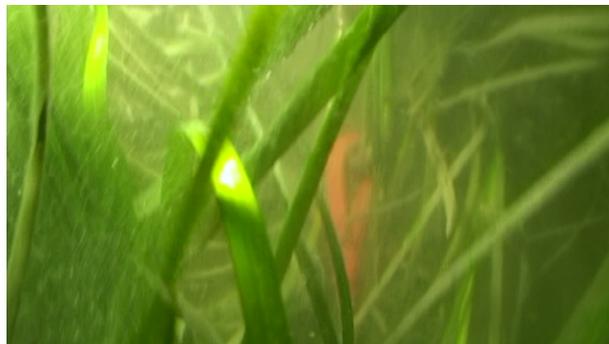
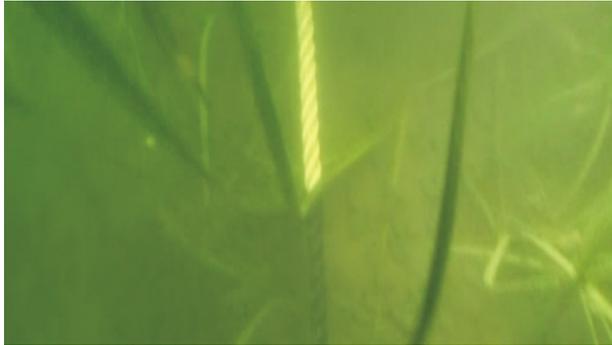
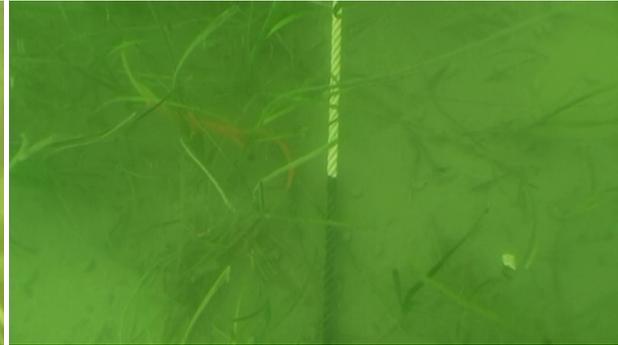
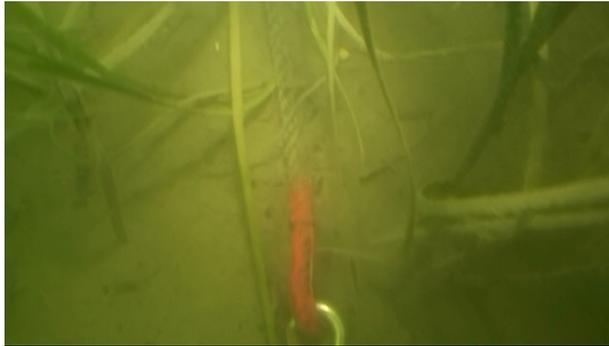
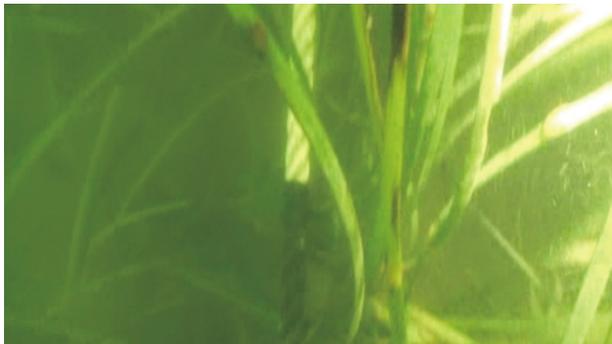
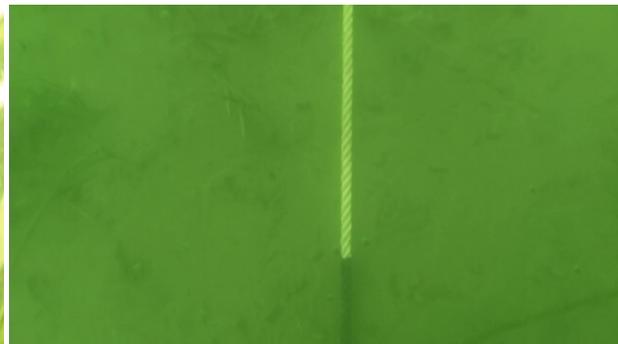
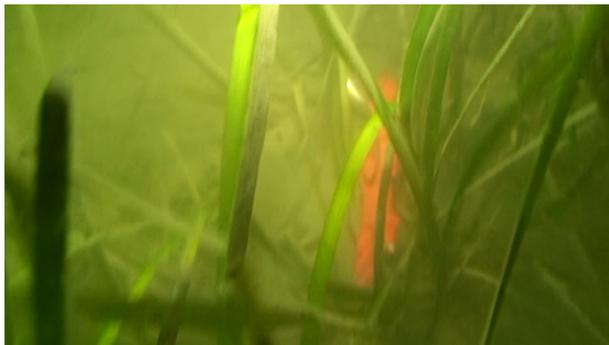
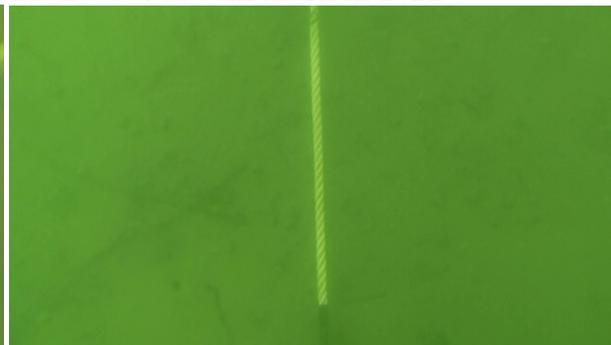
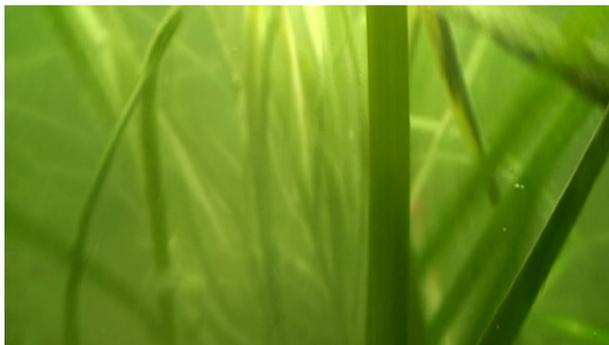
Still capture images taken from the videos at the 60m mark (this distance chosen arbitrarily) from the video recordings of Transects 1, 2, 3, and 4 of 2012, 2011 and 2008 are shown side-by-side in the series below for comparative purposes.

During the video recording in 2008 and 2012 the camera was carried somewhat closer to the bottom than during the 2011 recordings. Nevertheless, the 2008 images consistently show eelgrass while in 2011 only Transect 2 shows any substantive eelgrass, and in 2012 only Transects 2 and 3 show any substantive eelgrass; the images from the other transects show only a few plants or none at all.

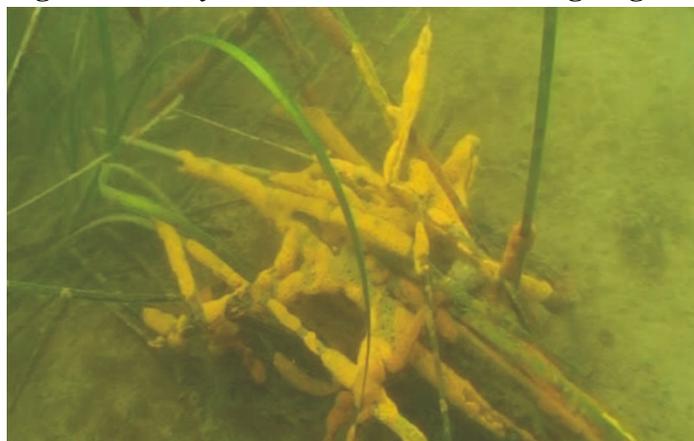
**Figure 8. *Botrylloides violaceus* encrusting eelgrass**

As observed elsewhere during the mooring scar survey, the incidence of the invasive tunicate, *Botrylloides violaceus*, shown in Figure 8 below, was substantially greater in 2012 at Simpsons Point than previously observed. The potential implications of this are discussed later.

The occurrence and effects of invasive tunicate encrustation on eelgrass have been reported by Carman *et al.* (2009; 2010) working on Martha’s Vineyard, Massachusetts and Block Island, Rhode Island and Wong, *et al.* (2012) working in Nova Scotia. *B. violaceus* was observed in both studies along with other invasive tunicate species, including the cream-colored pancake batter tunicate, *Didemnum vexillum* (Carman *et al.*, 2010). Wong *et al.* (2010) found that even minimal amounts of tunicate growth can substantially affect light attenuation by eelgrass blades; at high biomass of tunicate ( $>0.5$  dry mg/cm<sup>2</sup>) attenuation can reach 85-95% of incident light reaching the blade. This attenuation of light reaching the blades results in reduced photosynthesis and growth and in physical effects likely resulting in blades breaking away, eventually leading to reduced number of leaves per shoot, shoot length and shoot density within the bed. Additionally, the breaking away of blades carrying encrusted tunicates can serve as a

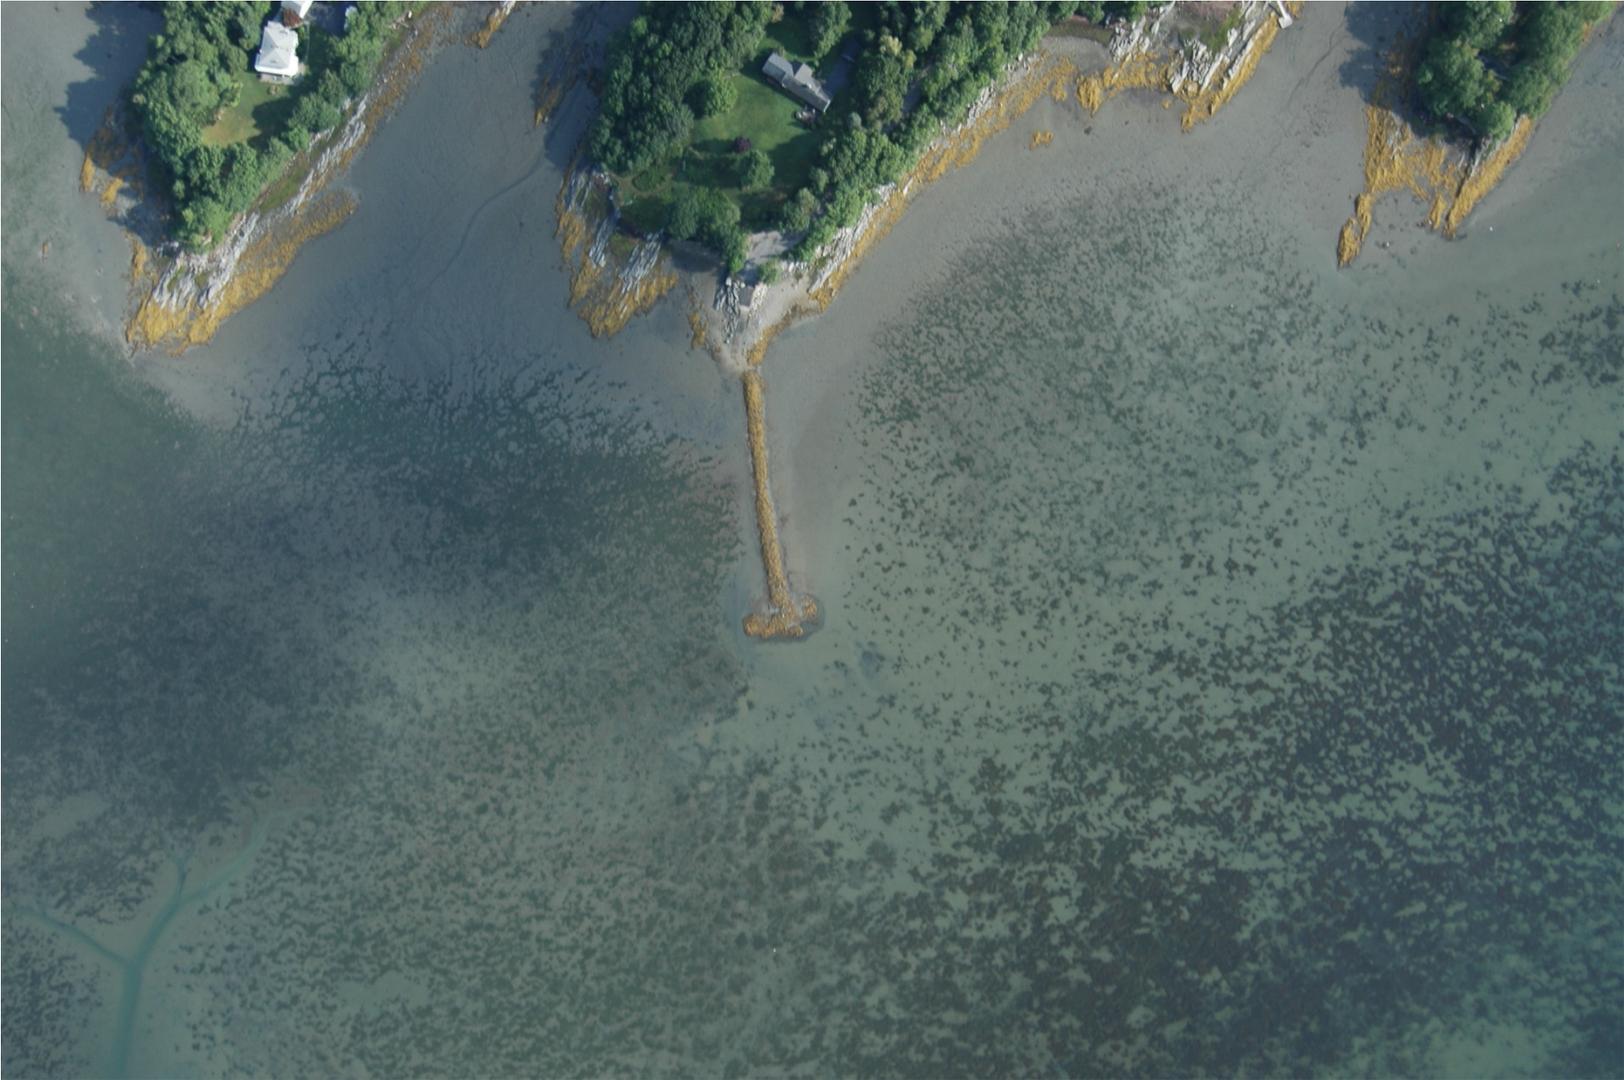
**Figure 9. August 6, 2012 aerial photo of Simpsons Point landing area**

The 2012 aerial photo and those previously taken in 2007 through 2011 are shown in the figures below for comparative purposes. Figure 9 shows an aerial photo taken August 6, 2012 of the broader Simpsons Point landing area. Figure 10 shows a geo-referenced detail of the photo taken August 6, 2012 of the Simpson Point landing area and includes the geo-referenced video transects and upper eelgrass boundary delineation. Figure 11 shows the August 31, 2011 aerial photo of the area and includes the geo-referenced video transects, upper eelgrass boundary based on the video review, and the boundary of the eelgrass meadow based on the diver delineation GPS points. Figure 12 shows the September 2008 aerial photo of the same area along with the geo-referenced video transects and diver-delineated upper boundary of the eelgrass for that year. Figure 13 shows the same area in 2007 prior to the closing of the boat landing to motorized vessels.

Comparison of these photos clearly shows a decline in the density of eelgrass within the area over the time period 2007 through 2012; these aerial observations are corroborated by the video recordings over the period 2008 through 2012. The most obvious change is in the apparent decrease in eelgrass density and the expansion of barren sediment areas between the eelgrass patches. Although barren areas existed within the meadow in 2008, these were generally small however, over the period these have increased in number as well as size.

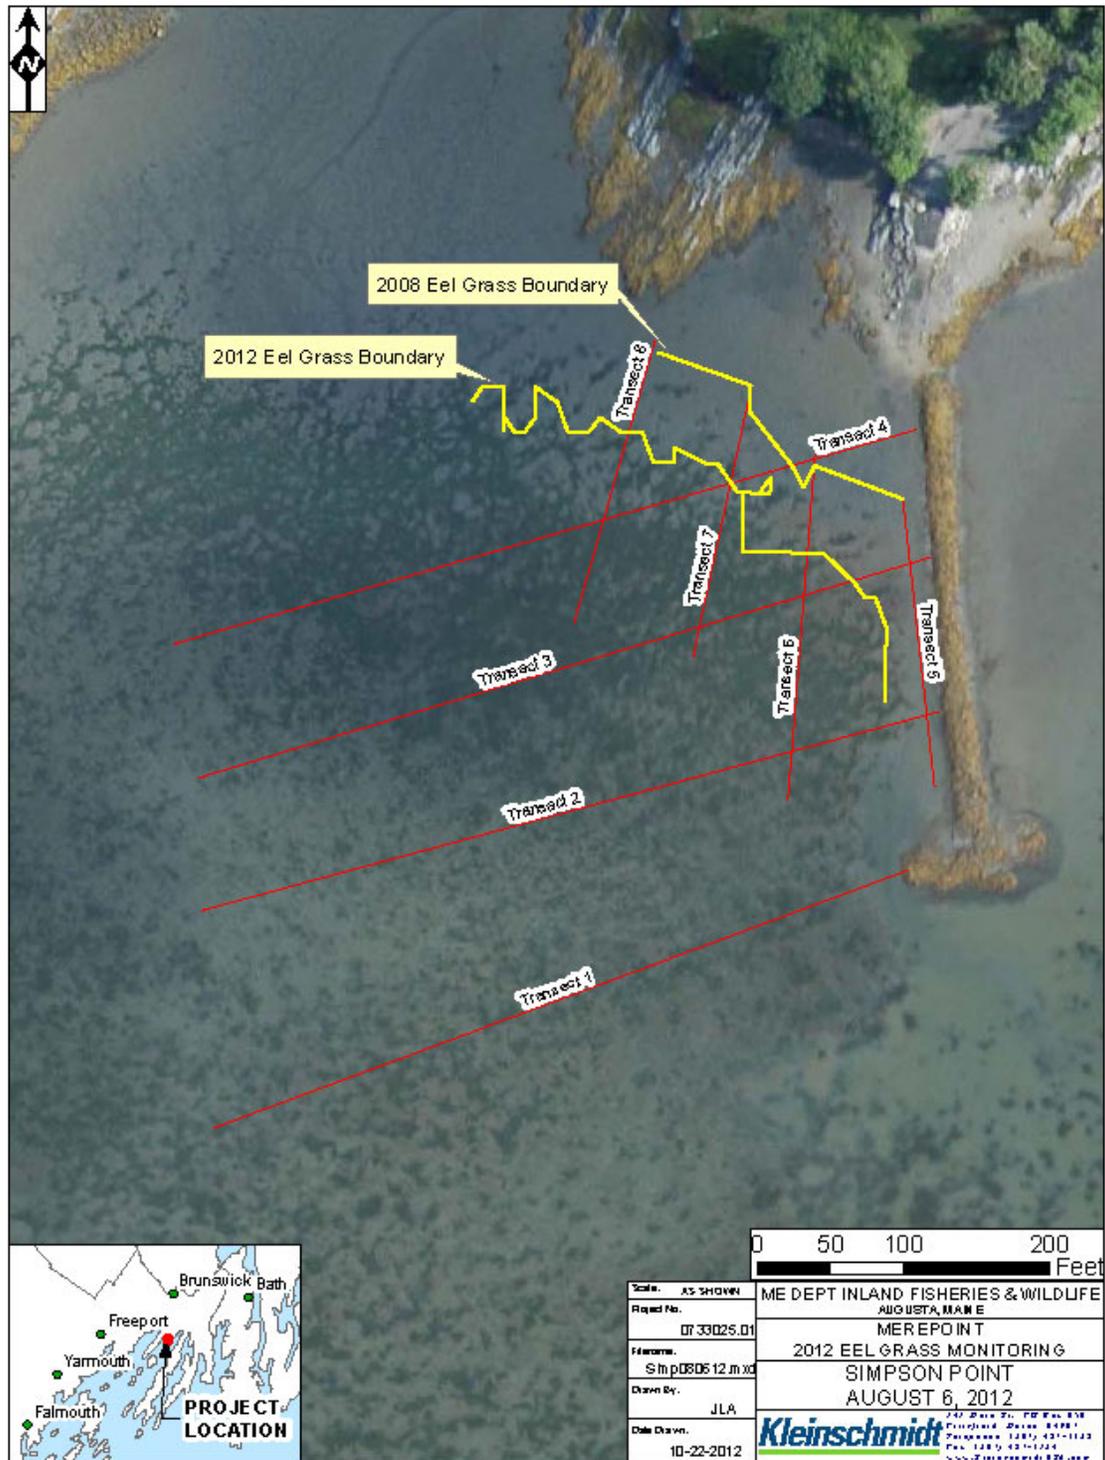
**Figure 10. Geo-referenced aerial photo of Simpsons Point landing area of August 6, 2012 aerial photo showing dive transects and upper eelgrass boundary delineation of 2011 and 2008.**

Using the same procedure as used in 2008 and 2011, GPS coordinates were also recorded for individual diver-set points to define the upper eelgrass meadow edge by having the diver mark the edge of the meadow at intervals using pins with attached small buoys; the interval distance between points was reduced in 2012 resulting in a substantially larger number of points. Coordinates were collected by placing the boat directly over the point and recording the latitude and longitude; these are listed in Table 4 and are shown in the geo-referenced aerial photo shown in Figure 10.

Aerial photography collected by John Sowles, 2012  
 Eel grass boundary location delineated by M E R Assessment, Inc. on August 20, 2012.

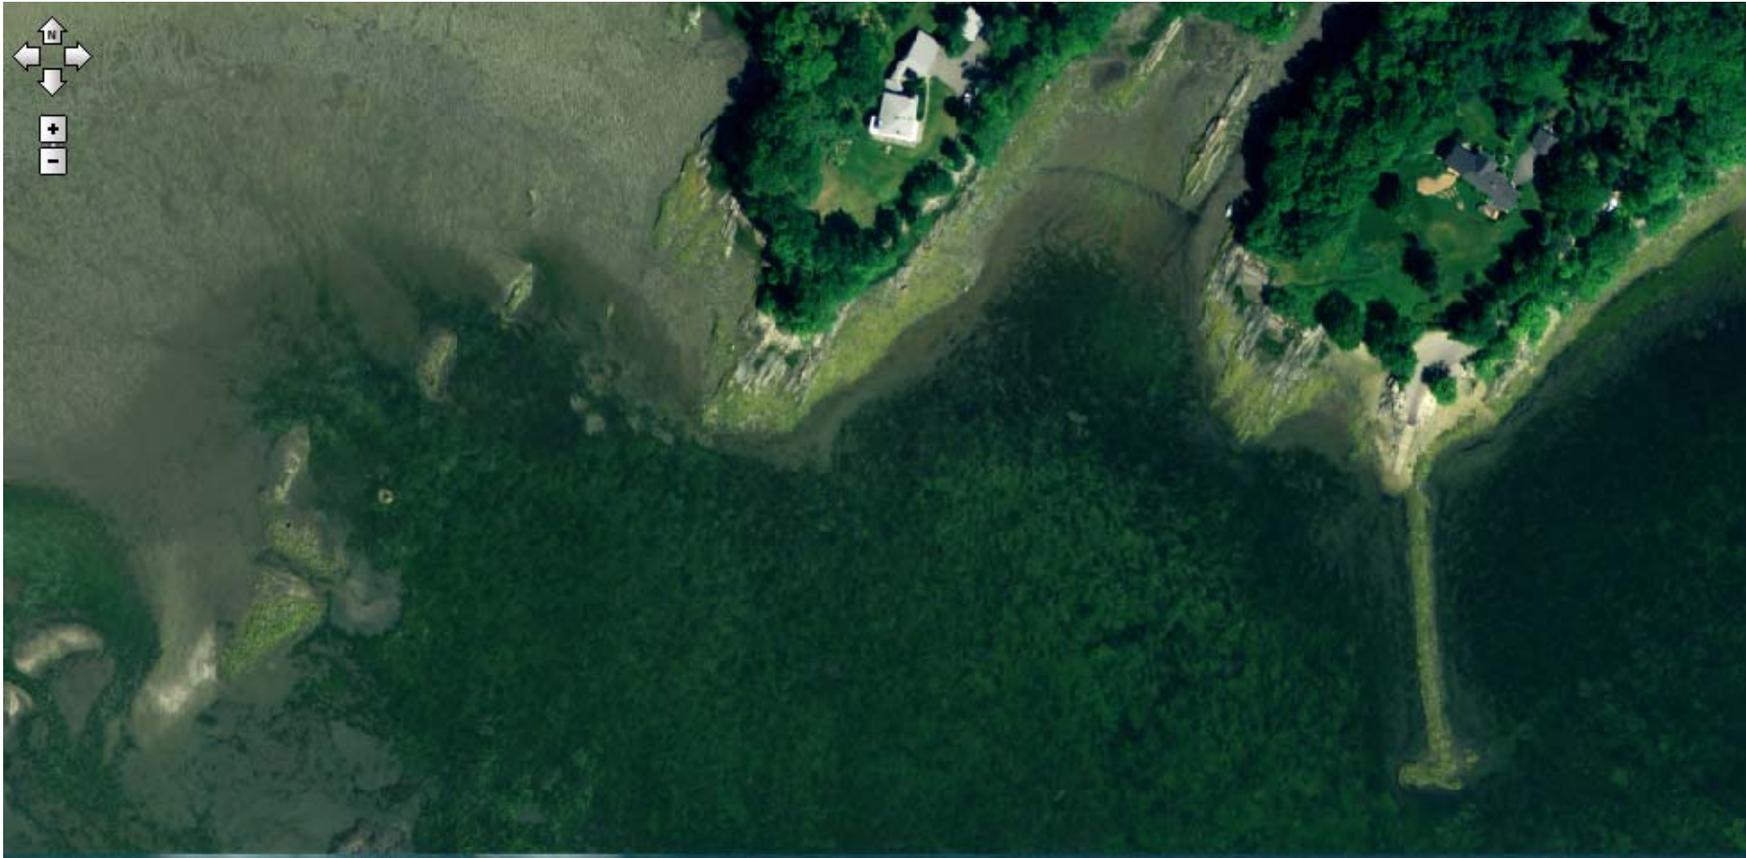
**Figure 14. DeLorme photo of Simpsons Point landing area in 2003**

Figure 14 is a screenshot image of low tide photography taken by DeLorme in 2003 and available on the Maine office of GIS website at: <http://megiswebmaps.maine.gov/orthoviewer/default.aspx>. The DeLorme photo appears color-enhanced to highlight the vegetation; however, the photo clearly shows the extent and density of the eelgrass coverage in that year, both to the east and west of the old stone pier, and serves to highlight the extent to which eelgrass in the area has declined over time.

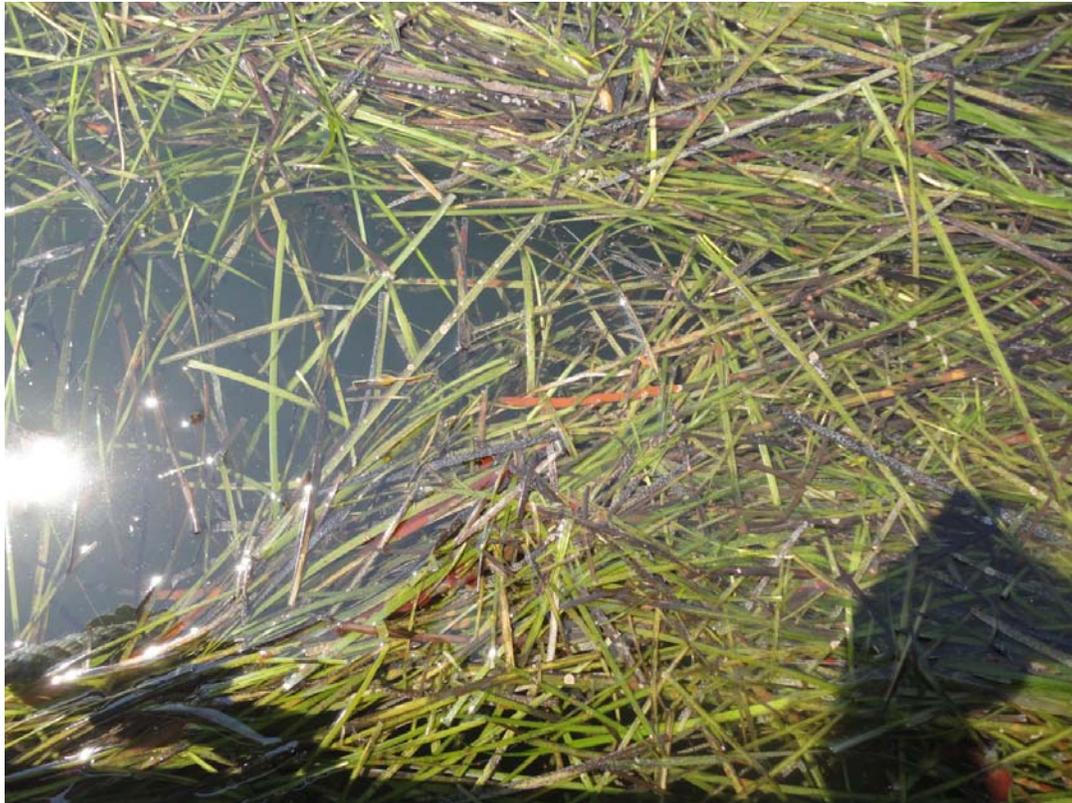
**Figure 15. Rafting of broken eelgrass blades carrying *Botrylloides violaceus***

transport mechanism to infest other areas. Indeed, during the mooring scar survey, rafts of floating eelgrass were observed with a high percentage of the blades carrying at least some level of tunicate (see Figure 15). Some of the blades are clearly encrusted. Careful examination of this photo reveals that most of the blades are carrying some level of tunicate colonies. Infestation of eelgrass by *B. violaceus* has also been reported elsewhere in Casco Bay including the mouth of the Royal River (Steve Walker, Department of Inland Fisheries and Wildlife/Brunswick resident, pers. comm.).

Since the cause of the slow recovery of the mooring scars and the general decline of the eelgrass meadow at Simpsons Point appear to be related, at least in part, to the tunicate infestation, the need for additional remedial measures by IF&W does not seem warranted. In our 2011 report we suggested that colonization of the scars might be accelerated by efforts to increase seed propagation within the scar area (Pickerell *et al.*, 2005) or transplanting eelgrass shoots into the scars (Short, 2002). However, in view of the continued lack of recovery within the mooring scar areas and the decline of eelgrass in the vicinity of Simpsons Point resulting from causes apparently beyond immediate control, such efforts would likely prove futile and therefore are probably not advisable until the causes of decline are more definitively identified and better understood.

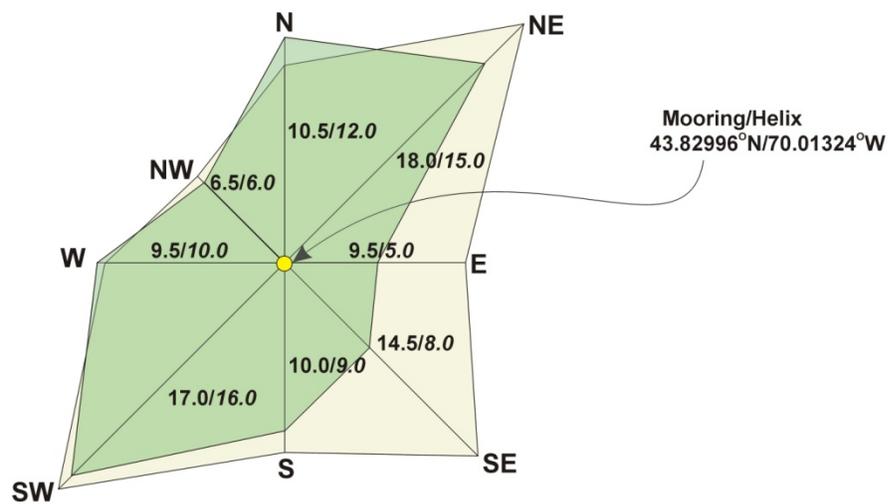
2012 Area = 284 ft<sup>2</sup>

2008 Area = 390 ft<sup>2</sup>

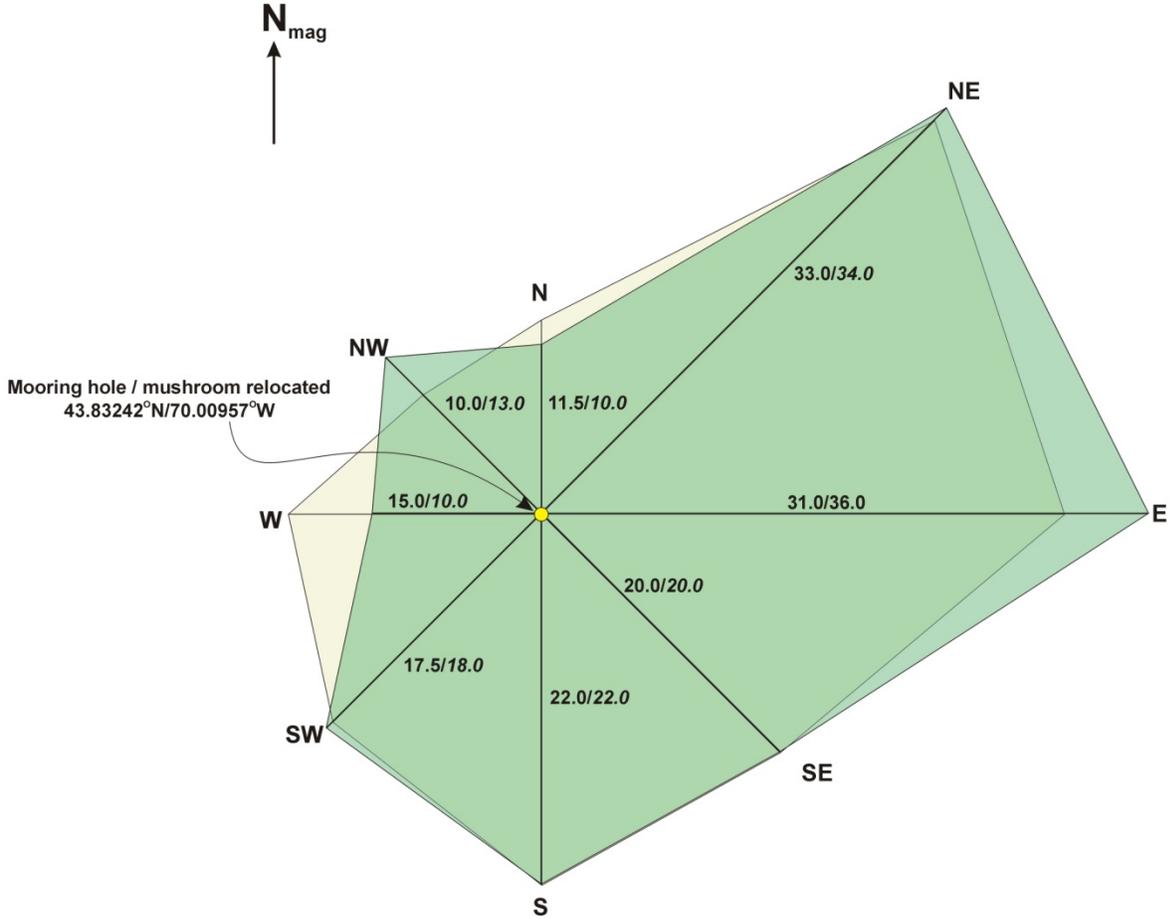
**MER 15 (MPXXX)**

2012 Area = 1,259 ft<sup>2</sup>  
 2008 Area = 1,193 ft<sup>2</sup>
