Village review design guidelines

Part I – Architectural Context

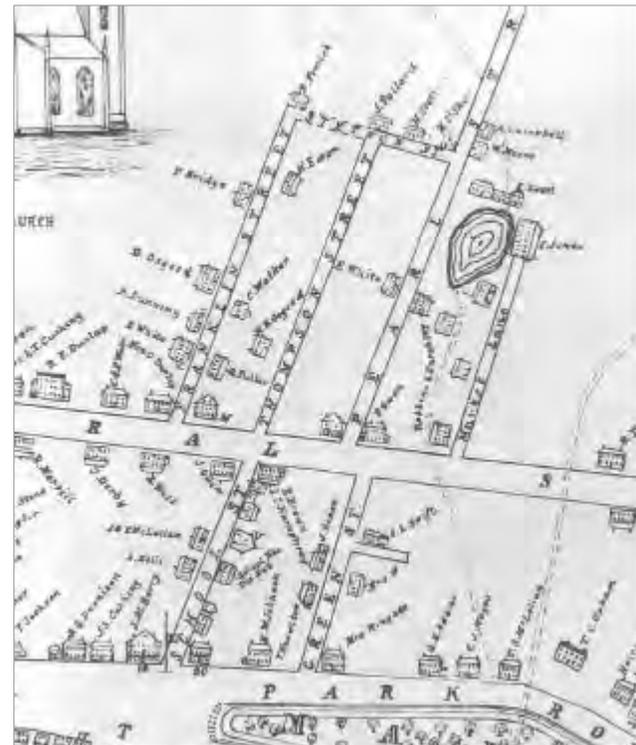
Above: This 1846 map of Brunswick clearly illustrates the types of houses in the neighborhood and shows where development was occurring. Map was surveyed and drawn by C.J. Noyes and published by J.B. Bufford & Co. of Boston.

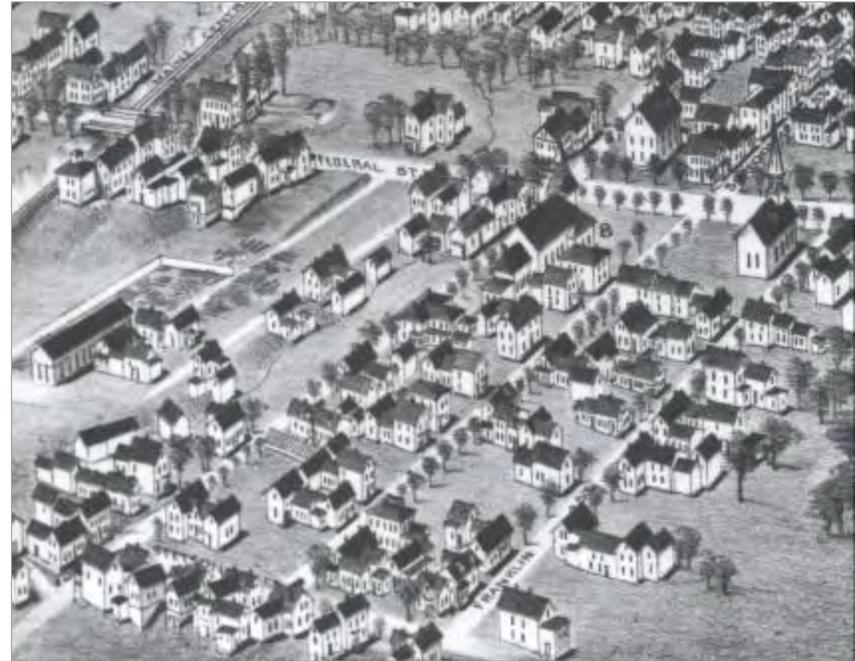
Above: This 1887 map of Brunswick provides excellent views of buildings in the Franklin-Maple Street neighborhood towards the end of the 19th century.

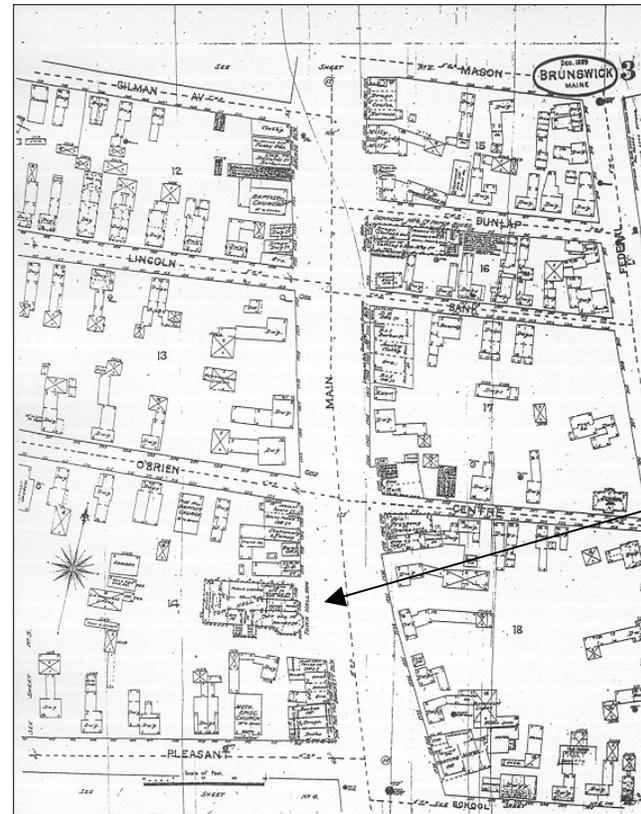
Left: Maps, such as this one from 1889, provide excellent information about the configuration of Main Street.

Old Town Hall is clearly marked on this map.

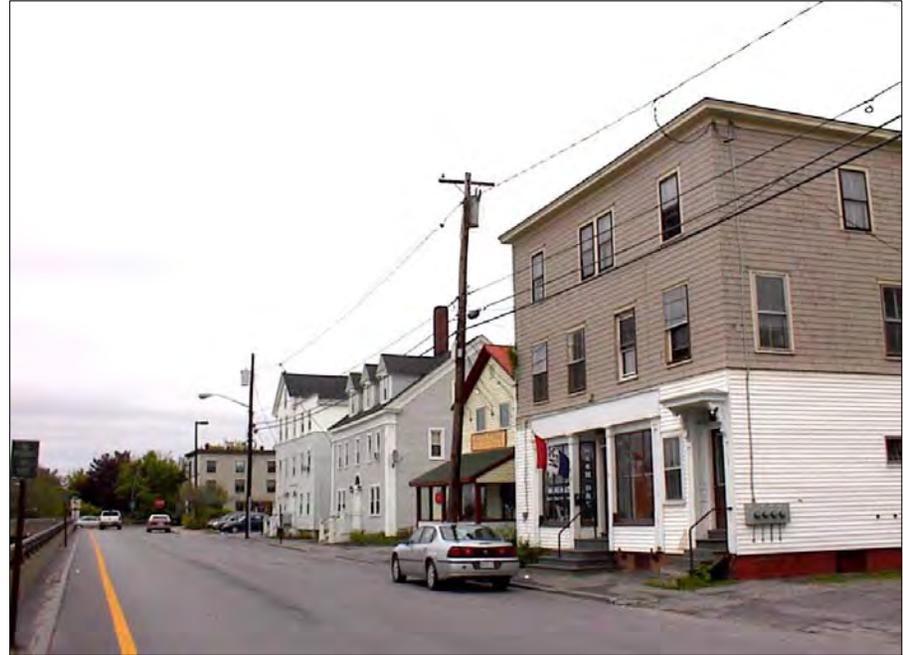
Above: These wood frame structures on Mill Street are representative of the character of the neighborhood during the mid-nineteenth century.

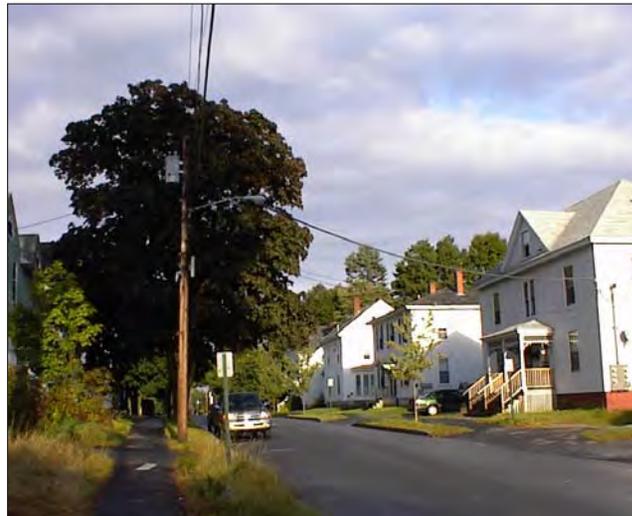
Left: The consistent setback of these houses on Cumberland Street defines a strong “edge” to the streetscape.

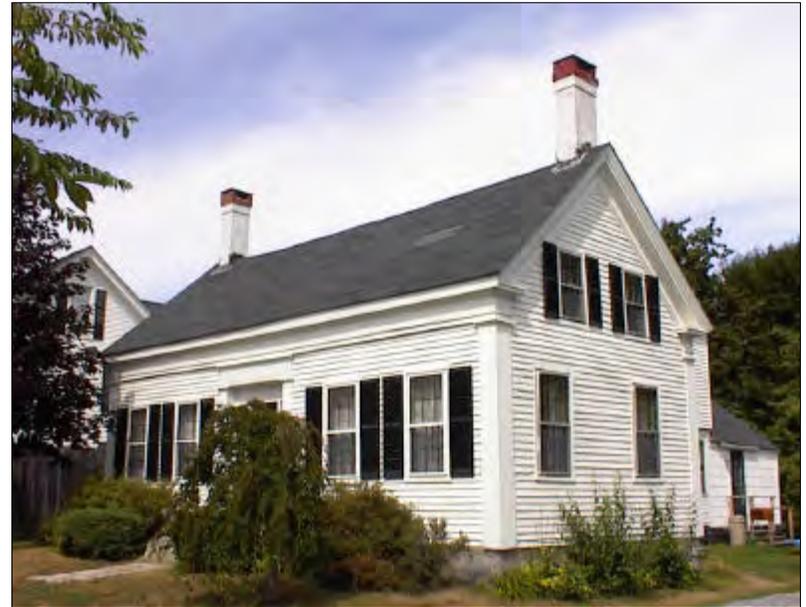
Above: Greek Revival capes are found throughout the district. The cape form is typically positioned with the side of the house facing the road. This house is located on Franklin Street.

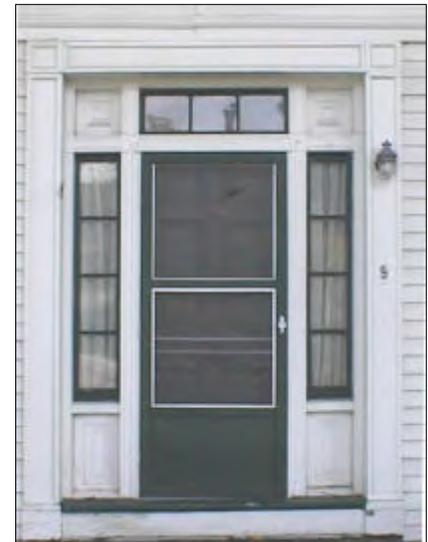
Right: This doorway represents a common Greek Revival configuration. The strong geometric forms of squares and rectangles are common stylistic features.

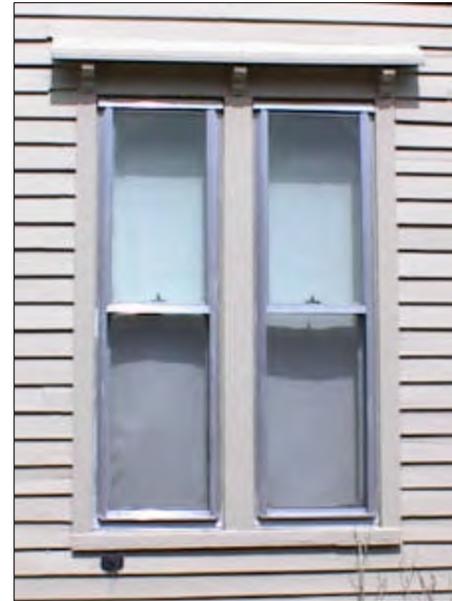
Upper Left: Paired windows with a simple decorative hood supported by small brackets is a common Italianate detail.

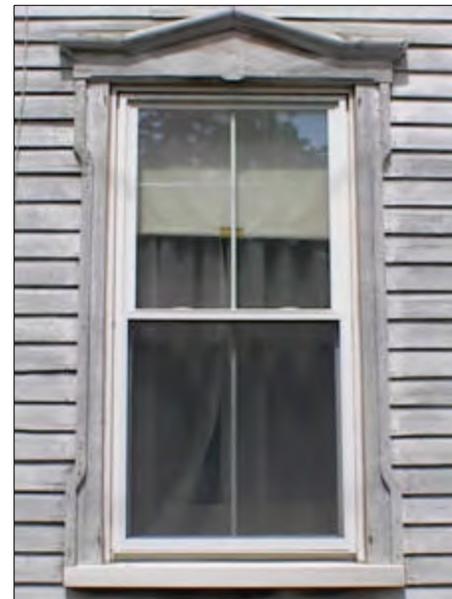
Lower Left: The bold profile on the hood and surround of this window represent another common Italianate characteristic.

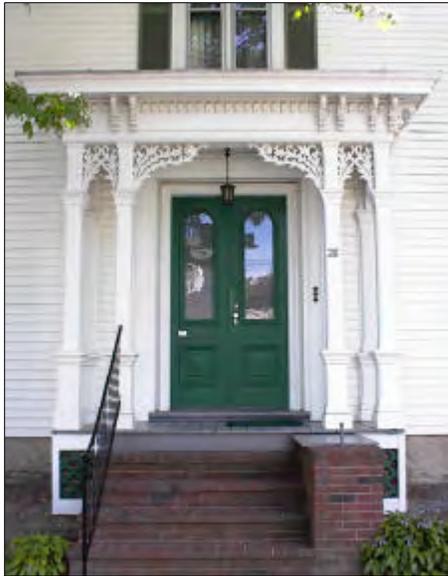
Left: This porch has several key Italianate elements, including paired brackets, double doors with arched glass panels, and paired porch columns.

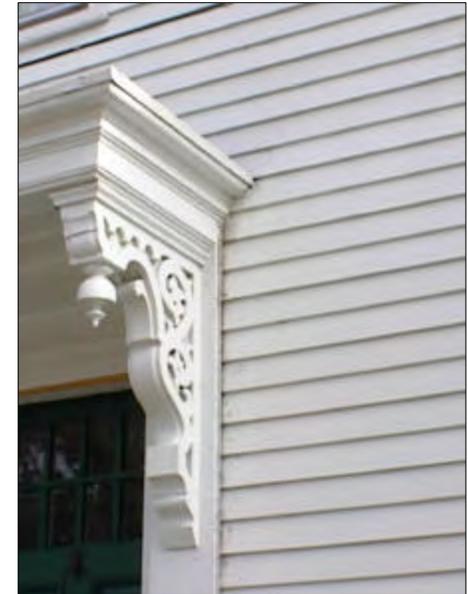
Right: This elaborately carved bracket is supporting an entry pediment. This feature is found on numerous buildings throughout the district.

The dropped pendant is a detail frequently found on this type of bracket.

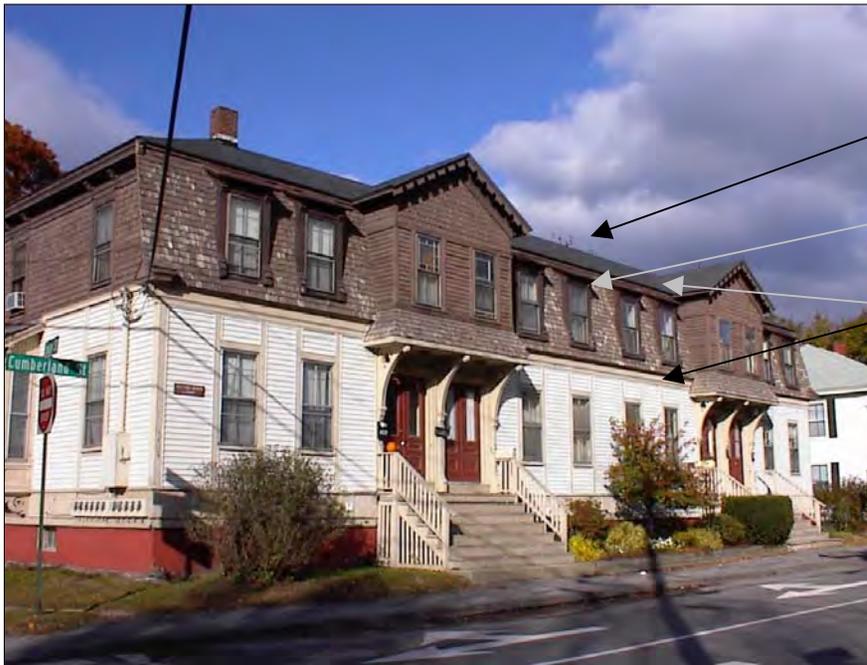
Second Empire Defining Features:

- Mansard roof. Note slight flare at base of roof.
- Hooded dormers.
- Heavy molding at top and bottom of roof slope.

The primary defining characteristic of Second Empire is the mansard roof with dormer windows. The roof form became popular because it created a functional full height attic space. It was not uncommon to see the roof of an existing house converted to a mansard form in order to gain additional useable space. Dormers often have elaborate hoods or decorative surrounds. Additional character-defining details include molded cornices at the top and bottom of the roof slope, and decorative brackets at the eaves.

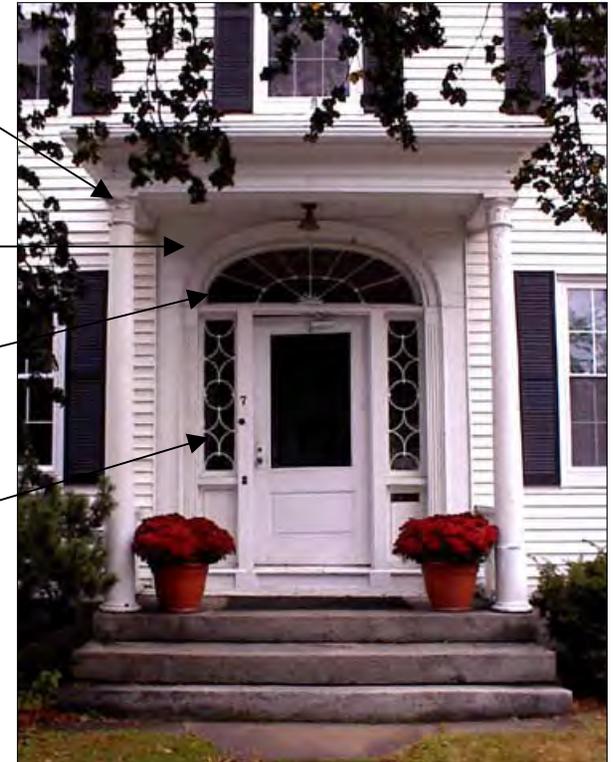
Elliptical fanlight.

Sidelights with delicate tracery work.

Above: Classic Federal details are evident at this main entry.

One of the primary defining features of a Federal style house is the main entrance. The front door is usually centered on the primary façade with a semi-circular or elliptical fanlight window above it. The door is flanked by sidelights that typically have lead tracery. The door is often accentuated with simple pilasters and a broken triangular pediment. In some houses, the entry pediment is carried forward to create an entrance portico. The portico may be rectangular or elliptical and is often supported by groupings of slender, Doric columns. This use of classical elements (columns, arches) is typical of the Federal period.

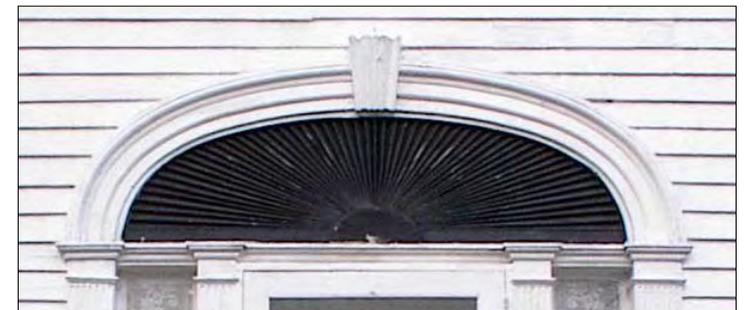
Above: Wooden fans can also be found in the district.

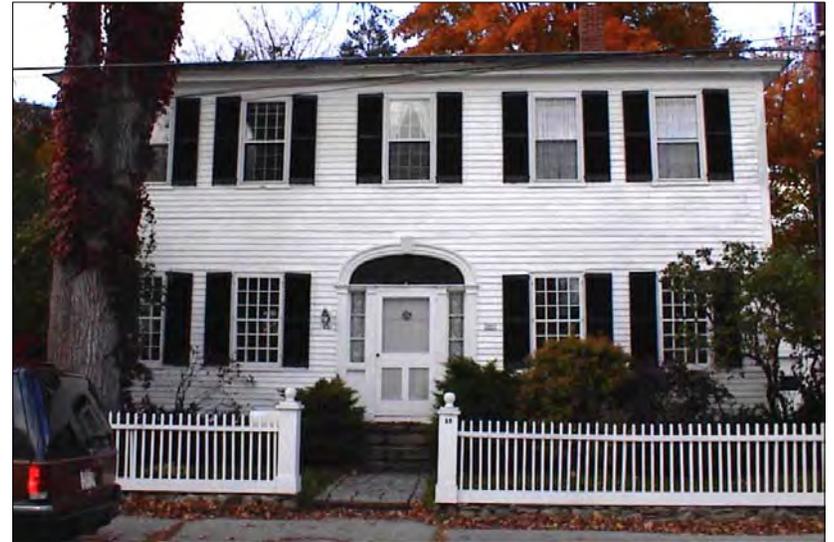
Above: Example of a typical Federal style house.

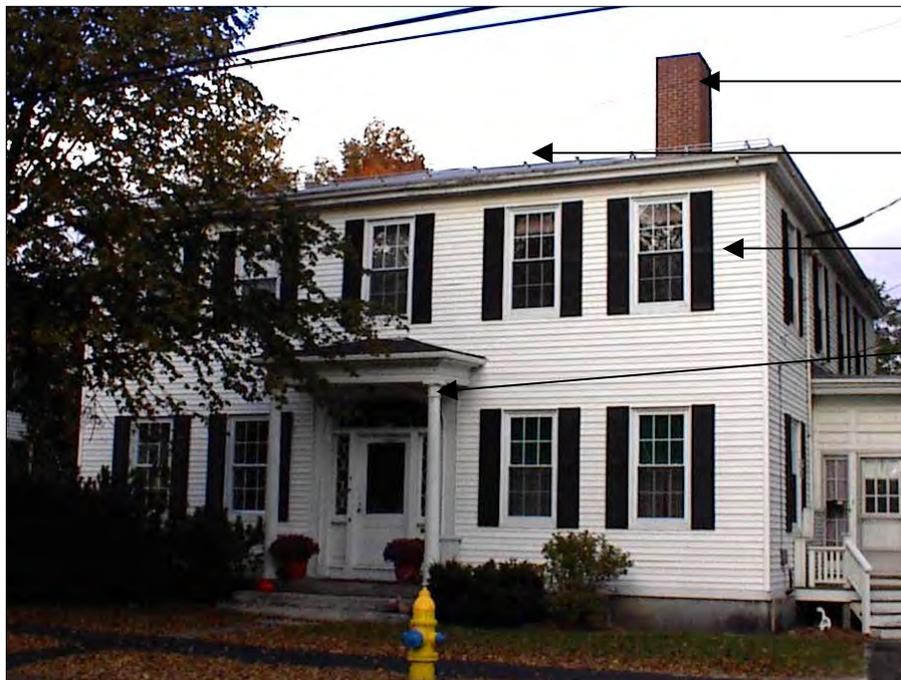
Federal Defining Features:

- Chimneys located towards either end of main block of house.
- Shallow pitched hip roof
- Symmetrical façade, typically five bays (openings)
- Main entry centered on façade with an elliptical or rounded fanlight above the door and sidelights.
- Rectangular building form with long side facing the street

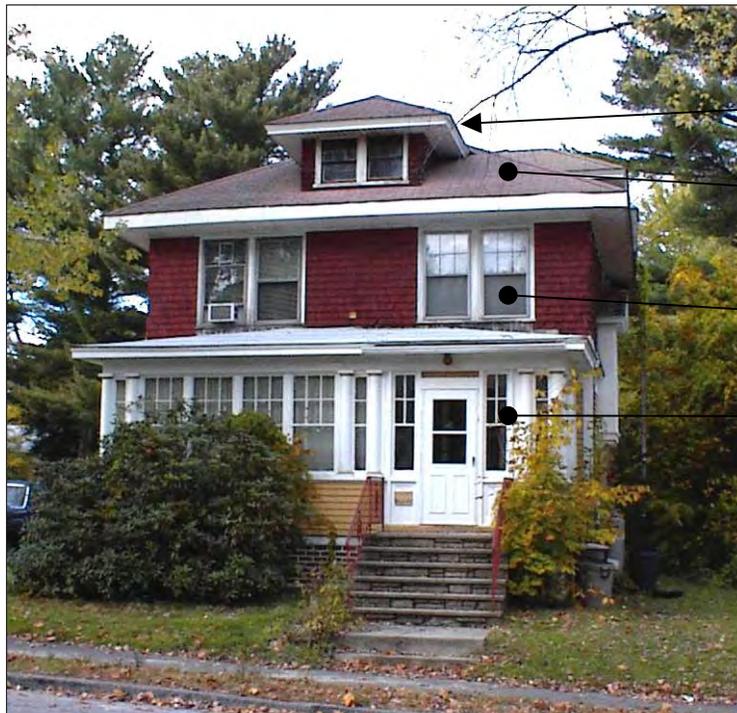
Four Square Defining Features:

Attached porch, occasionally enclosed as in this example, that extends across the full width of the house.

Entry off to one side.

As its name suggests, one of the hallmarks of a Four Square is its overall shape and form: a square footprint with four equal sides. Typically these houses are two-stories with a hipped roof that is often interrupted by hipped or shed dormers. Windows are typically grouped in pairs and are double-hung with multi-panes in the upper sash and a single pane in the lower sash. Rectangular bay windows and a one-story attached porch across the full width of the façade are typical characteristics. An enclosed porch or sunroom off one side of the house is another common feature of a Four Square. Clapboards and wood shingles are the predominant exterior cladding material. In many cases, there is a change in exterior wall surface treatment between the first and second story. In some cases this change in material is accentuated with a change in finish color.

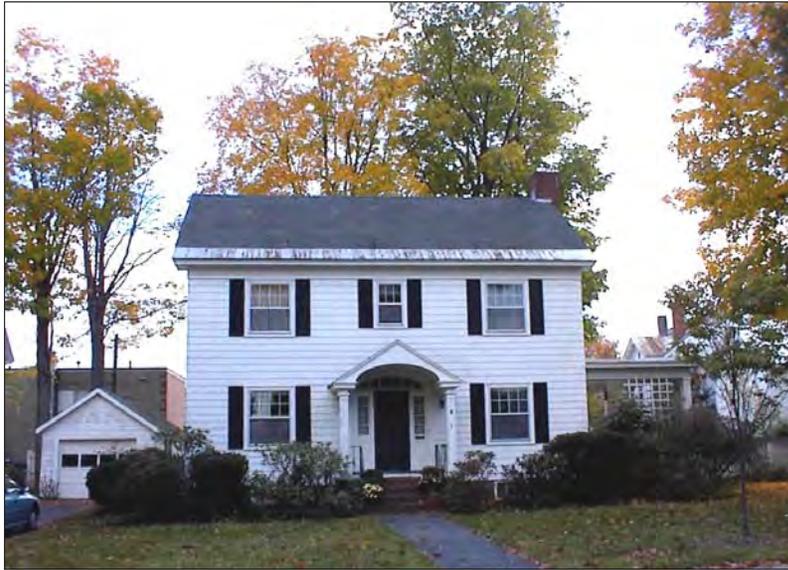
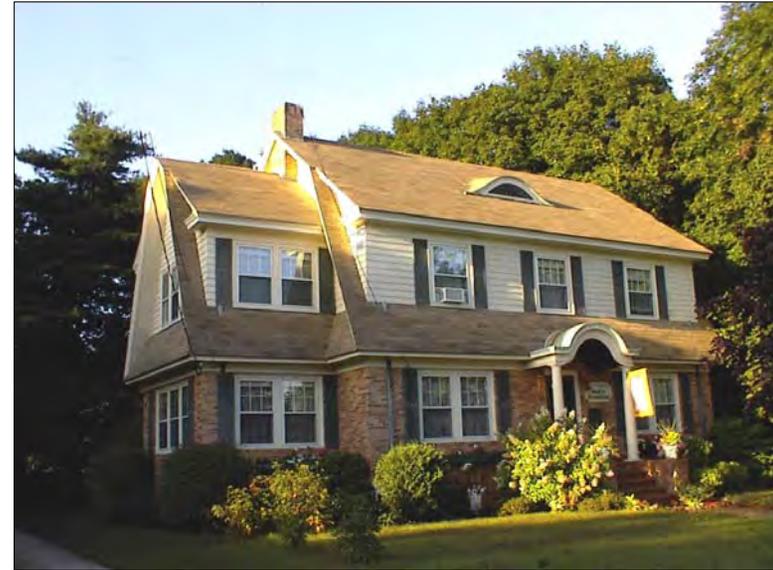
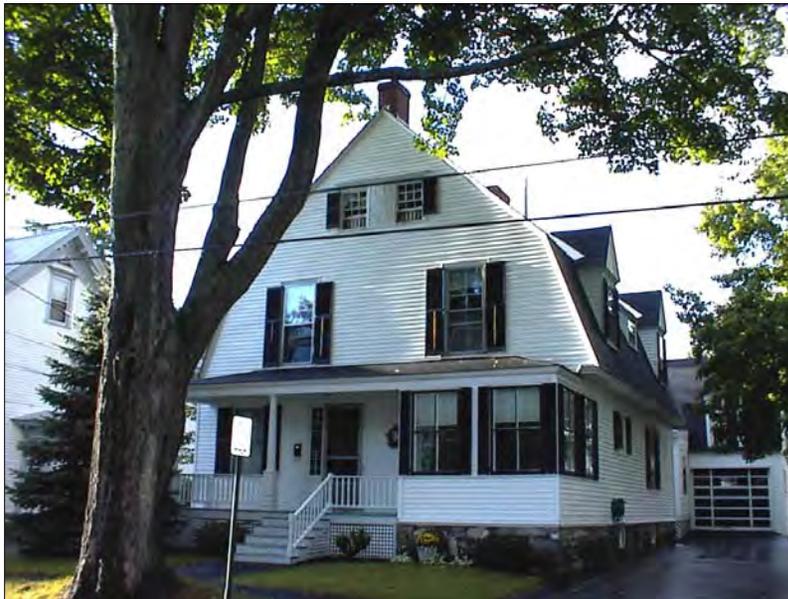
Other Colonial Revival Examples:

Top Left: A typical example of a “Colonial.” The windows are too wide and the entry portico too large for this house to be a true Colonial. Also note the side porch, a classic Colonial Revival feature.

Left: This house represents the eclectic mix commonly found on a Colonial Revival era house. The character defining features on this house include the gambrel roof, the small, multi-pane windows in the peak of the roof separated by a decorative panel, stone foundation, various types of dormers and a partially enclosed porch.

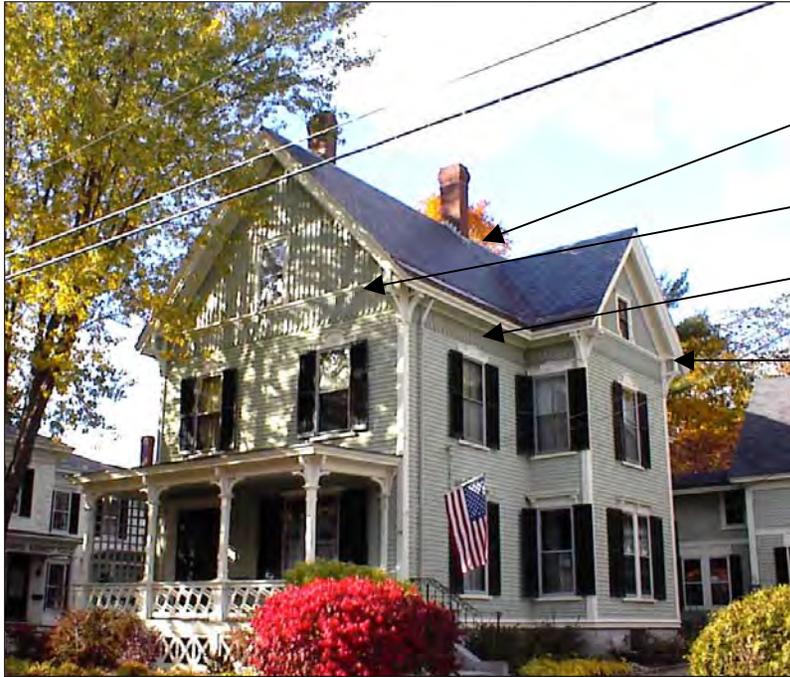
Stick Style Defining Features:

Cross gable roof.

Stick style detailing is typically comprised of horizontal, vertical or diagonal boards, or stickwork, that are intended to imply a sense of the building’s structure, but in reality have no correlation to the structural system. In some cases siding may be applied in different directions on a façade to create a complex pattern and texture.

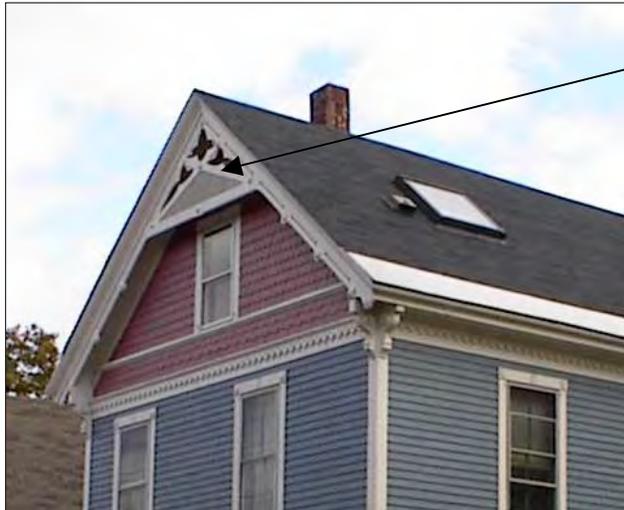
Left: Decorative trusses in the peak of the gable are a popular architectural detail in Stick Style houses.

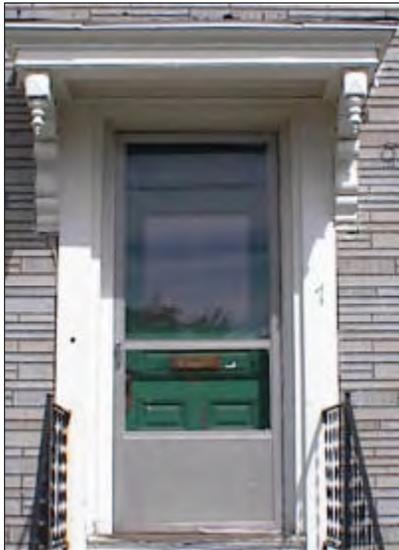
Left: Single wood paneled doors like this one are found throughout the district. The brackets supporting the roof, or pediment, over the doorway are also a common feature.

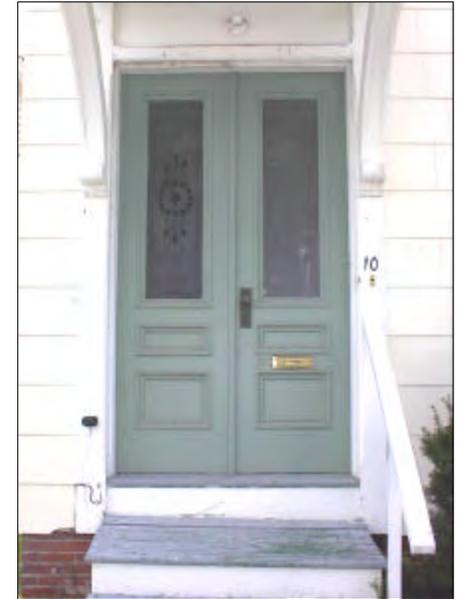
Occasionally, decorative glass panels are intact and should be preserved wherever possible.

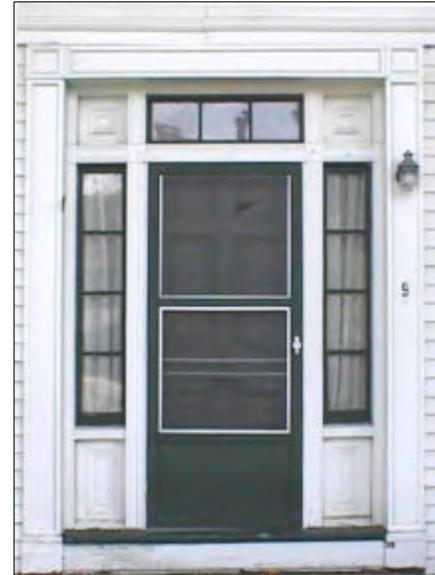
Left: This Greek Revival entryway represents a common doorway configuration found on Greek Revival houses in the district. The setback of the door within the framed opening is an important relationship to maintain.

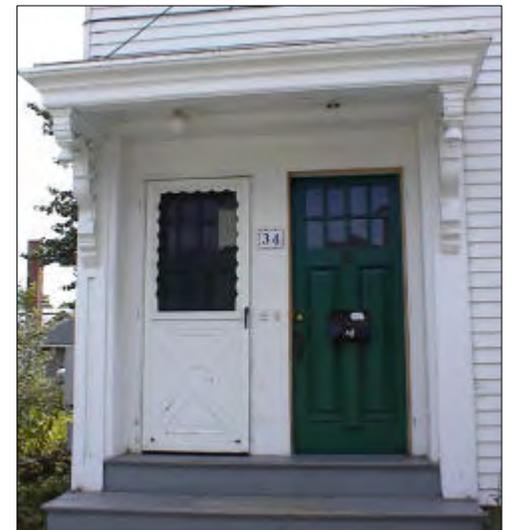
Storm doors often obscure large portions of a historic door. Here the white storm door does not obscure the glass in the upper part of the door, but would be more appropriate if the color were darker or matched the door color.

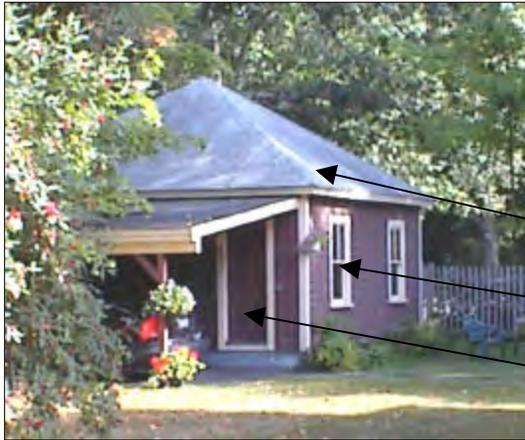
Right. On the right side, this garage retains its original hinged, wood doors with their vertical recessed panels and small panes of glass. On the left is a modern replacement door.

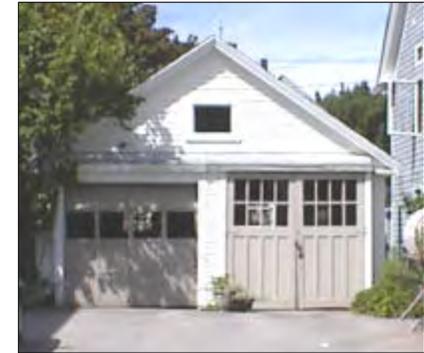
Although the modern door does incorporate panes of glass, it is not a compatible solution. The glass panes are much larger in scale than those on the original doors and the modern door's design emphasis is horizontal, as opposed to the vertical emphasis on the original doors.

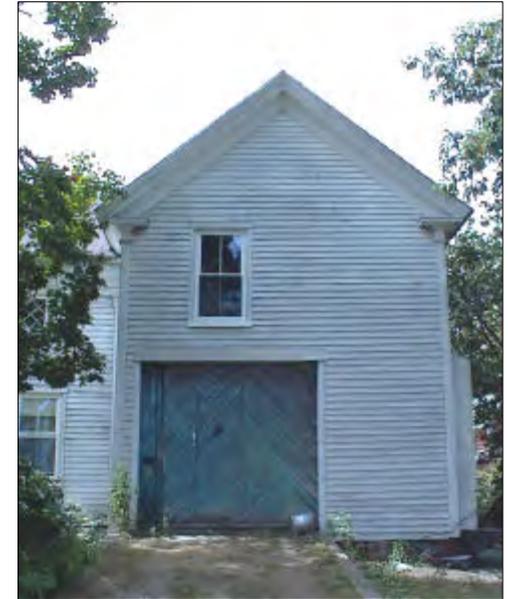
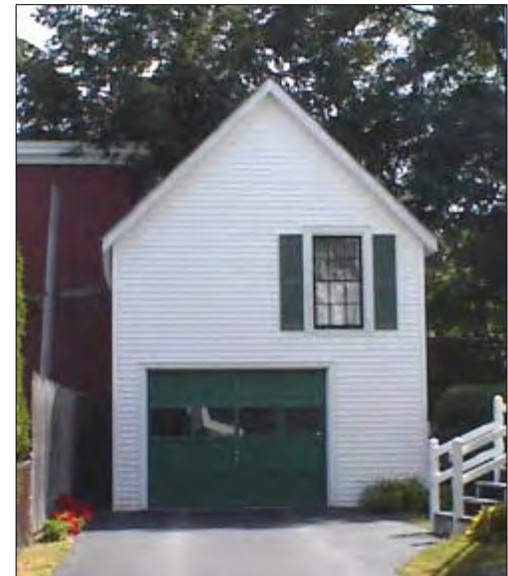
Right and Below: The attached carriage barn (right) and the detached carriage barn (below) both illustrate some of the typical carriage barn characteristics, including:

- an offset door in the gable end,
- the use of double-hung windows that match those in the main house, and
- architectural detailing that is similar to that used on the main house.

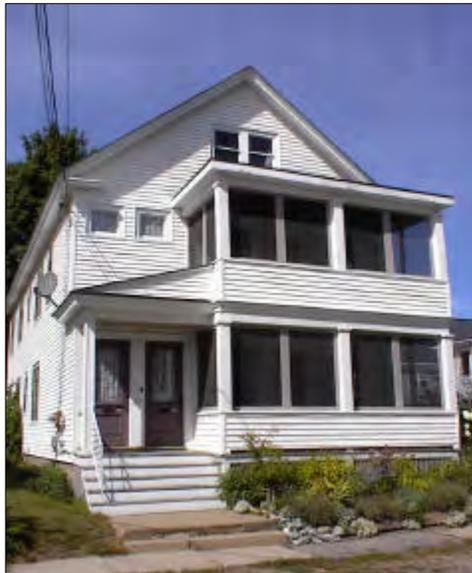
Right: Several houses in the district, like this one on School Street, (particularly double houses) have stacked or double porches.

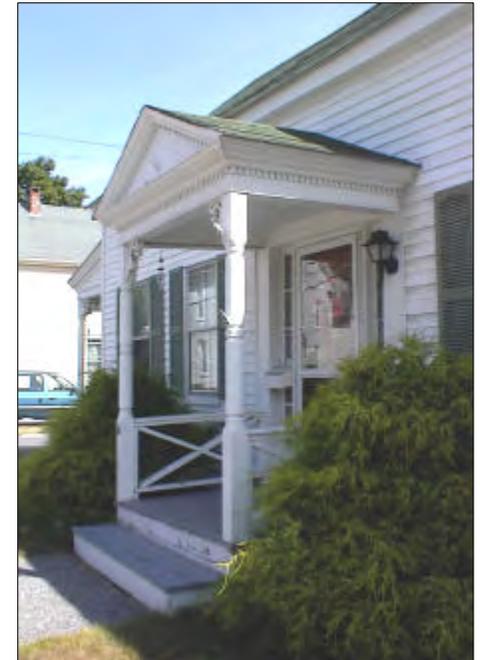
Right: Small entry porches are common throughout the district. Porches were often added to a house with a much earlier date of construction in an effort to up-date the house.

Wood is the most common material used for entry steps.

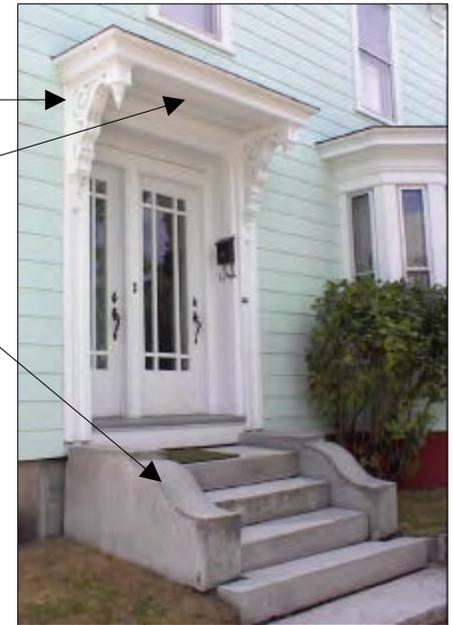
Right: This distinctive entry pediment is found on a few houses in the district. It appears to be most frequently used on cape houses.

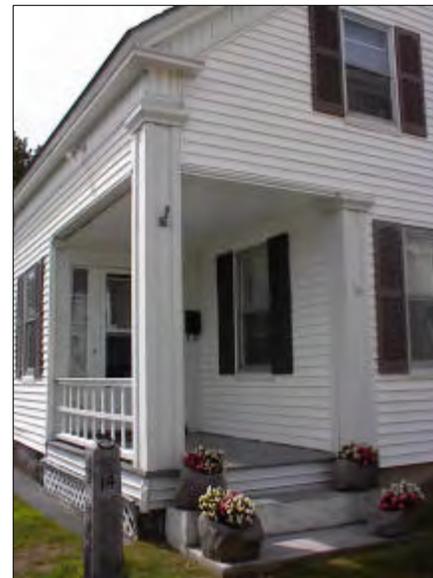
Left: Corner porches carved out of the main body of the house are also found in the district. This example is on Franklin Street. Typically, this porch configuration is found on Greek Revival style houses.

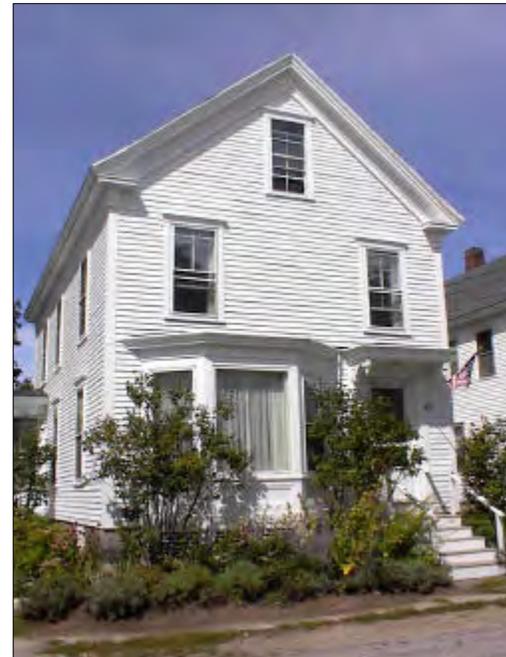
Left: The main entry's location on the "end" of this house on School Street is what makes this an end gable roof configuration. Many houses in the district are positioned with the gable end facing the street. A building's orientation contributes to the character and rhythm of the streetscape.

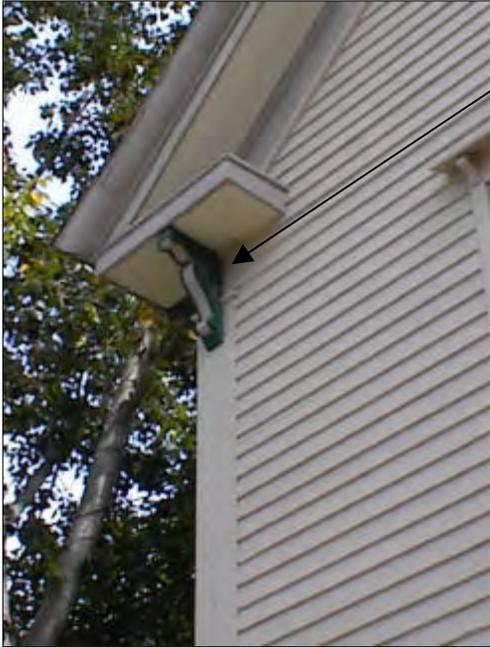
Left: Brackets are often found along the eaves of Italianate style houses. They can be single brackets, like this one, or grouped in pairs.

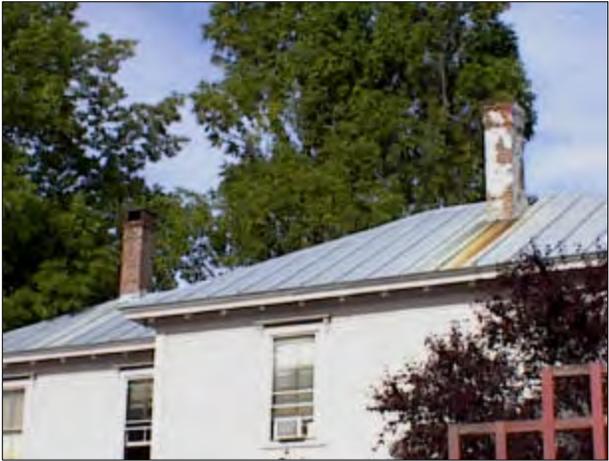
Above: Hipped roof with a standing seam metal roof. The width between seams establishes a strong pattern, which contributes to the character of the building. Typically, metal roofs in the district are aluminum or pewter colored, as opposed to bright colors.

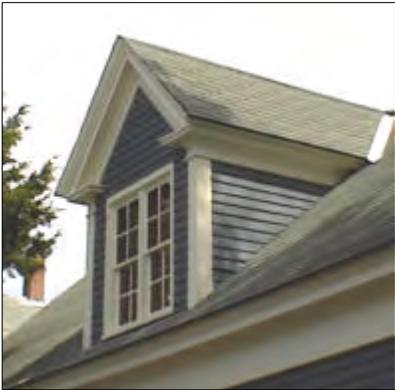
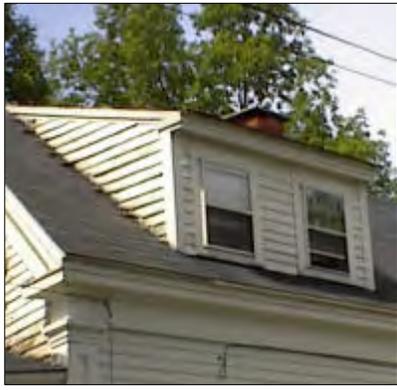
Below: Two examples of common dormer configurations: to the lower left is a gable dormer and to the right, a shed dormer.

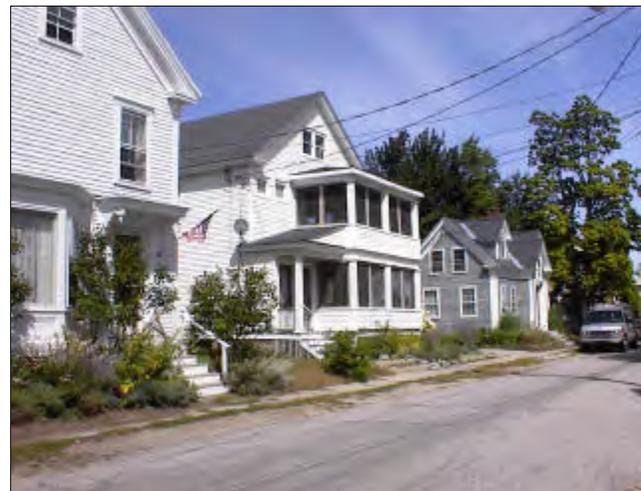
Left: This streetscape along School Street is defined by a sidewalk, houses situated close to the street and close to each other, and front steps leading directly onto the sidewalk.

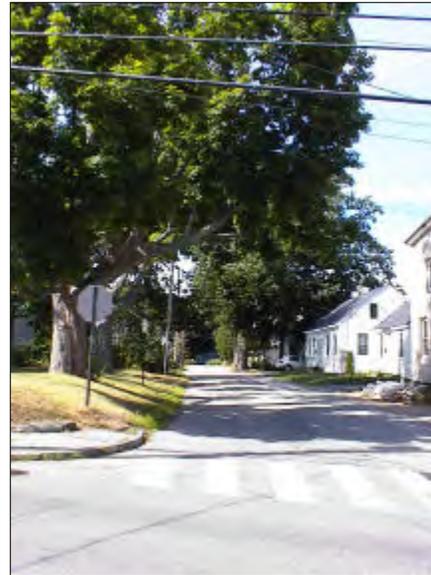
Left: The formal sidewalk and curbing ends at this intersection and the side street maintains a soft (or informal) street edge with no curbing or sidewalk. This change in the streetscape character reflects the difference between a major and a minor street. When considering alterations to the streetscape it is critical to understand the hierarchy of the streets, as well as the streetscape elements historically used in that particular neighborhood.

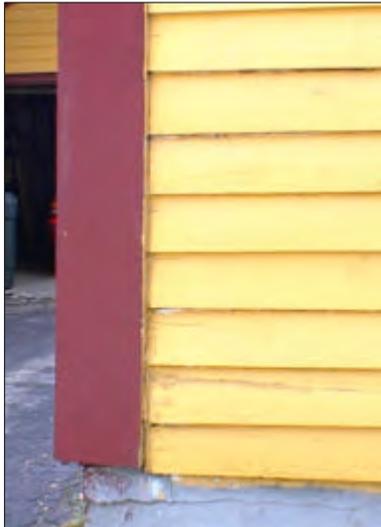
Left: Simple corner board and wood clapboards.

Although asphalt shingles had covered these clapboards for many years, the wood was found to be in good condition when the shingles were removed.

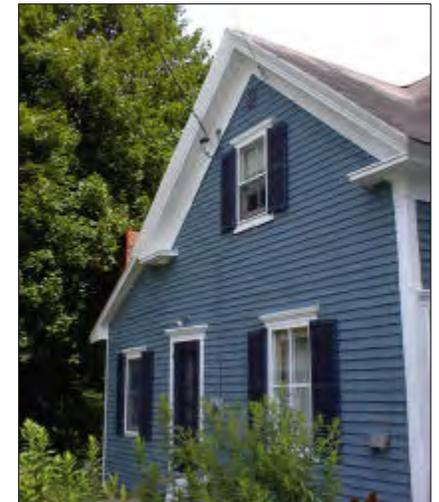
Right: Note how the clapboard edges, or coursing, align with the window and door lintels (trim at the top of the openings) as well as the window sills (bottom of the window trim).

This detail reinforces the horizontal emphasis of the exterior and unifies the building's appearance.

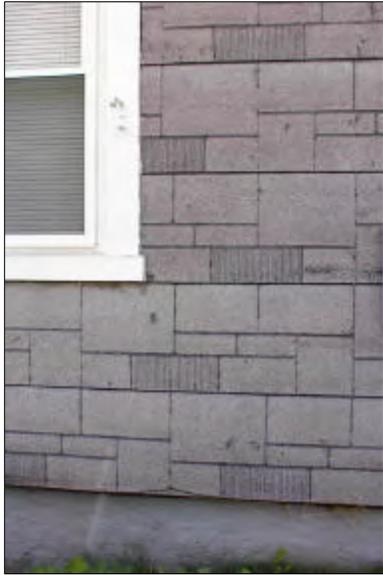
Left: Asphalt and/or asbestos shingles are often applied over original clapboards. These are not appropriate substitute materials because they do not simulate the original material.

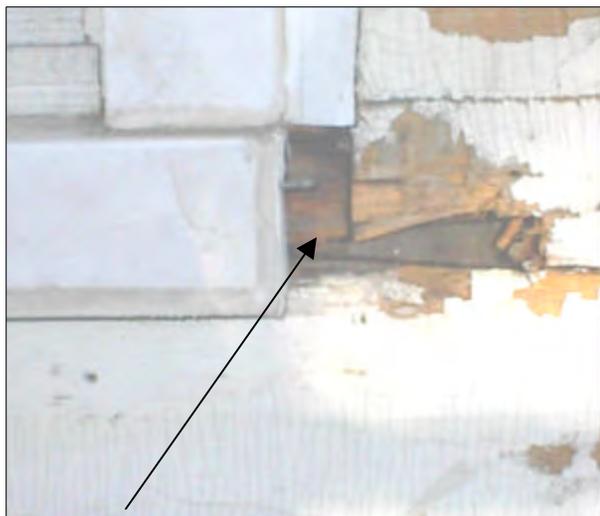
Above: The “ear” of end of the window sill was cut and removed to accommodate the installation of vinyl siding. Such a modification is not appropriate and diminishes the historic integrity of a building.

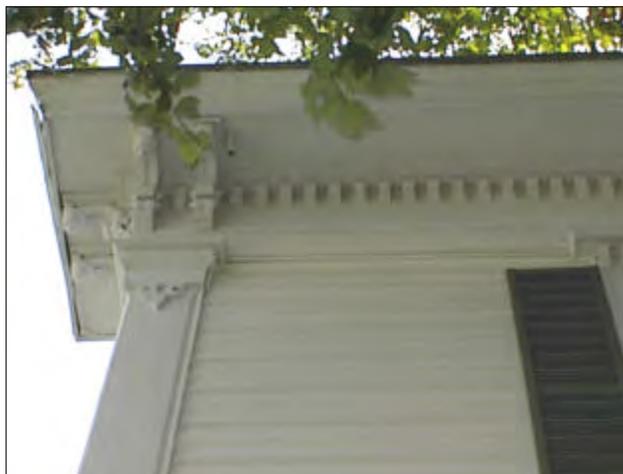
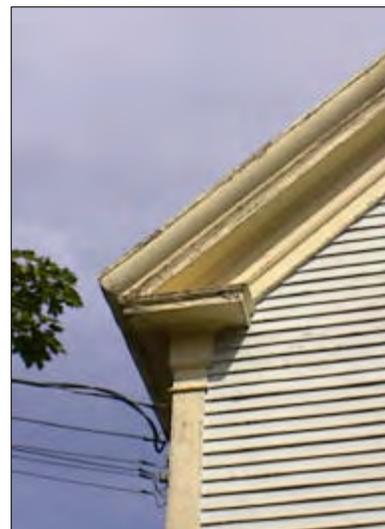
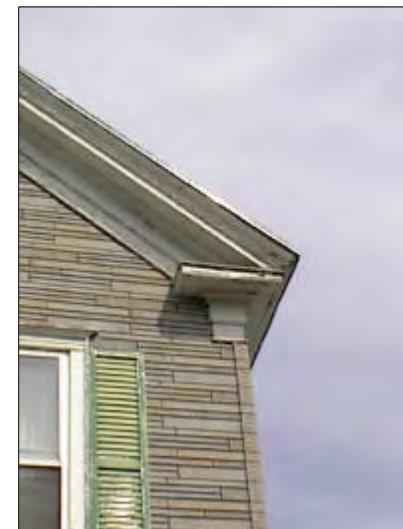
Above: The images above illustrate how the improper installation of a substitute material diminishes the historic character of a house.

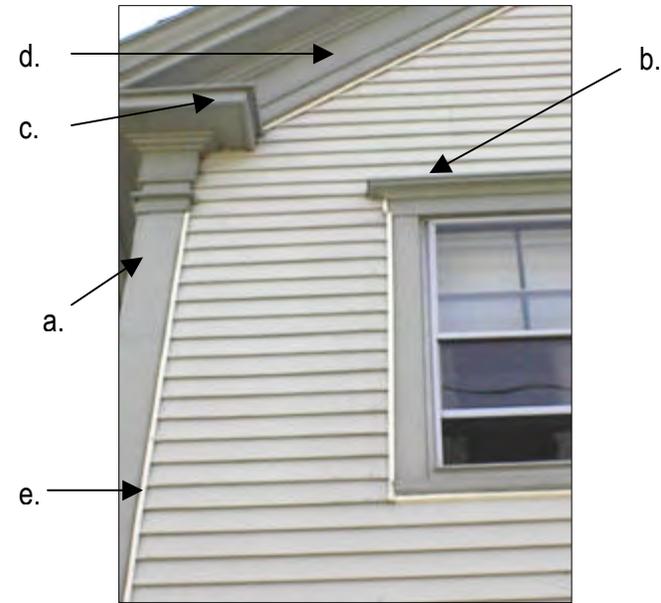
Above: Although preserving or restoring original cladding is preferable, this vinyl installation is an acceptable compromise. The important character-defining features have been retained, preserved, and remain uncovered, including:

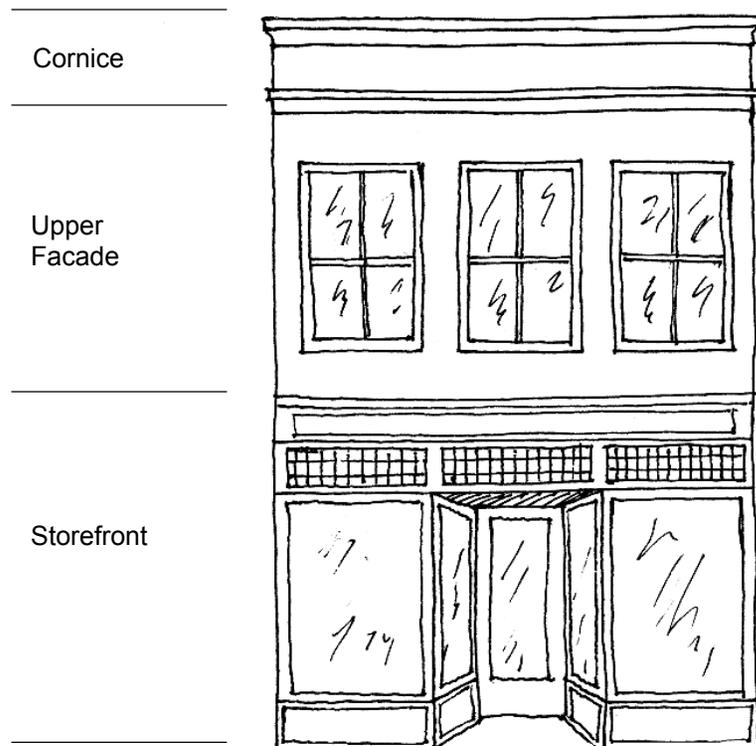
Facades are comprised of three different parts as illustrated below:

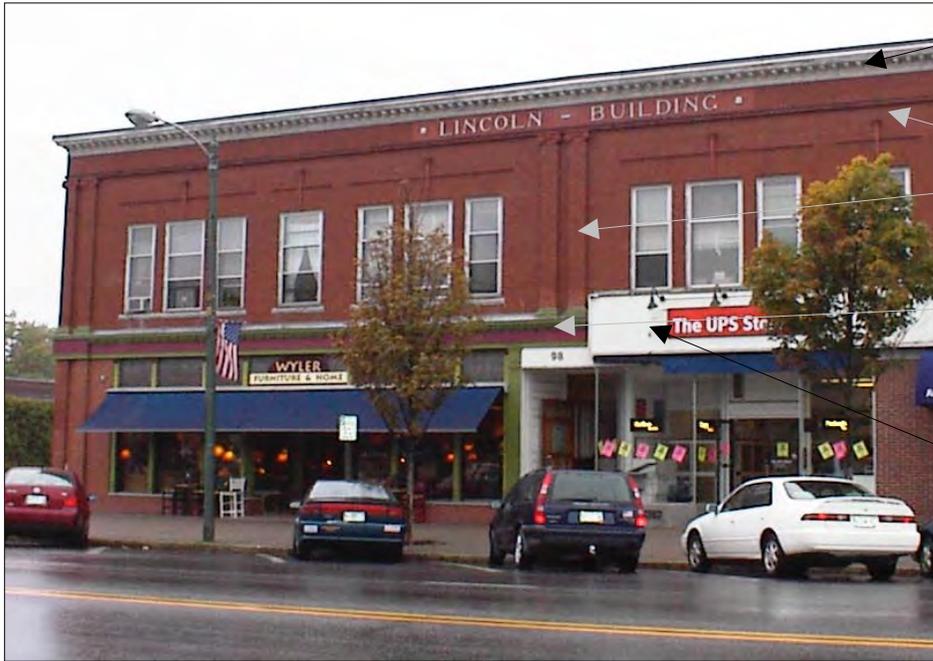
The majority of the buildings in downtown Brunswick are two or three stories in height with flat roofs. Common materials are brick, wood, and granite. Display windows are usually encased in wood, cast iron or aluminum frames. Recessed entries can be found throughout downtown. Upper floors are characterized by double-hung windows with bay windows found on some buildings.

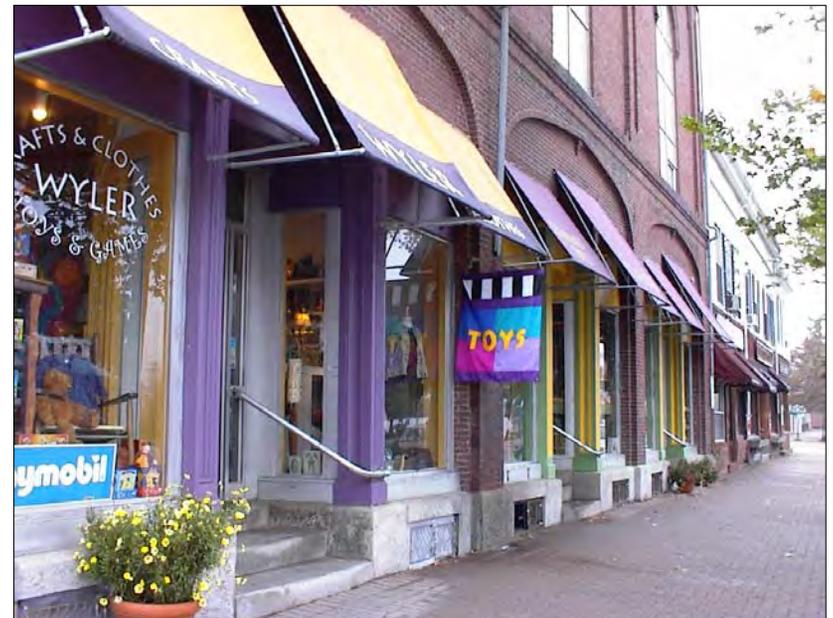
Right: Recessed entries and display windows establish a strong rhythm along the sidewalk. The brick and cast iron piers define a major rhythm with the display windows establishing a minor rhythm. The awnings also reinforce the pattern of openings.

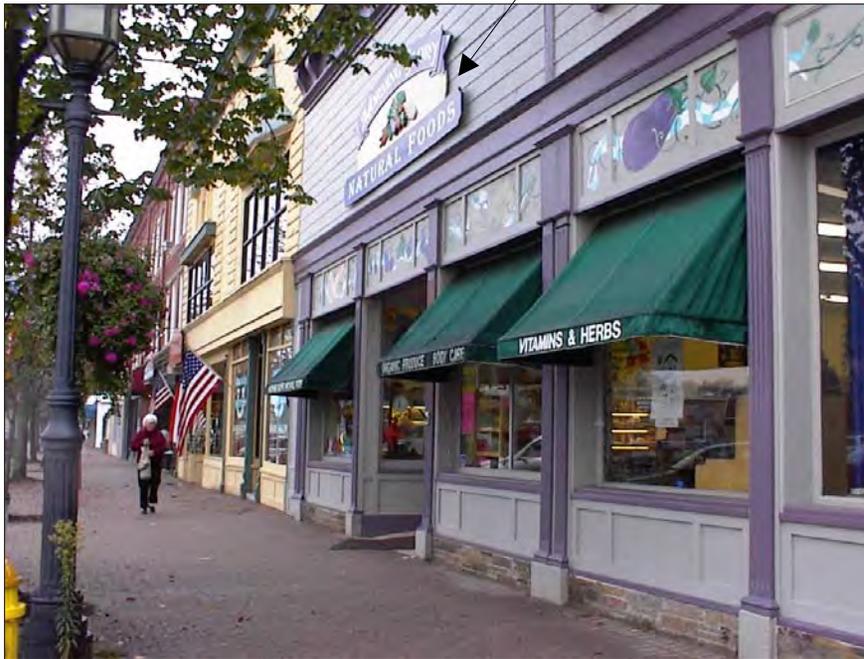
Flush mounted sign.

Above: This image of Maine Street illustrates how flush mounted signs can be used in conjunction with awnings to communicate information about a business.

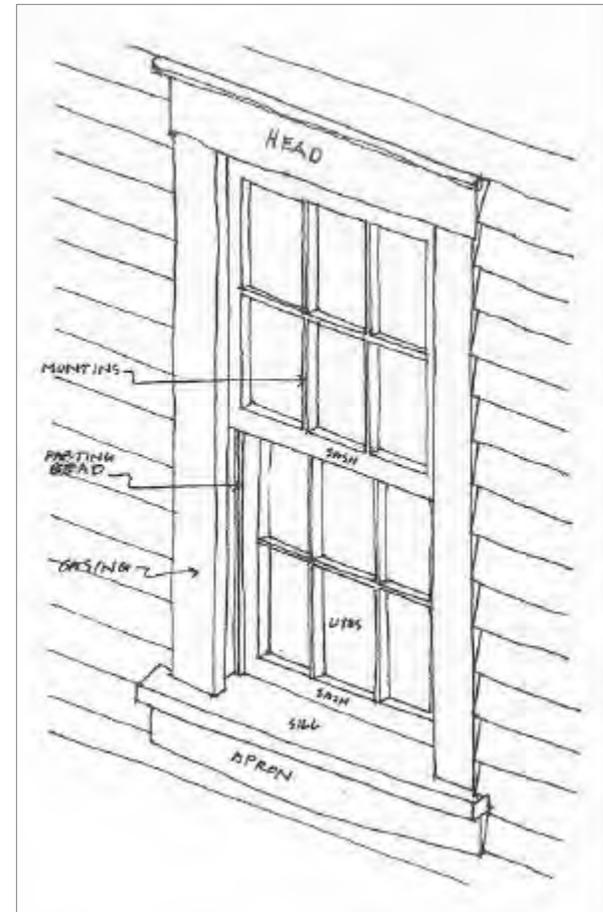
Above: The parts of a double-hung window.

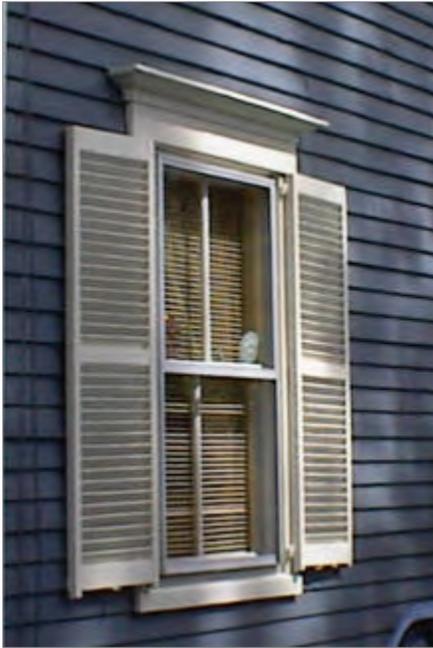
Left: The exterior aluminum storm on this window is barely discernable and does not detract from the two-over-two window configuration. Character-defining features like the lintel above the window are important to repair and retain.

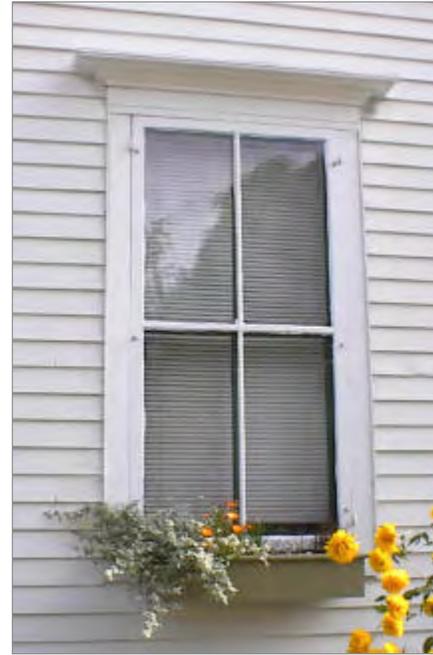
Left: Maintaining or replicating the original exterior wooden storms is an appropriate design solution for older windows. Storms should match the configuration of the windows as in the case of the window pictured to the left.
