Village review design guidelines

Part I – Architectural Context

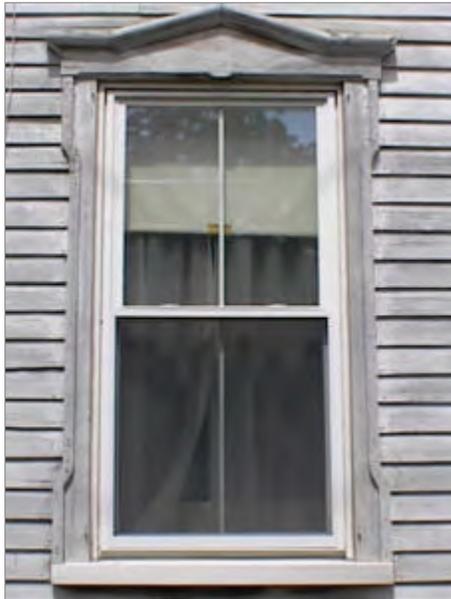
Above: Decorative trim (surrounds) around the window is an important character-defining feature to maintain whether or not the sash needs to be replaced.

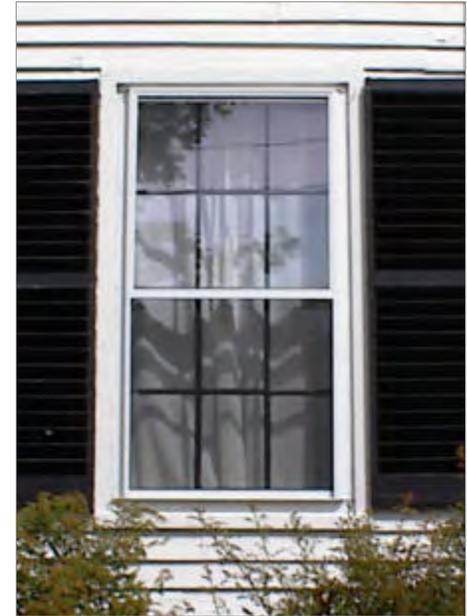
Right: Double-hung, wood windows are common throughout the district. Typical glazing configurations are: six-over-six (as pictured here); four-over-four and two-over-two.
