PORCHES & ENTRIES

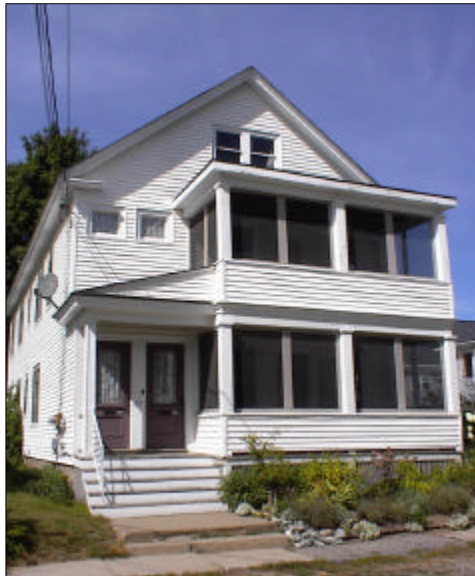
Right: Several houses in the district, like this one on School Street, (particularly double houses) have stacked or double porches.

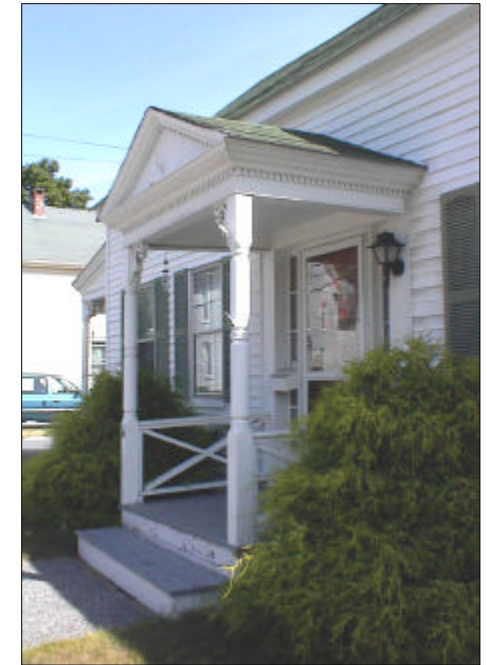
Right: Small entry porches are common throughout the district. Porches were often added to a house with a much earlier date of construction in an effort to up-date the house.

Wood is the most common material used for entry steps.

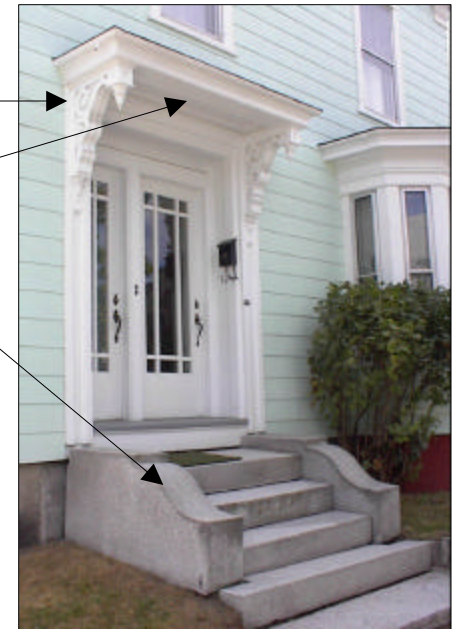
Important entry features:

Brackets

Small pediment

Steps and side walls

The majority of Federal and Greek Revival style houses in Brunswick did not originally have entry porches; however, porches were often added to these houses. There are many properties with a small roof pediment over the main entry, which is supported by decorative brackets. This detail was common during the mid-to-late 1800s and is characteristic of the Italianate style.

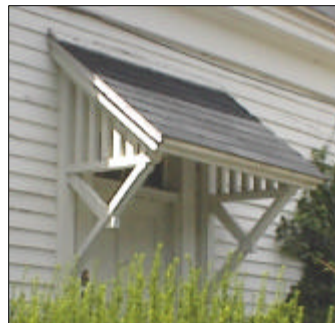
Right: This distinctive entry pediment is found on a few houses in the district. It appears to be most frequently used on cape houses.

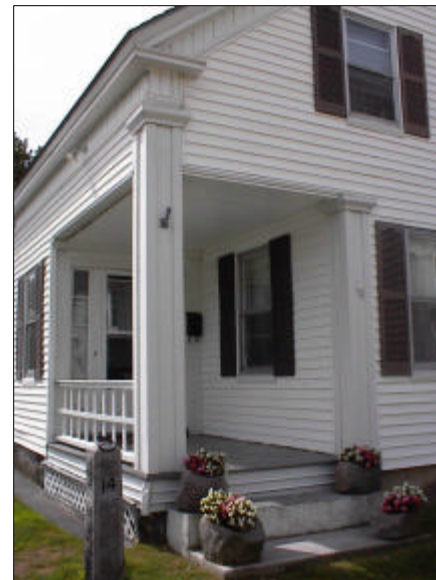
Left: Corner porches carved out of the main body of the house are also found in the district. This example is on Franklin Street. Typically, this porch configuration is found on Greek Revival style houses.
